# Annual Compliance Report

17 October 2023 to 16 October 2024 EPBC 2013/7057  
Spring Mountain Mixed Use Master Planned Community  
Development, Spring Mountain, Queensland

Prepared for Lendlease Communities (Springfield) Pty Limited  
14 January 2025

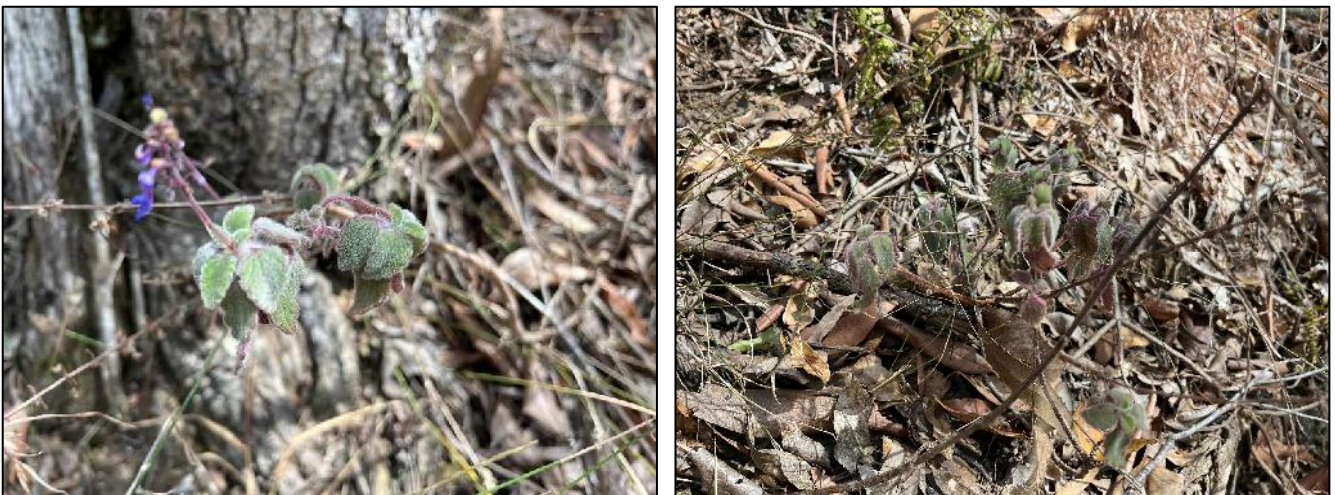
**Photo set 1:** Observed specimens of *C. habrophyllus* specimens within the on-site conservation area.

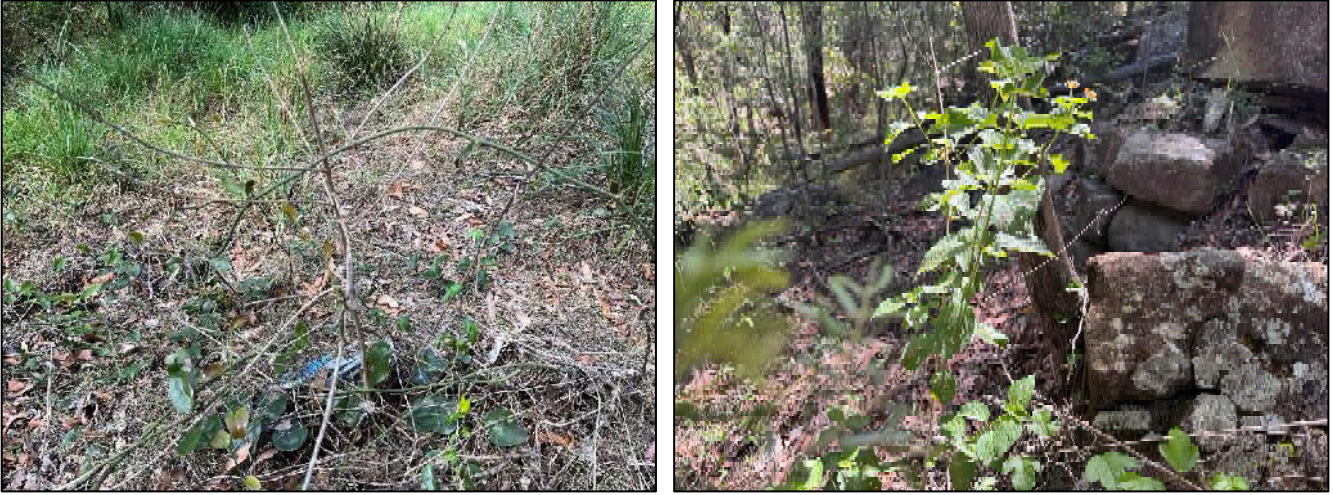
**Photo set 2:** Treated Lantana (left) and regrowth Lantana (right) within on-site conservation area.

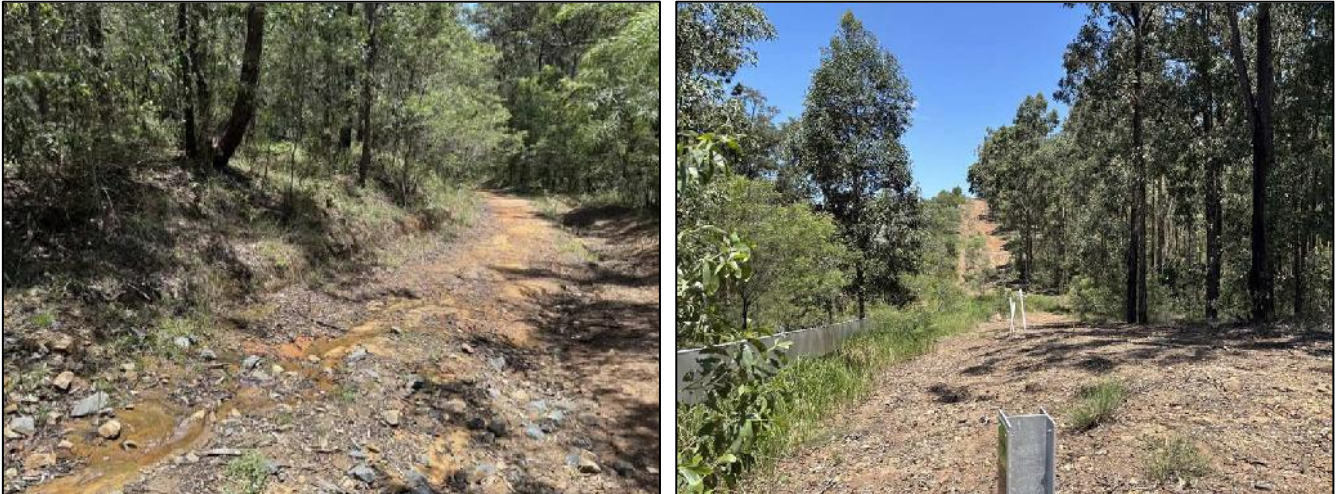
Upon the survey conducted during the Years 7 and 8 ACR, all tracks which are required to be maintained were found to be accessible and well-maintained (refer **Photo set 3**). There was no evidence found that would suggest areas of significant erosion.

**Photo set 3:** Access tracks within the Offset Area indicating minimal erosion.

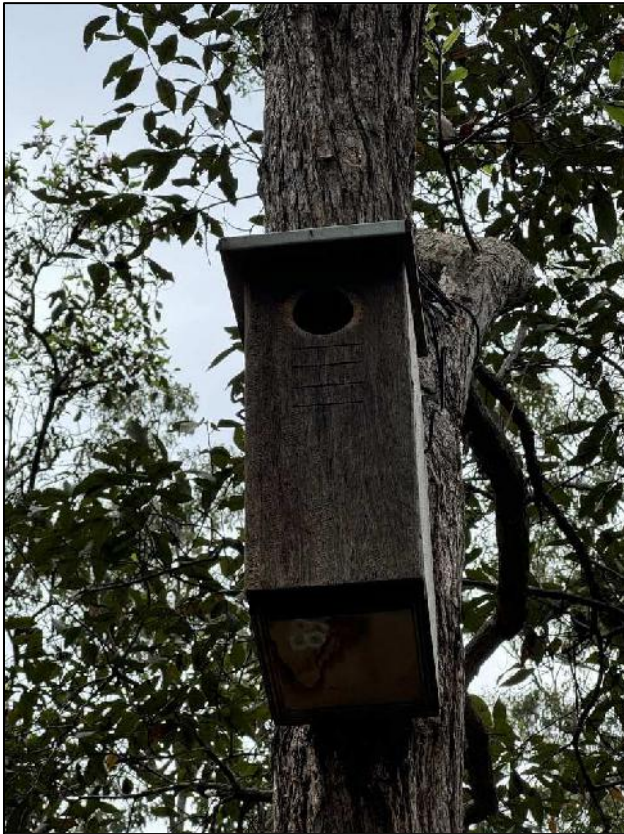
Maintenance Checklist of Nest Box ID: <b>Box 3</b>	Correct	Incorrect	Other
1. Box is not occupied by pest species	✓		
2. Box is not vandalised or missing	✓		
3. Box is securely attached with slight lean forward	✓		
4. Box is located at optimal height	✓		
5. Box is not damaged or rotten	✓		
6. The foot holds/ladder in interior of box for young is intact	✓		
7. There are no blockages in drainage holes	✓		
8. Entrance hole is free from obstruction and not damaged or worn	✓		
9. Nesting materials have been replaced to cover floor of box	✓		
10. All soiled materials like old shavings, membrane, egg shells have been removed	✓		
11. Box is aligned away from prevailing winds, rain and excessive heat	✓

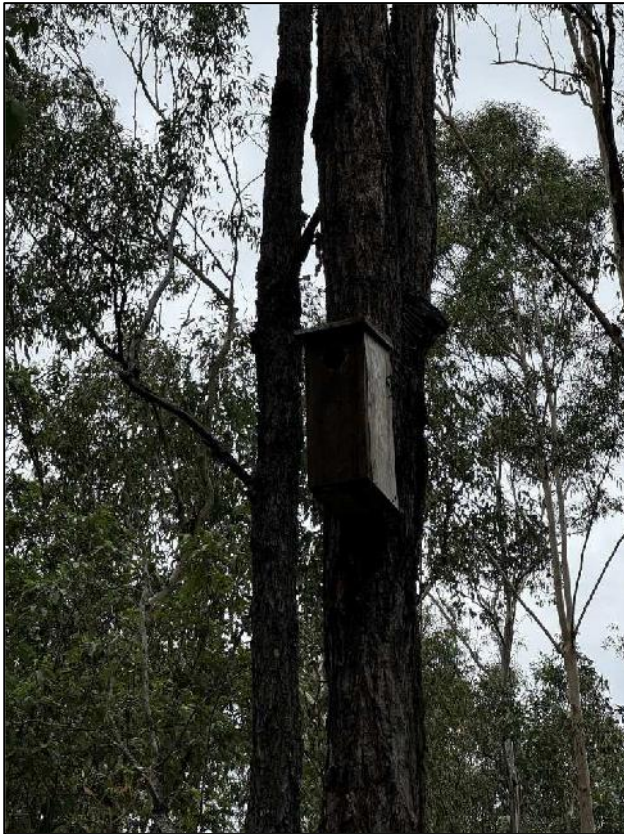
Maintenance Checklist of Nest Box ID: <b>Box 4</b>	Correct	Incorrect	Other
1. Box is not occupied by pest species	✓		
2. Box is not vandalised or missing	✓		
3. Box is securely attached with slight lean forward	✓		
4. Box is located at optimal height	✓		
5. Box is not damaged or rotten	✓		
6. The foot holds/ladder in interior of box for young is intact	✓		
7. There are no blockages in drainage holes	✓		
8. Entrance hole is free from obstruction and not damaged or worn	✓		
9. Nesting materials have been replaced to cover floor of box	✓		
10. All soiled materials like old shavings, membrane, egg shells have been removed	✓		
11. Box is aligned away from prevailing winds, rain and excessive heat	✓
