Caloundra South

2018/2019 Annual Compliance Report -

EPBC 2011/5987

12 April 2019

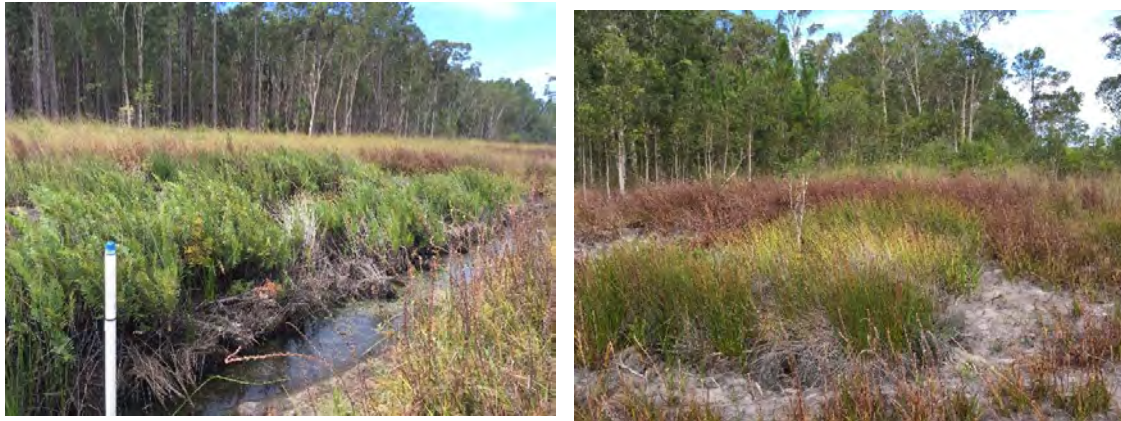
Figure 4: Completed Wallum Sedge Frog habitat ponds along the southern bank of Bells Ck Nth

Frog ponds within the northern movement corridor (Precinct 2, Lamerough Creek), and northern bank of Bells Creek North (Precincts 2-5) were created during the 2015/2016 and 2016/17 reporting periods respectively. These ponds were subject to biannual monitoring, with some of the ponds (Precinct 2 ponds) collectively reported to support all three Acid Frogs - the Wallum Froglet (breeding confirmed), Wallum Rocket Frog, and Wallum Sedge Frog (breeding confirmed) (Figure 5). Several Precinct 2 ponds required corrective actions in 2016, in response to high pH and low tannin staining water quality results. Recent results from the pH testing of these ponds show pH levels as low as 5.25 (December 2018), which is significantly less than the average value of 6.11 in 2016 prior to corrective actions. Increased organic matter growth, death, decay and accumulation will likely further decrease the pH levels within these ponds. Further information about the implementation of the Wallum Sedge Frog Management Plan is provided in Section 3 and Appendix A.

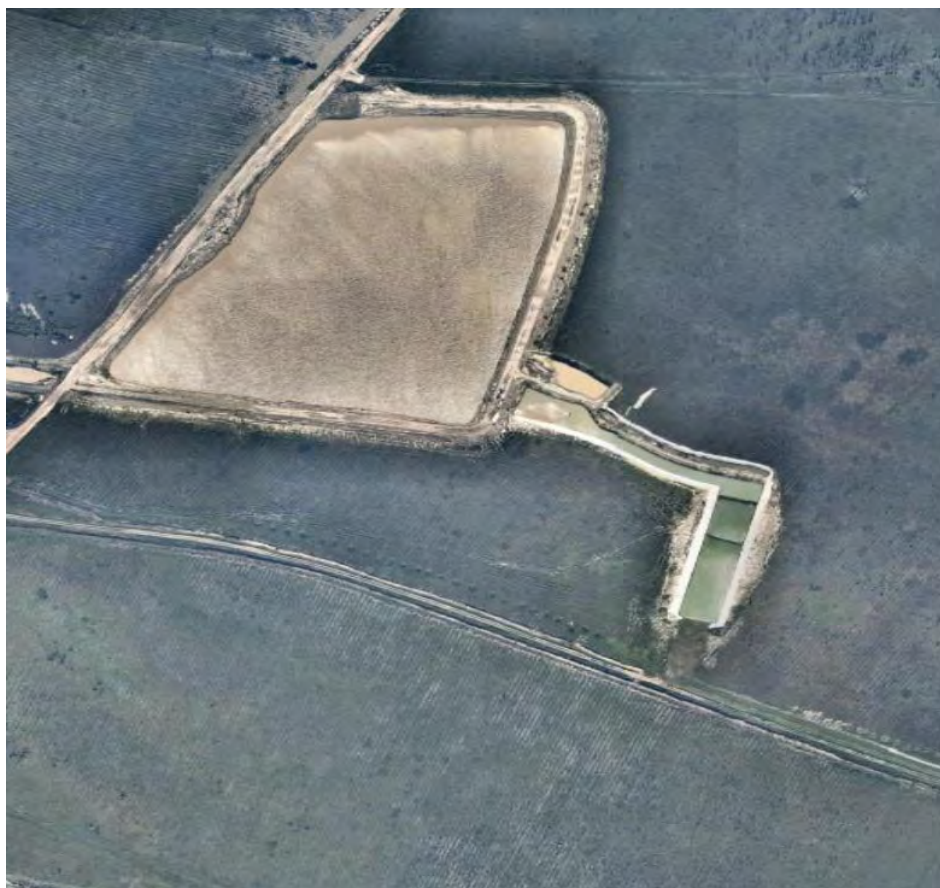
Figure 7: High efficiency sediment basin installed as part of Precinct 7-10 works

The design and operation of high efficiency sediment basins is continually being improved to adapt to local soil conditions and construction activities. A hybrid design of high efficiency sediment basin has been developed and implemented on site, which is capable of treating runoff continuously during a rainfall event, as well as capturing and storing runoff for treatment following cessation of the rainfall event, as per the design of a traditional sediment basin (Figure 7).

This hybrid design has been implemented to address site specific conditions, particularly the presence of low pH surface runoff, which typically requires additional treatment and retention time to ensure downstream discharge requirements are achieved. The hybrid design offers an increased level of protection to sensitive receiving environments and provides the flexibility to refine the operation of the high efficiency sediment basins. High efficiency sediment basins have also been designed to have a kidney shape to accommodate a wetland function following completion of construction.
