LENDLEASE COMMUNITIES SPRINGFIELD RISE - VILLAGE 13 BASIN SITE BASED MANAGEMENT PLAN - GRANDE AVENUE

This phase specific Site Based Management Plan (SBMP) has been prepared for works associated with the Village 13 Basin (V13 Basin) at Springfield Rise, Spring Mountain Estate and incorporates the management intent, objectives and specifications detailed within the overarching environmental management plans prepared for the development.

The 2,600m2 biorention basin will be divided into three cells and stormwater inlets will be optimised to ensure even distribution of flows into the split cells. Flow will entre via a 150m2 forbay before being split into the cells. The approved basin design has been informed by the MUSIC assessment.

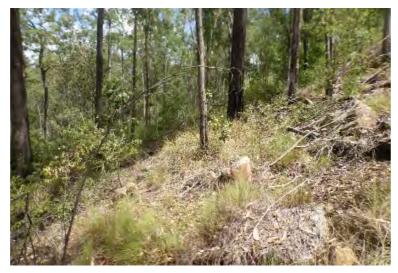
Photo: Rock outcrops within the ridgeline areas observed along south facing slope.

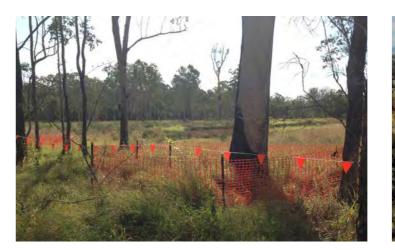
Significant Tree Protection Fencing

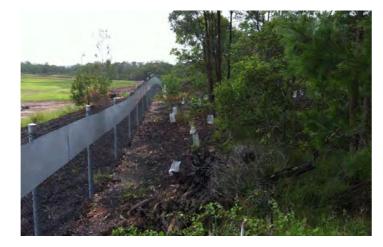
Fauna Exclusion Fencing

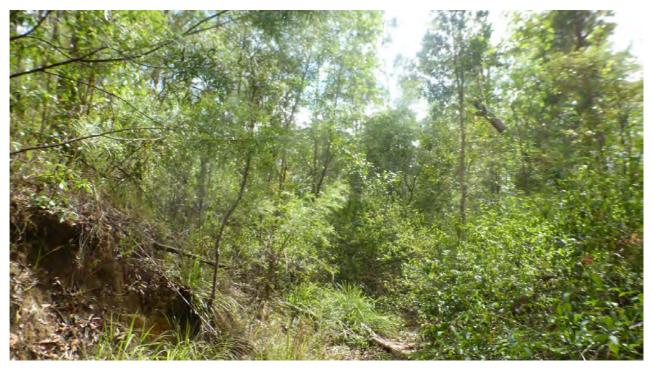
Photo: Transect 1 waterway areas dominated by dense Lantana camara (Lantana)

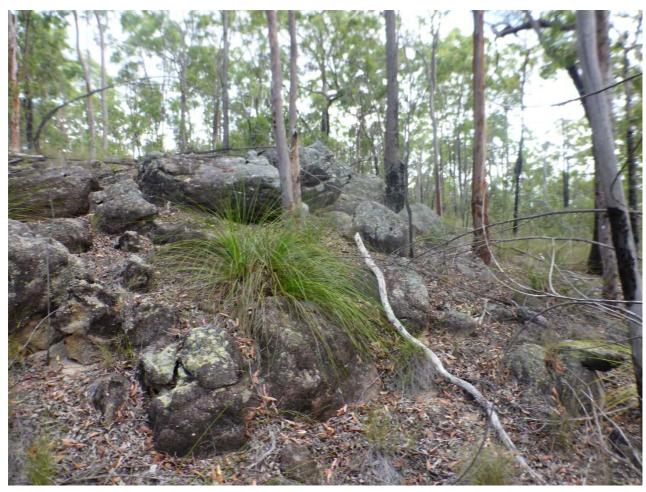
Photo: Transect 1 rock outcrops within the ridgeline areas observed along western facing slope.

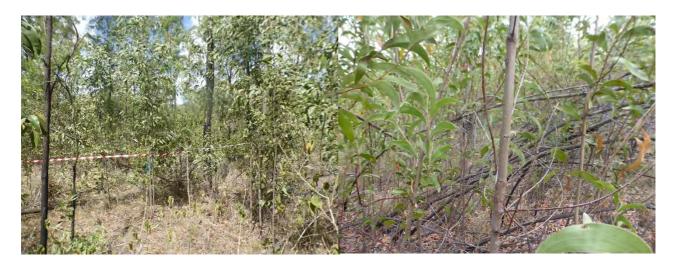
Photo: Transect 1 included patches of dense Acacia leiocalyx as a result of past fire periods.

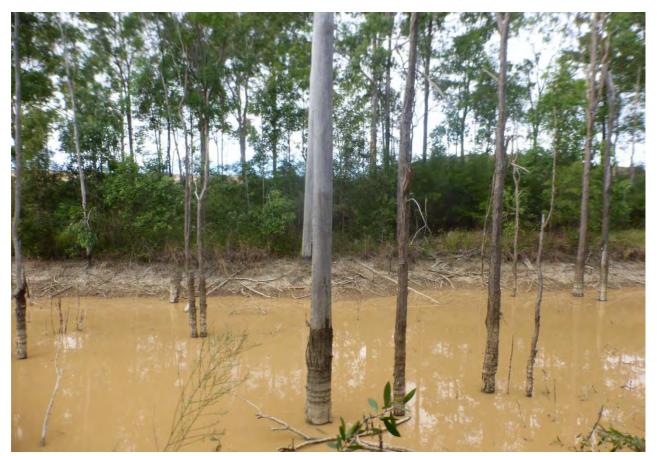
Photo: Transect 2 waterway areas dominated by dense Lantana camara (Lantana)

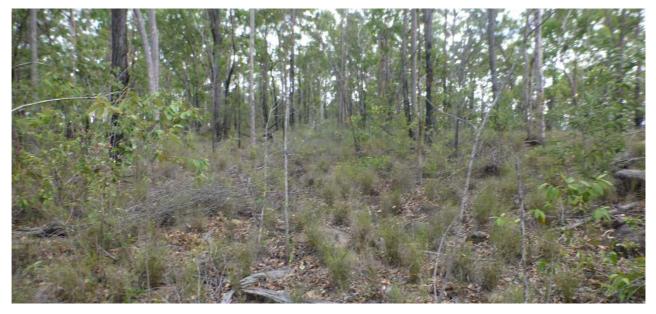
Photo: Transect 2 rocky outcrops within the ridgeline areas.

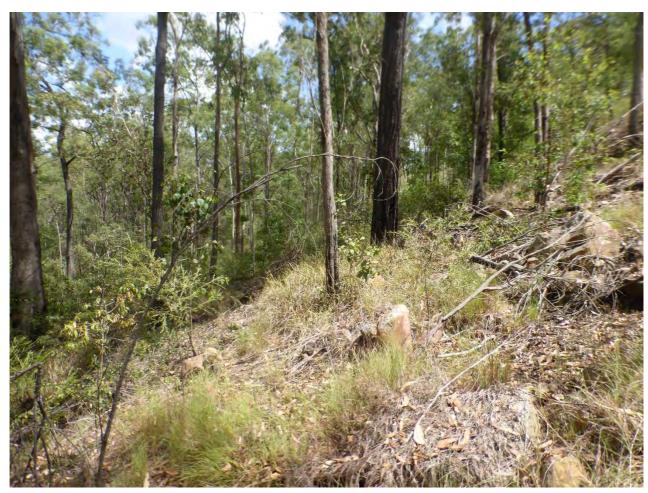
Photo: Transect 2 Steep south facing slope.

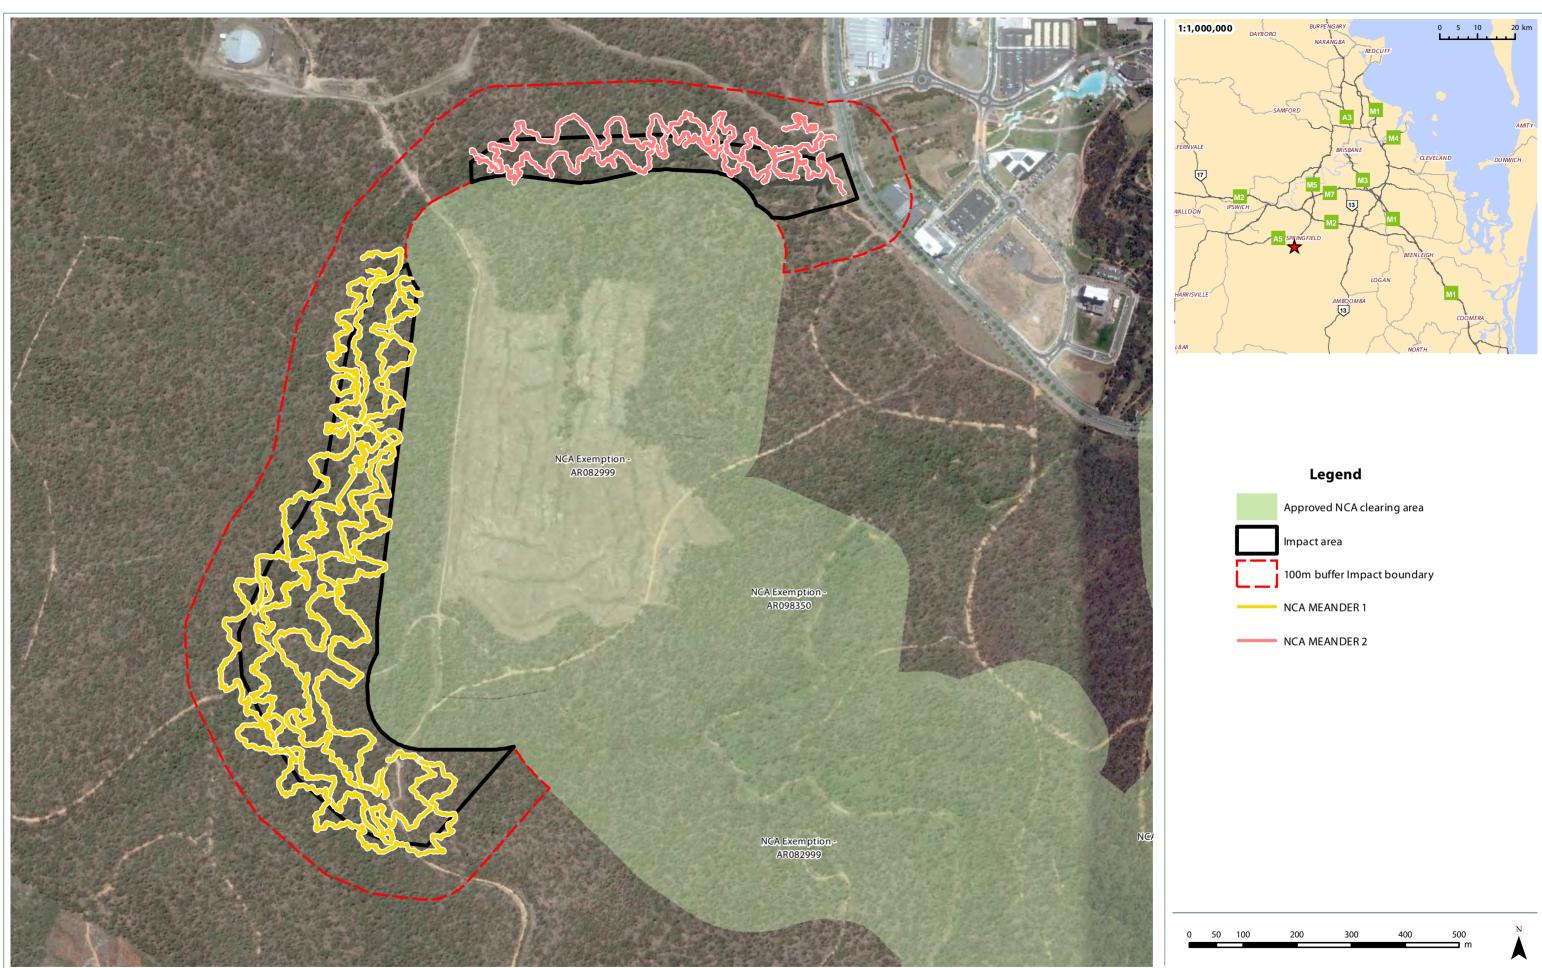
Attachment I – *Plectranthus habrophyllus* Pre-clearance Survey Extent

Approximate extent of Plectranthus habrophyllus ID - Plec 1. Approximately 10 mature individuals within approximately 500m². Development footprint, proposed residential, 20m to northwest.

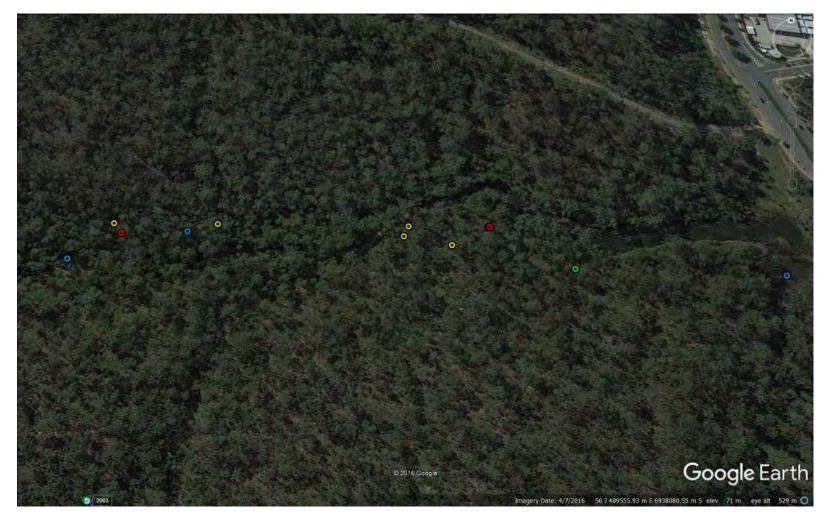
Map 2: Localities for identified terrestrial and arboreal habitat features
