LENDLEASE COMMUNITIES

SPRING MOUNTAIN

SITE BASED MANAGEMENT PLAN - HAUL ROAD

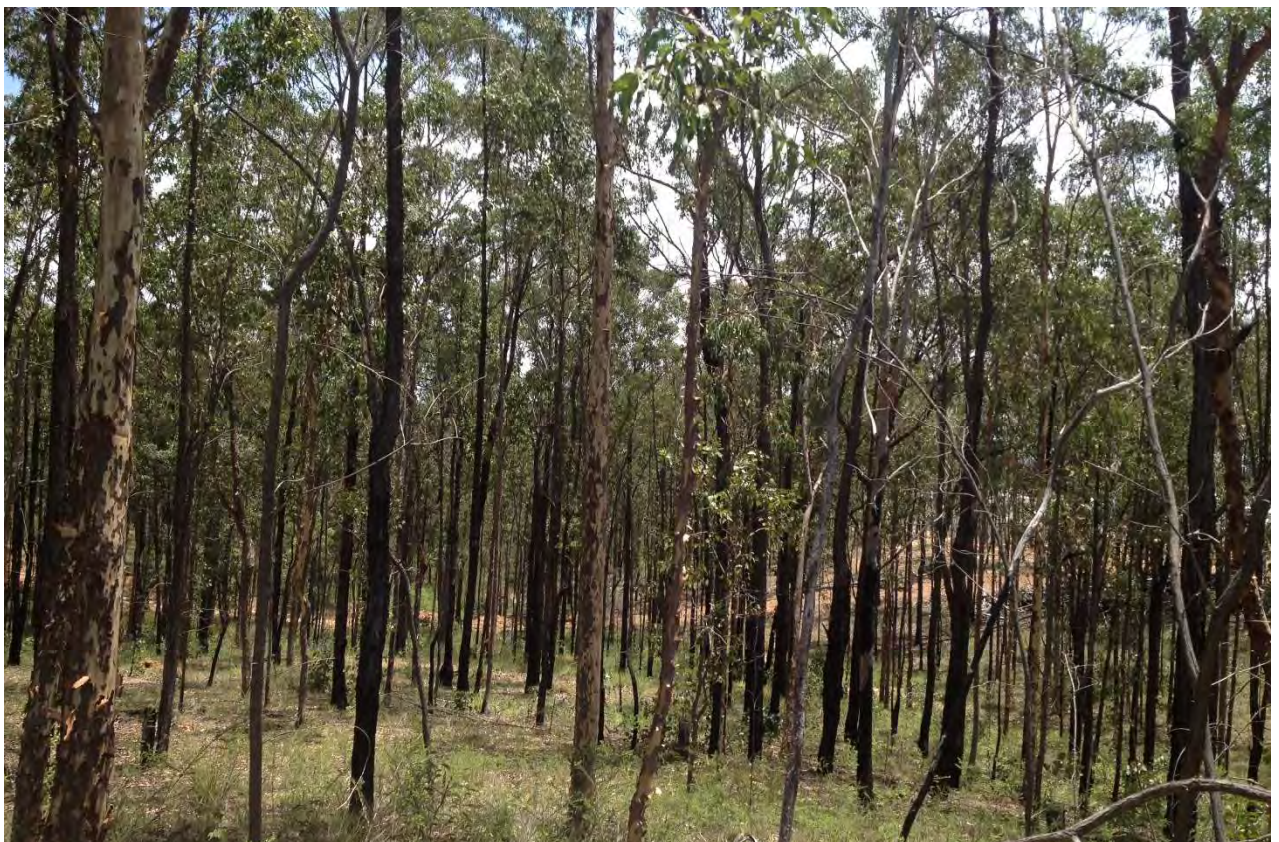
Only a small area of exposed rock surface was observed along a portion of the ridge line adjacent to the cleared track throughout the transect area. This area was thoroughly searched specifically for both *Marsdenia coronata* (Slender Milk Vine) and *Plectranthus habrophyllus* (Plectranthus) both of which have habitat niches suited to this terrain. The remaining area retained an open understorey and ground layer.

Photo: Transect 1 dominated by *Corymbia henryi* and *Eucalyptus fibrosa*.

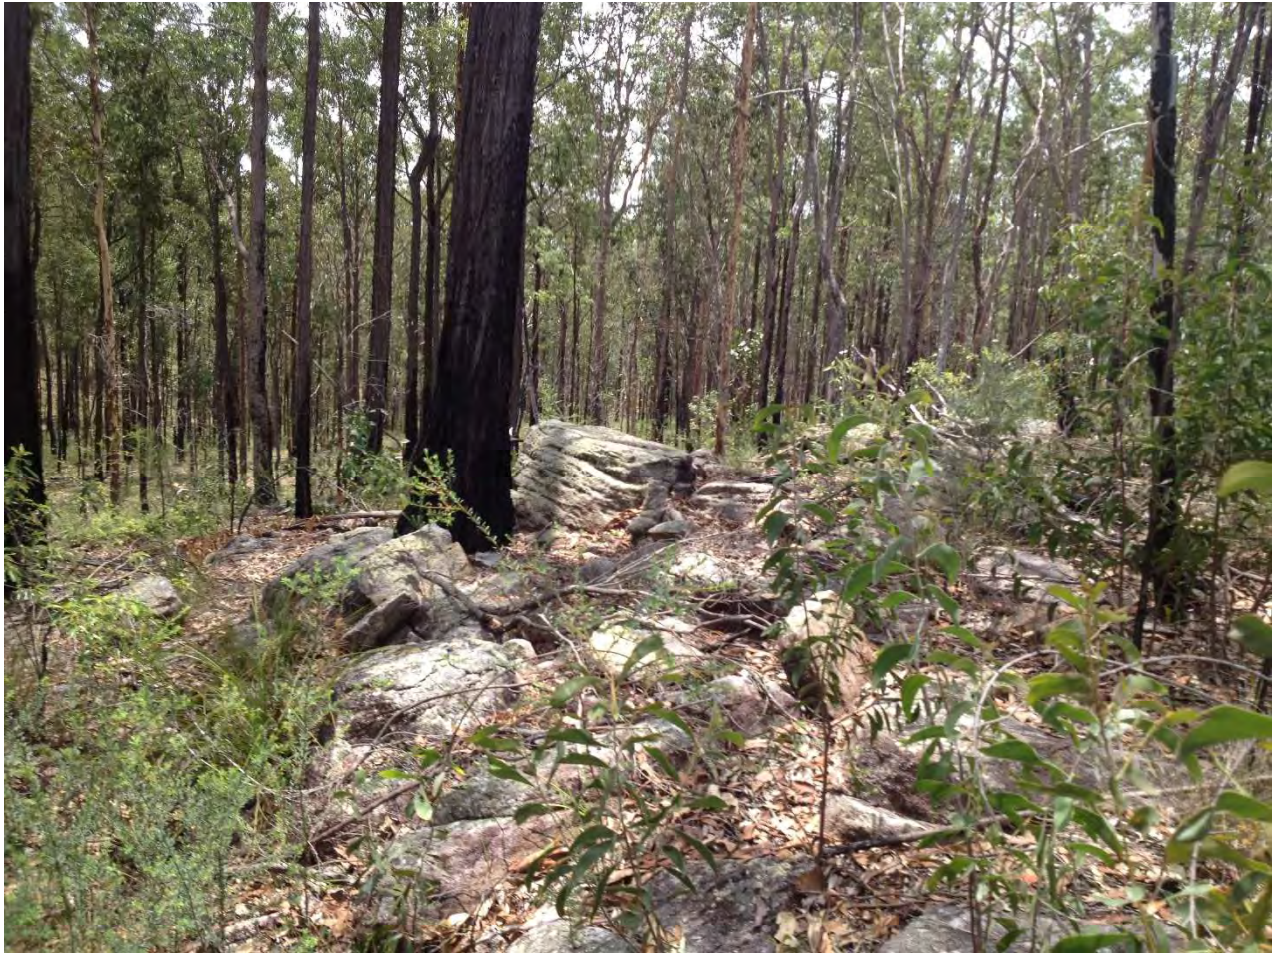
Photo: Exposed rocky terrain observed along the ridge line.
