Annual Compliance Report

17 October 2020 to 16 October 2021 EPBC 2013/7057
Spring Mountain Mixed Use Master Planned Community
Development, Spring Mountain, Queensland
Prepared for Lend Lease Communities (Springfield) Pty Limited
17 January 2022

Job No. 7243 E

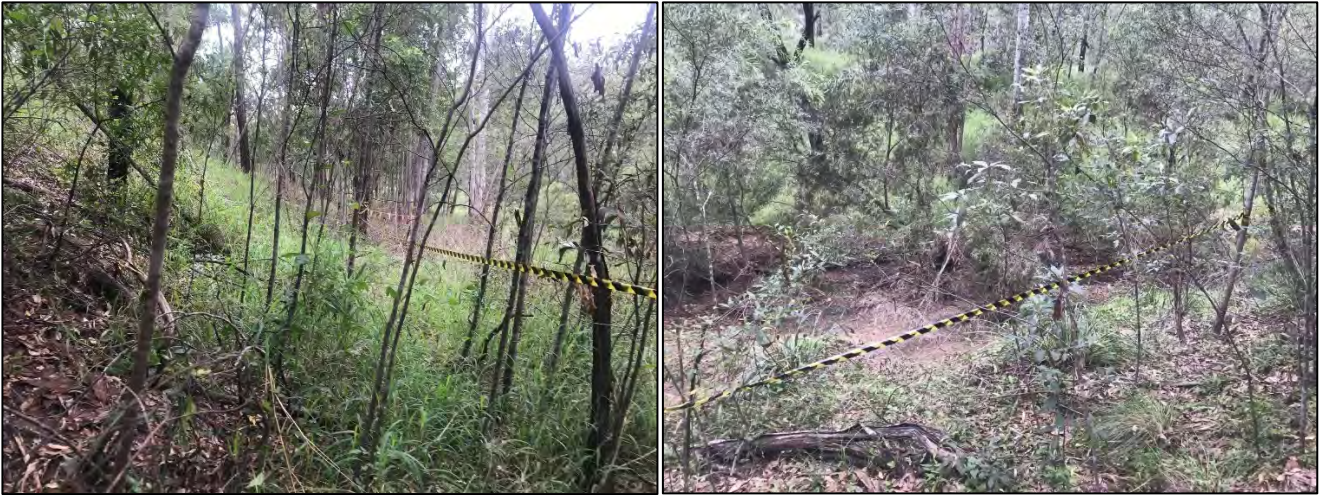
Photo Set 1: Demarcation fencing within Conservation Area

Due to the increased number of observed *Coleus habrophyllus* specimens and findings from the site inspection on 22 April, an assessment to determine the density of *C. habrophyllus* within the conservation area was performed on 15 July 2021 by two (2) Ecologists. Due to the high numbers of the species observed, a density-based population assessment was used as it was not feasible to count every specimen. The assessment was carried out in accordance with the Queensland *Flora Survey Guidelines – Protected Plants* by two (2) Ecologists from Saunders Havill Group. During this assessment, a small cluster of *C. habrophyllus* specimens was identified approximately 10 m west of the existing demarcated conservation area. As a result, the buffer area was extended to reflect the on-ground extent of the *C. habrophyllus* population

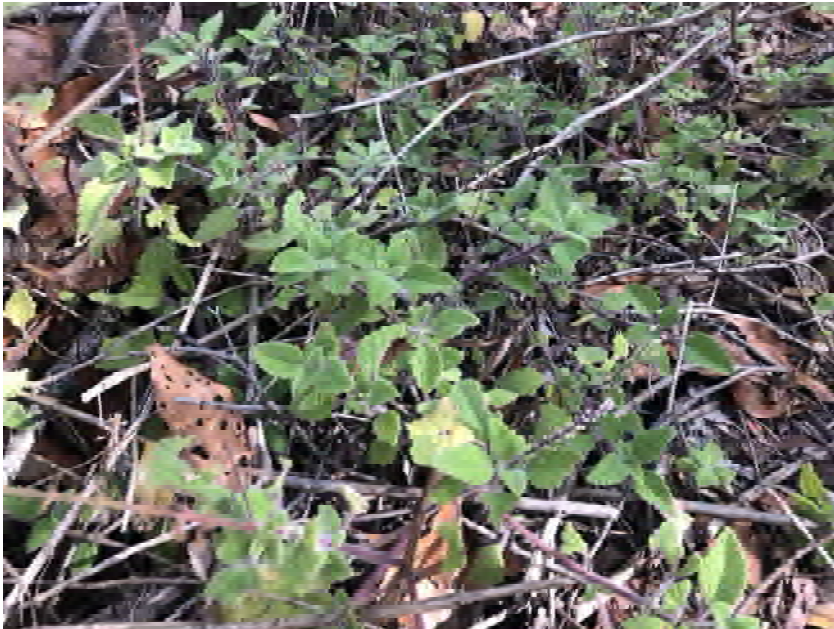
Photo 1: One *Coleus habrophyllus* specimen observed within on-site conservation area

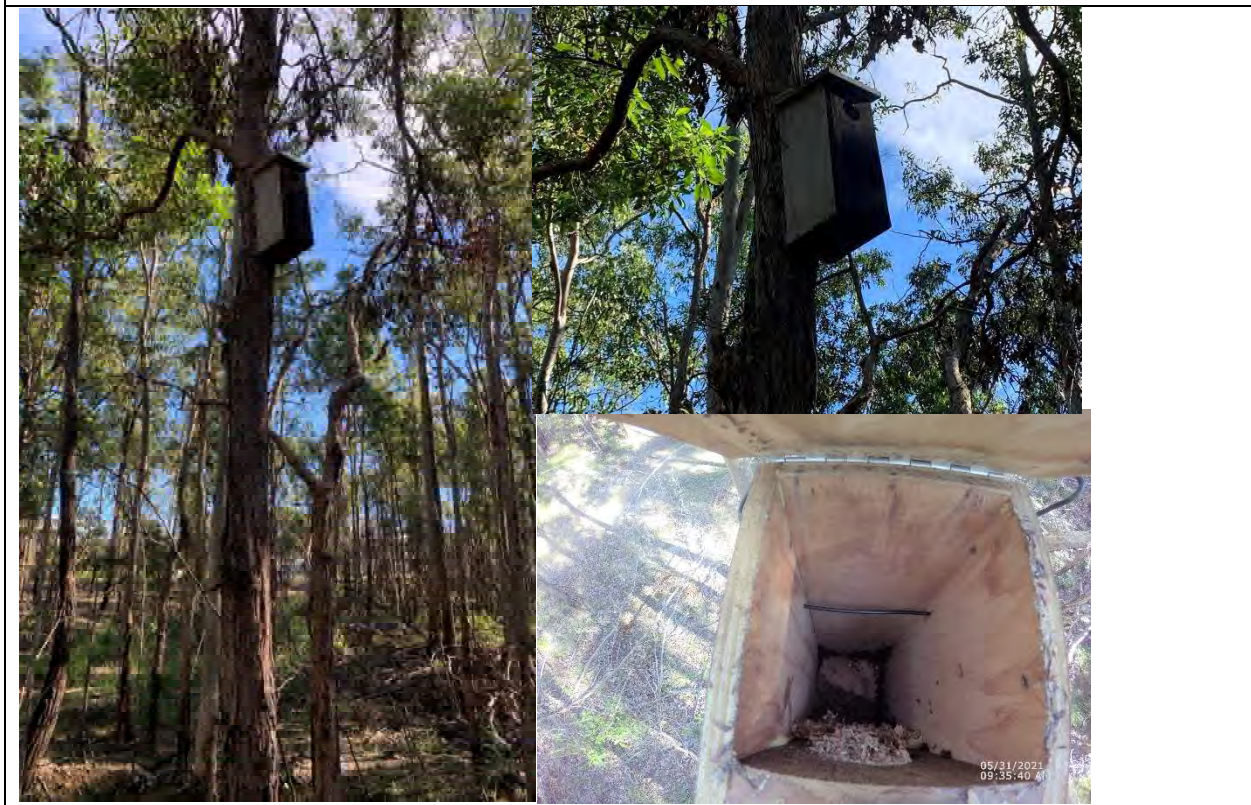
Nest Box Monitoring Sheet 2			
Maintenance Checklist of Nest Box ID: Box 3	Yes	No	Other
1. Box is not occupied by pest species		✓	Spider nest inside box.
2. Box is not vandalised or missing	✓		
3. Box is securely attached with slight lean forward	✓		
4. Box is located at optimal height	✓		
5. Box is not damaged or rotten	✓		
6. The foot holds/ladder in interior of box for young is intact	✓		
7. There are no blockages in drainage holes	✓		
8. Entrance hole is free from obstruction and not damaged or worn	✓		
9. Nesting materials have been replaced to cover floor of box	✓		
10. All soiled materials like old shavings, membrane, egg shells have been removed	✓		
11. Box is aligned away from prevailing winds, rain and excessive heat	✓

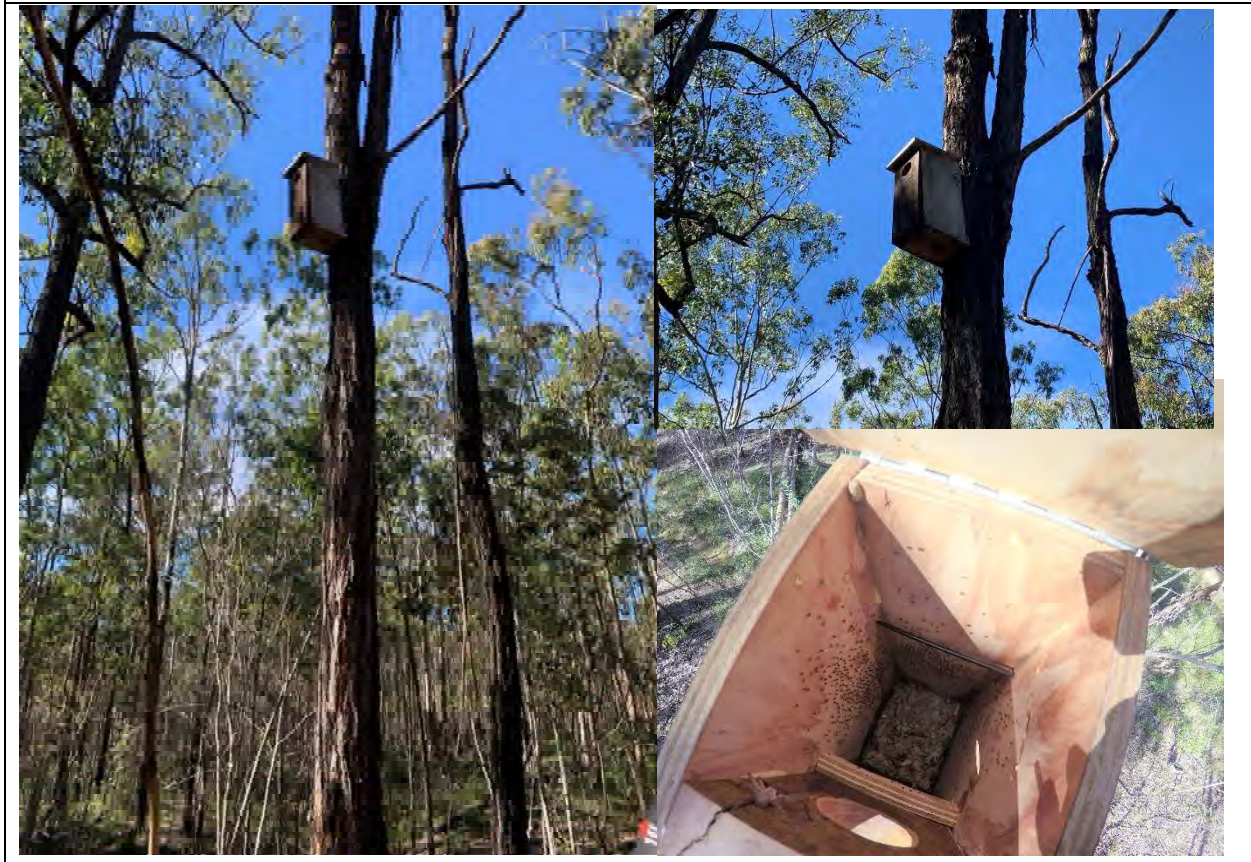
Nest Box Monitoring Sheet 2			
Maintenance Checklist of Nest Box ID: Box 4	Yes	No	other
1. Box is not occupied by pest species		✓	Spider nest inside box.
2. Box is not vandalised or missing	✓		
3. Box is securely attached with slight lean forward	✓		
4. Box is located at optimal height	✓		
5. Box is not damaged or rotten	✓		
6. The foot holds/ladder in interior of box for young is intact	✓		
7. There are no blockages in drainage holes	✓		
8. Entrance hole is free from obstruction and not damaged or worn	✓		
9. Nesting materials have been replaced to cover floor of box		✓	
10. All soiled materials like old shavings, membrane, egg shells have been removed	✓		
11. Box is aligned away from prevailing winds, rain and excessive heat	✓

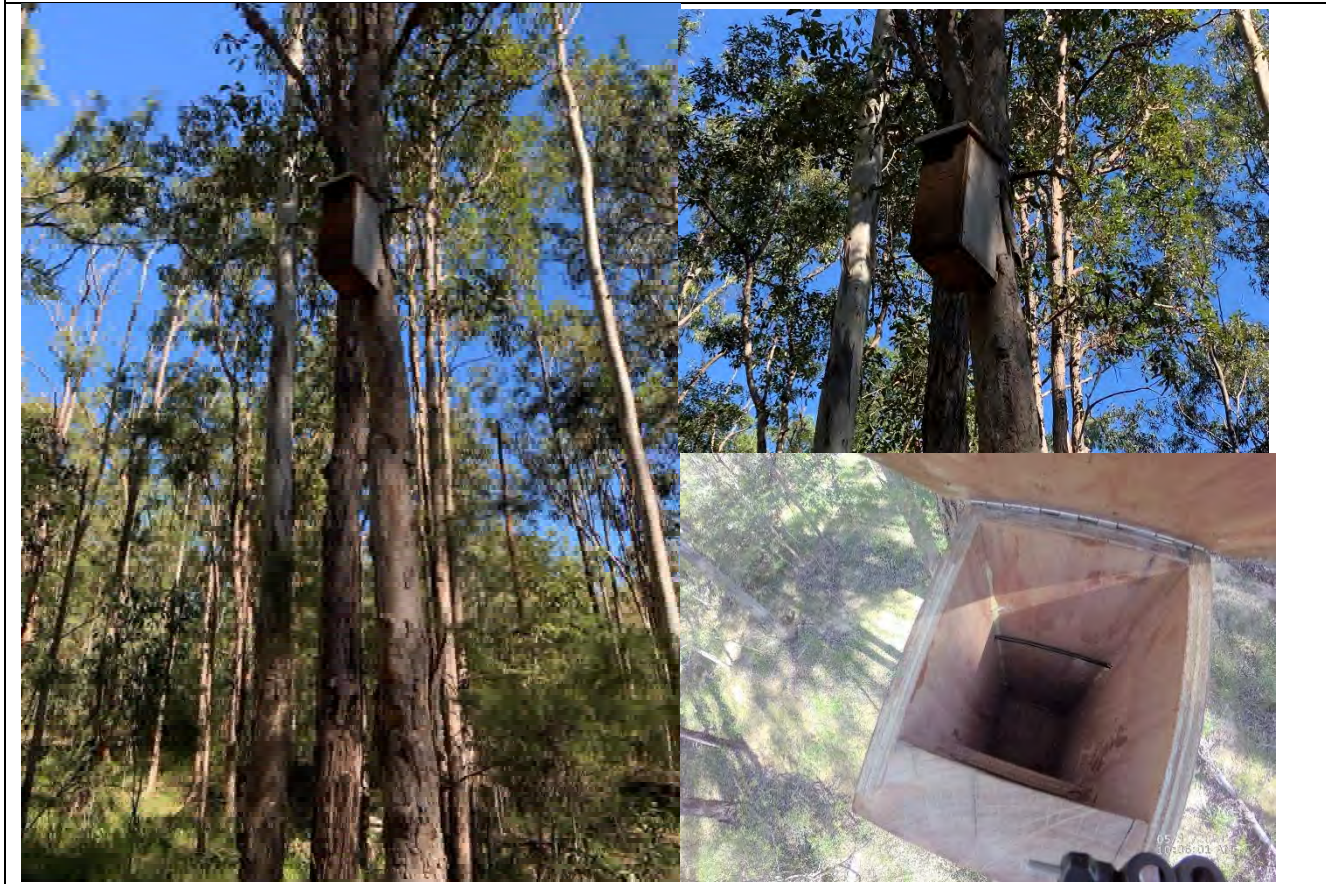
Nest Box Monitoring Sheet 2			
Maintenance Checklist of Nest Box ID: Box 7	Yes	No	Other
1. Box is not occupied by pest species		✓	Ants in box.
2. Box is not vandalised or missing	✓		
3. Box is securely attached with slight lean forward	✓		
4. Box is located at optimal height	✓		
5. Box is not damaged or rotten	✓		
6. The foot holds/ladder in interior of box for young is intact	✓		
7. There are no blockages in drainage holes	✓		
8. Entrance hole is free from obstruction and not damaged or worn	✓		
9. Nesting materials have been replaced to cover floor of box		✓	
10. All soiled materials like old shavings, membrane, egg shells have been removed	✓		
11. Box is aligned away from prevailing winds, rain and excessive heat	✓

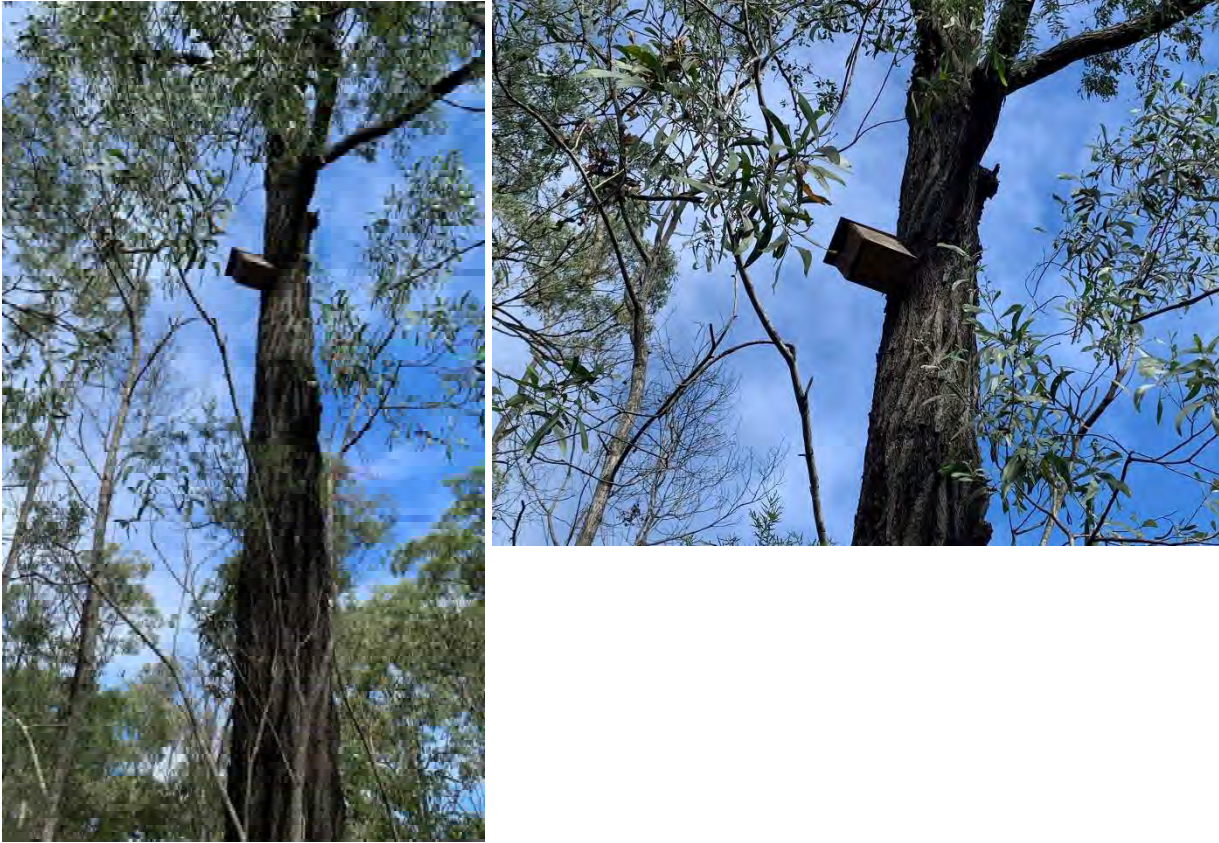
Nest Box Monitoring Sheet 2			
Maintenance Checklist of Nest Box ID: Box 17	Yes	No	Other
1. Box is not occupied by pest species	✓		
2. Box is not vandalised or missing	✓		
3. Box is securely attached with slight lean forward	✓		
4. Box is located at optimal height	✓		
5. Box is not damaged or rotten	✓		
6. The foot holds/ladder in interior of box for young is intact	-	-	Not assessed
7. There are no blockages in drainage holes	✓		
8. Entrance hole is free from obstruction and not damaged or worn	✓		
9. Nesting materials have been replaced to cover floor of box	-	-	Not assessed
10. All soiled materials like old shavings, membrane, egg shells have been removed	-	-	Not assessed
11. Box is aligned away from prevailing winds, rain and excessive heat	✓		
Comments			
Box too high for fauna monitoring.			
Photos

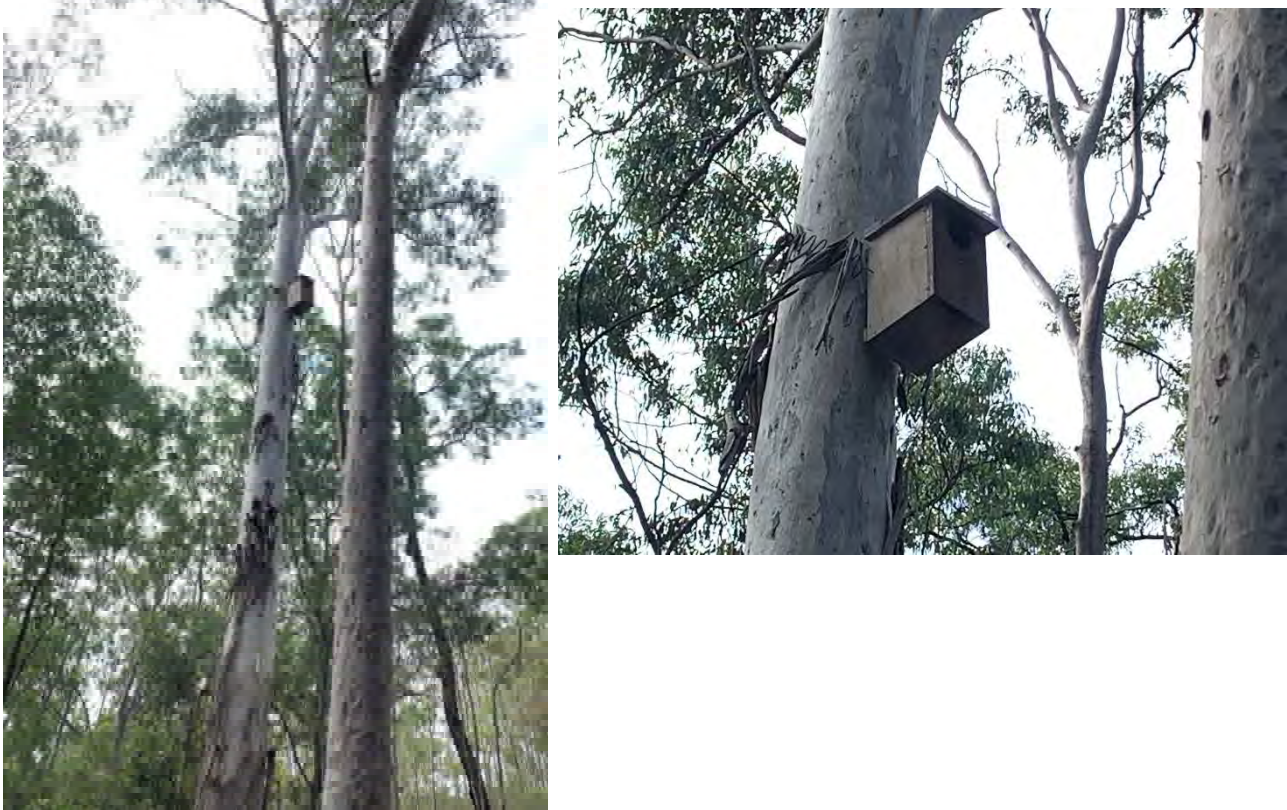
Nest Box Monitoring Sheet 2			
Maintenance Checklist of Nest Box ID: Box 18	Yes	No	Other
1. Box is not occupied by pest species	✓		
2. Box is not vandalised or missing	✓		
3. Box is securely attached with slight lean forward	✓		
4. Box is located at optimal height	✓		
5. Box is not damaged or rotten	✓		
6. The foot holds/ladder in interior of box for young is intact	-	-	Not assessed
7. There are no blockages in drainage holes	✓		
8. Entrance hole is free from obstruction and not damaged or worn	✓		
9. Nesting materials have been replaced to cover floor of box	-	-	Not assessed
10. All soiled materials like old shavings, membrane, egg shells have been removed	-	-	Not assessed
11. Box is aligned away from prevailing winds, rain and excessive heat	✓		
Other comments			
Box too high for fauna monitoring. Box on slight angle but appears to be attached securely.			
Photos

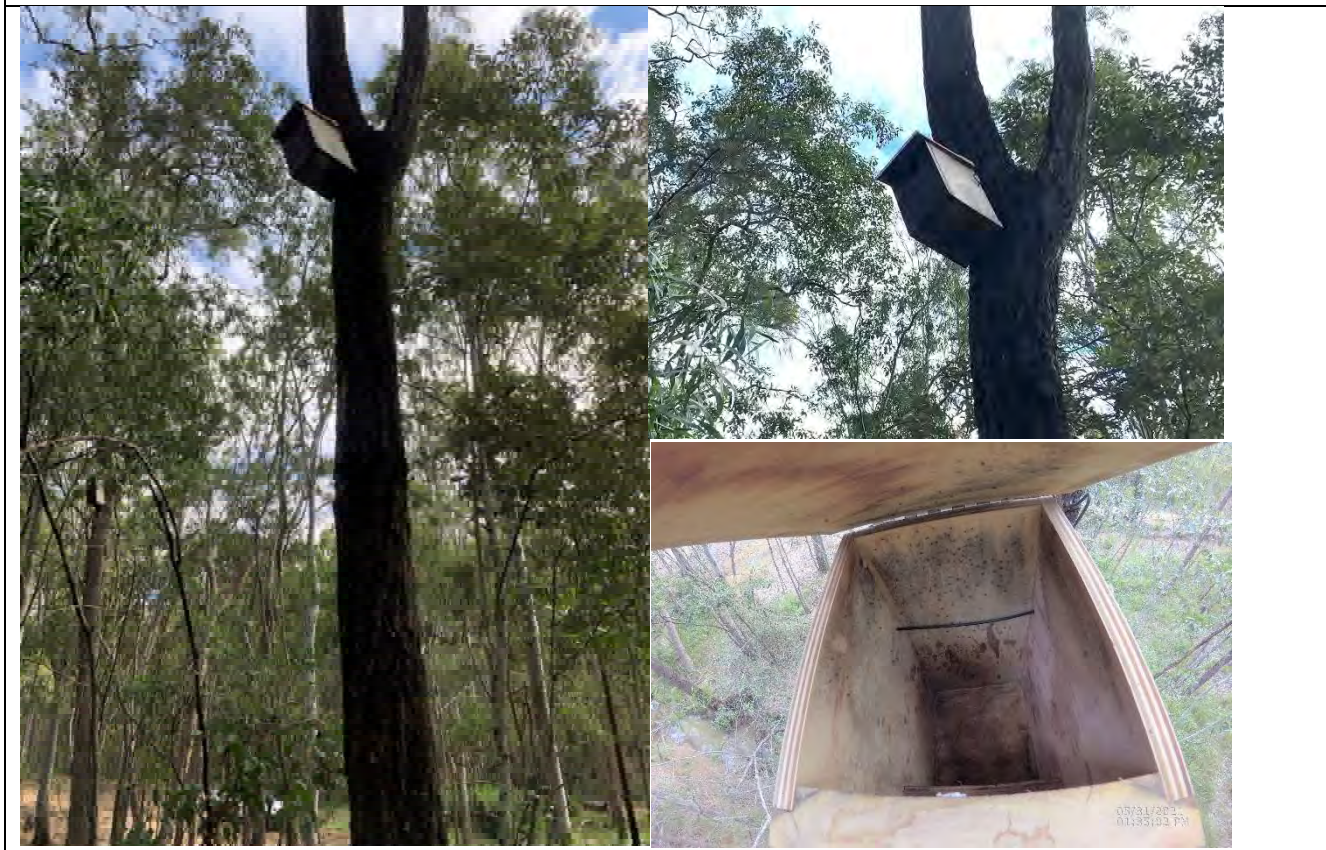
Nest Box Monitoring Sheet 2			
Maintenance Checklist of Nest Box ID: Box 20	Yes	No	Other
1. Box is not occupied by pest species	✓		
2. Box is not vandalised or missing	✓		
3. Box is securely attached with slight lean forward	✓		
4. Box is located at optimal height	✓		
5. Box is not damaged or rotten	✓		
6. The foot holds/ladder in interior of box for young is intact	-	-	Not assessed
7. There are no blockages in drainage holes	✓		
8. Entrance hole is free from obstruction and not damaged or worn	✓		
9. Nesting materials have been replaced to cover floor of box	-	-	Not assessed
10. All soiled materials like old shavings, membrane, egg shells have been removed	-	-	Not assessed
11. Box is aligned away from prevailing winds, rain and excessive heat	✓		
Other comments			
Box too high for fauna monitoring. Some fauna scratch marks noted around entry hole.			
Photos

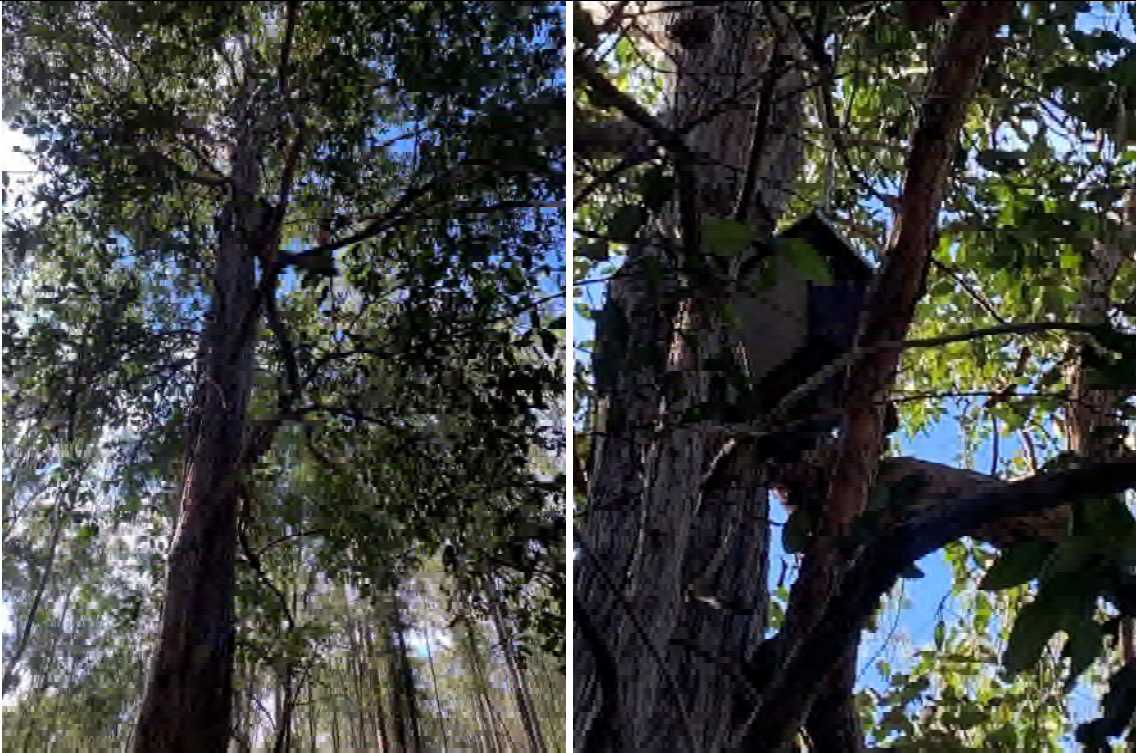
Nest Box Monitoring Sheet 2			
Maintenance Checklist of Nest Box ID: Box 23	Yes	No	Other
1. Box is not occupied by pest species	✓		
2. Box is not vandalised or missing	✓		
3. Box is securely attached with slight lean forward	✓		
4. Box is located at optimal height	✓		
5. Box is not damaged or rotten	✓		
6. The foot holds/ladder in interior of box for young is intact	✓		
7. There are no blockages in drainage holes	✓		
8. Entrance hole is free from obstruction and not damaged or worn	✓		
9. Nesting materials have been replaced to cover floor of box	✓		
10. All soiled materials like old shavings, membrane, egg shells have been removed	✓		
11. Box is aligned away from prevailing winds, rain and excessive heat	✓		
Other comments			
Leaf litter in box. Some fauna scratch marks noted around entry hole. Fauna scat noted at top of box.			
Photos

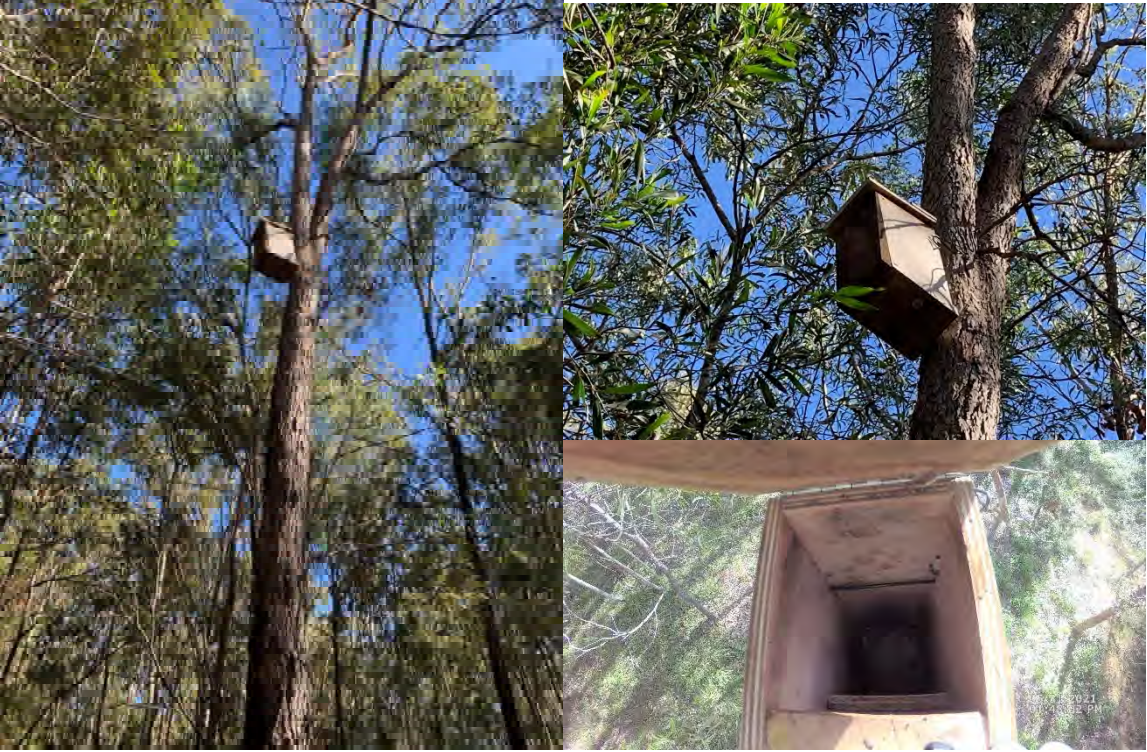
Nest Box Monitoring Sheet 2			
Maintenance Checklist of Nest Box ID: Box 24	Yes	No	Other
1. Box is not occupied by pest species		✓	Flies in box.
2. Box is not vandalised or missing	✓		
3. Box is securely attached with slight lean forward	✓		
4. Box is located at optimal height	✓		
5. Box is not damaged or rotten	✓		
6. The foot holds/ladder in interior of box for young is intact	✓		
7. There are no blockages in drainage holes	✓		
8. Entrance hole is free from obstruction and not damaged or worn	✓		
9. Nesting materials have been replaced to cover floor of box		✓	
10. All soiled materials like old shavings, membrane, egg shells have been removed	✓		
11. Box is aligned away from prevailing winds, rain and excessive heat	✓		
Other comments			
No leaf litter present. Box securely attached. Stains and scratch marks on front of box. Lots of flies inside box.			
Photos

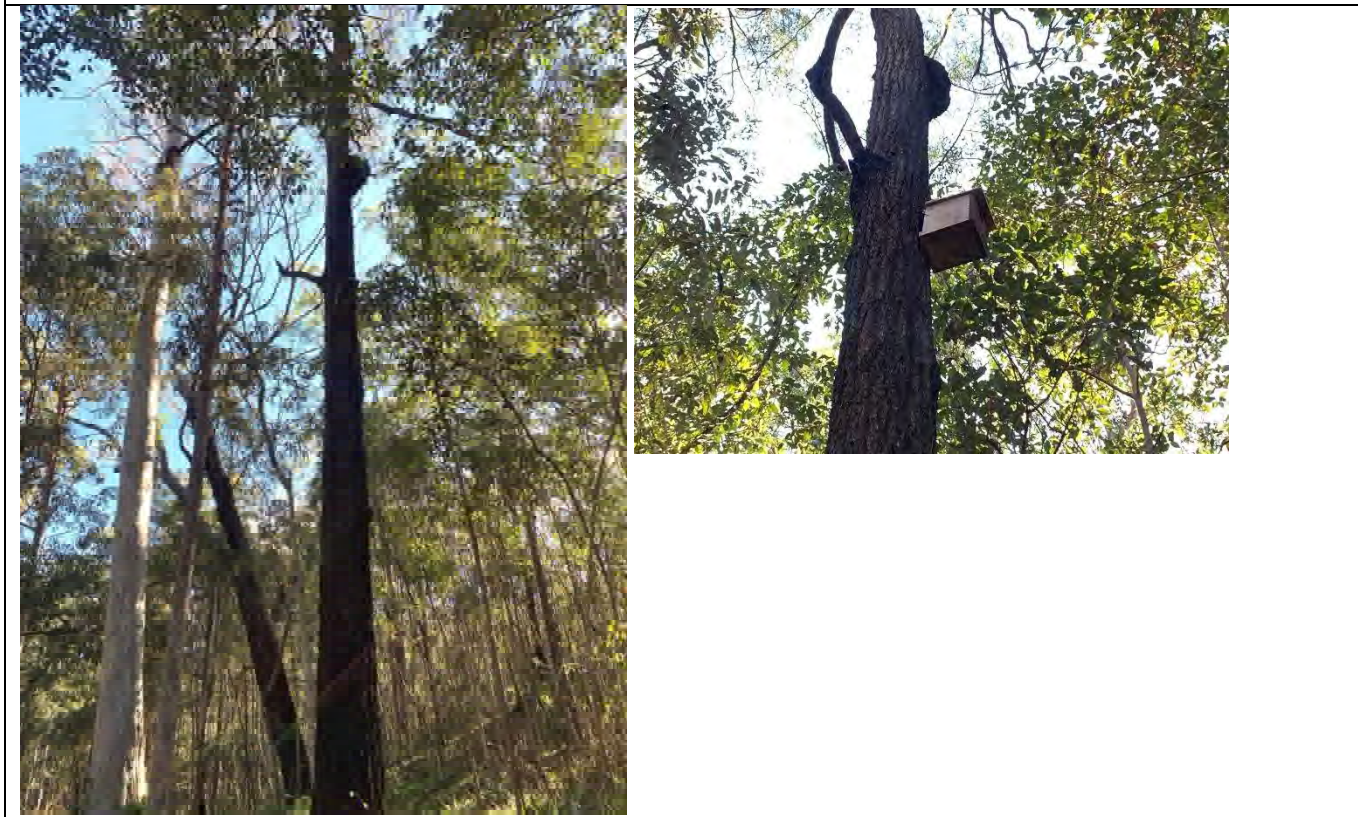
Nest Box Monitoring Sheet 2			
Maintenance Checklist of Nest Box ID: Box 26	Yes	No	Other
1. Box is not occupied by pest species	✓		
2. Box is not vandalised or missing	✓		
3. Box is securely attached with slight lean forward	✓		
4. Box is located at optimal height	✓		
5. Box is not damaged or rotten	✓		
6. The foot holds/ladder in interior of box for young is intact	-	-	Not assessed
7. There are no blockages in drainage holes	✓		
8. Entrance hole is free from obstruction and not damaged or worn	✓		
9. Nesting materials have been replaced to cover floor of box	-	-	Not assessed
10. All soiled materials like old shavings, membrane, egg shells have been removed	-	-	Not assessed
11. Box is aligned away from prevailing winds, rain and excessive heat	✓		
Other Comments			
Too high for fauna monitoring. Box securely attached.			
Photos
