Annual Compliance Report

17 October 2022 to 16 October 2023 EPBC 2013/7057
Spring Mountain Mixed Use Master Planned Community
Development, Spring Mountain, Queensland

Prepared for Lendlease Communities (Springfield) Pty Limited
9 January 2024

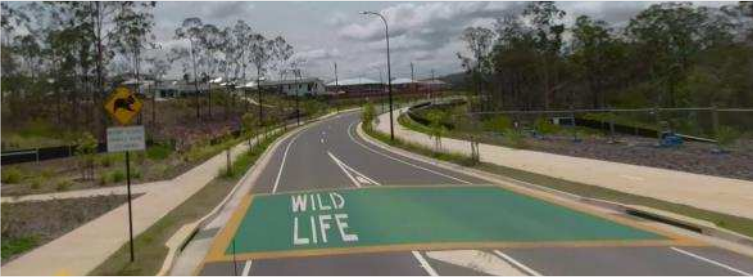
Condition number / reference	Condition	Is the project compliant with this condition?	Evidence / comments
			<p><i>management measures will be completed as part of practical completion works for the road area.</i></p> <ul style="list-style-type: none"> • Implement measures to improve driver awareness, and thereby minimise the incidence of fauna-vehicle collisions, including: <ul style="list-style-type: none"> a) The installation of general signage to signal the presence of Koalas within the site will be undertaken at all primary (strategic) road entry points to the site. b) More specific signage treatments will be installed to signal areas within the site where there is an increased likelihood of encountering Koalas on the road. Circumstances where such signage will be installed, including (but not limited to) any section of road or residential street which intersects with a retained habitat area. c) "Cat's eye" reflectors to be installed in conjunction with the specific signage treatment zones. <p><i>Driver awareness measures were installed as part of completing roads across the project at locations agreed with Ipswich City Council. Signage will be installed along roads traversing retained habitat areas once construction is complete for future works.</i></p> <p><i>Example of driver awareness signage and markings:</i></p>

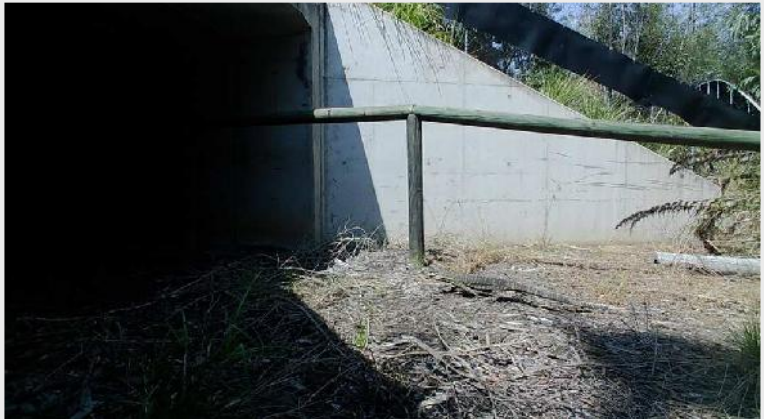
<p><i>Lace Monitor</i></p>

Condition number / reference	Condition	Is the project compliant with this condition?	Evidence / comments
			<ul style="list-style-type: none"> Annual monitoring event to assess Koala usage and an integrity audit of structures to be implemented for each of five years - to be initiated at the beginning of the "off-maintenance" period for each crossing treatment. <p><i>For operational road crossings, annual monitoring events are recurring. The October survey event revealed a variety of fauna utilise the dry passage fauna however there were no instances of koalas observed at that point in time. Remaining road crossing treatments still under construction have not entered the off-maintenance/practical completion period and therefore monitoring has not commenced.</i></p> <p><i>The following photos illustrate some of the species observed in October 2023 at the functional dry passage culvert locations.</i></p>

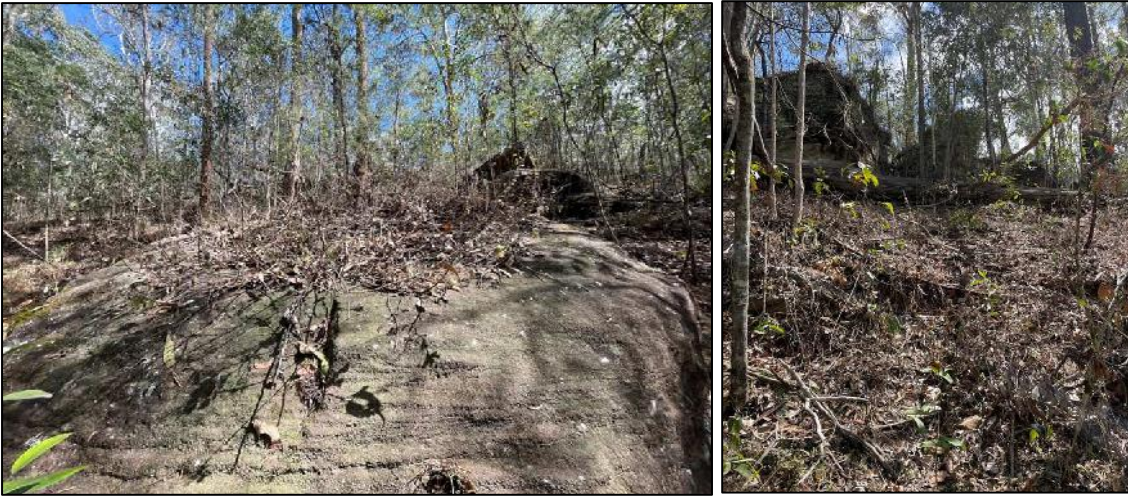
management of WONS. Numerous juvenile *C. habrophyllus* specimens were identified within the on-site conservation area (refer **Photo set 1**).

Photo set 1: *C. habrophyllus* specimens located within the conservation area.

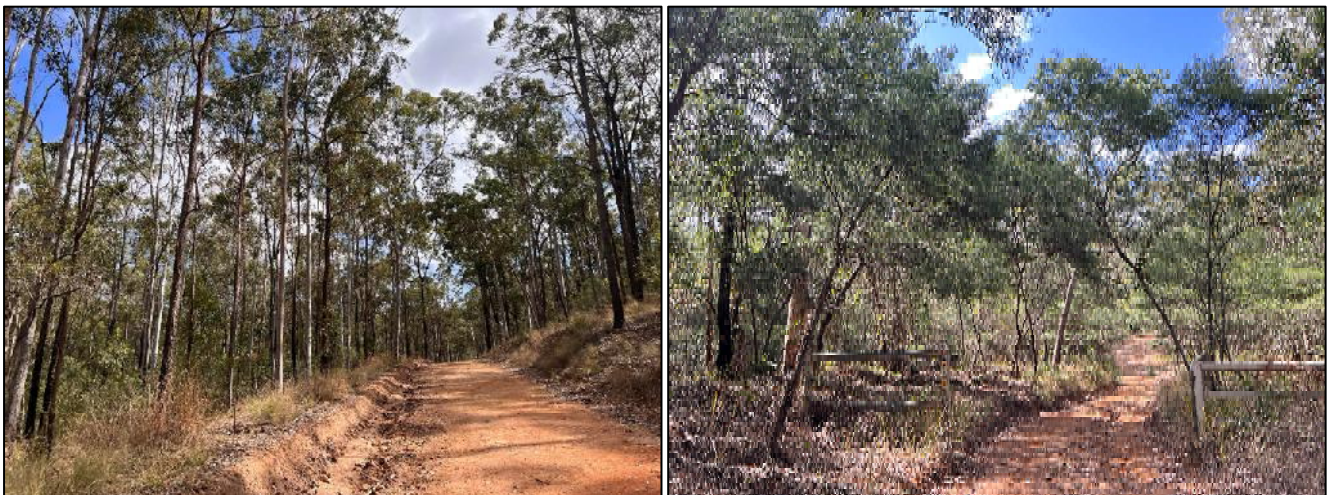
Photo set 2: Access tracks through the Offset Area.

As noted previously within this report, ESC issues were identified within the latter stages of a previous reporting period (17 October 2019 – 16 October 2020). Although not viewed as a non-compliance with the EPBC Approval, the matter continues to be monitored and managed throughout the current reporting period. Upon the survey conducted during the Year 7 ACR, all tracks which are required to be maintained were found to be accessible (refer **Photo set 2**). There was no evidence found that would suggest areas of significant erosion.

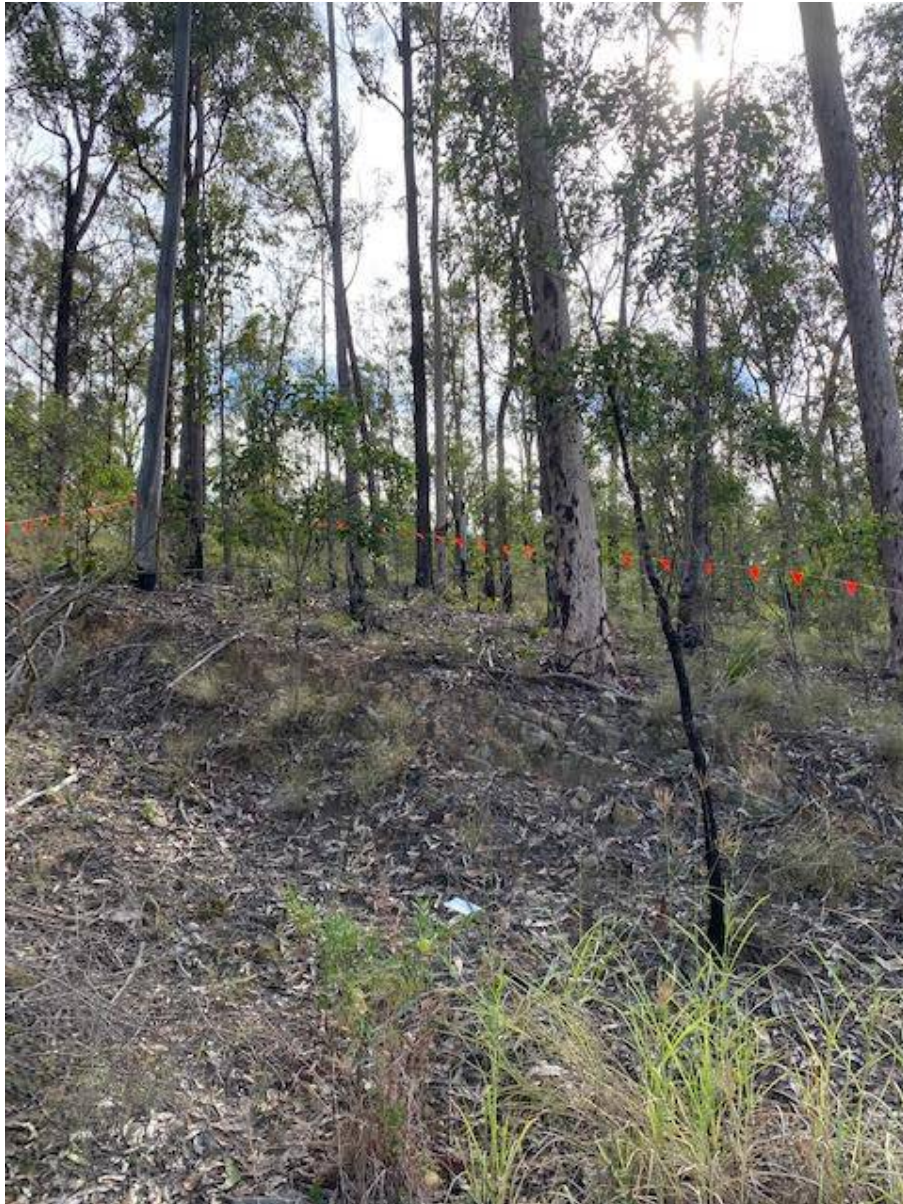
Low numbers of NJKHT's were scheduled for removal during this phase. Open egress areas are evident throughout the site.

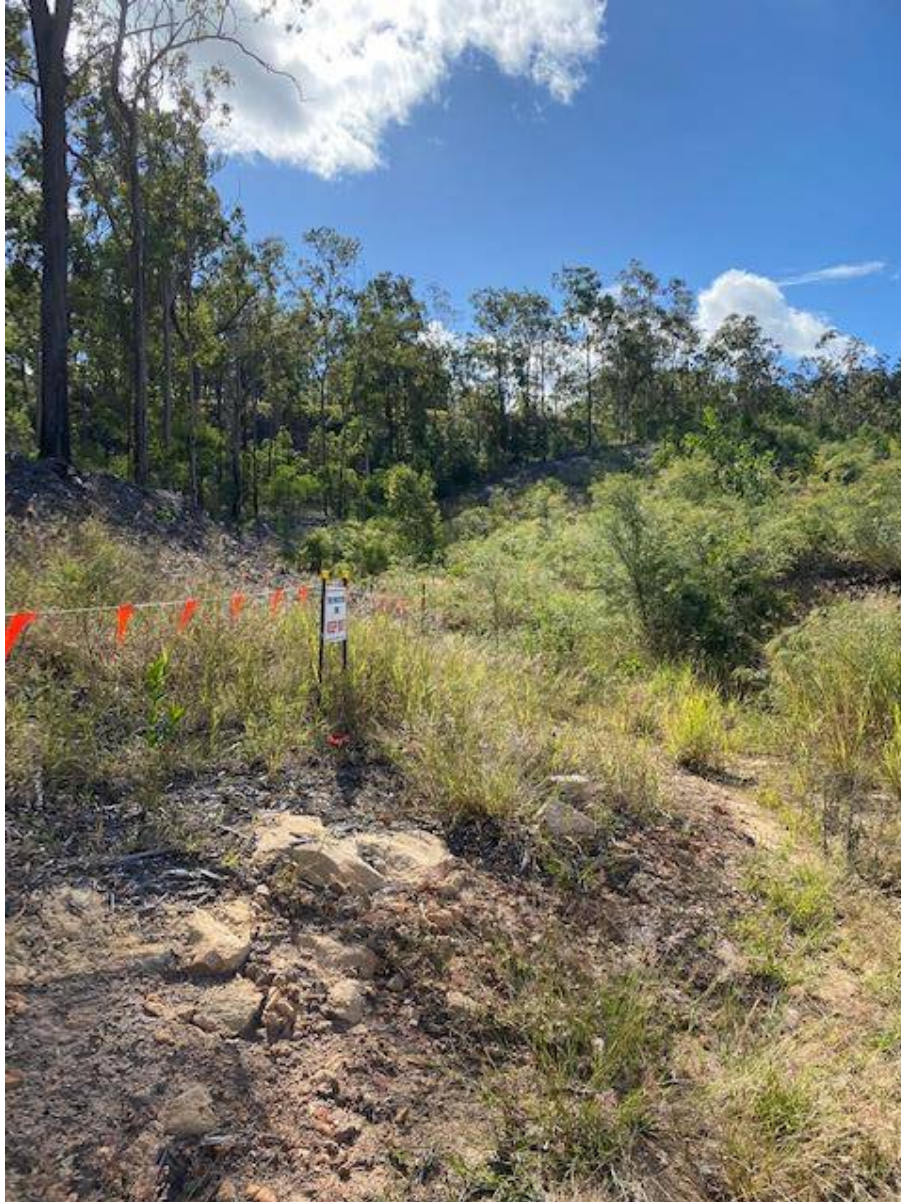
TPZ were established.

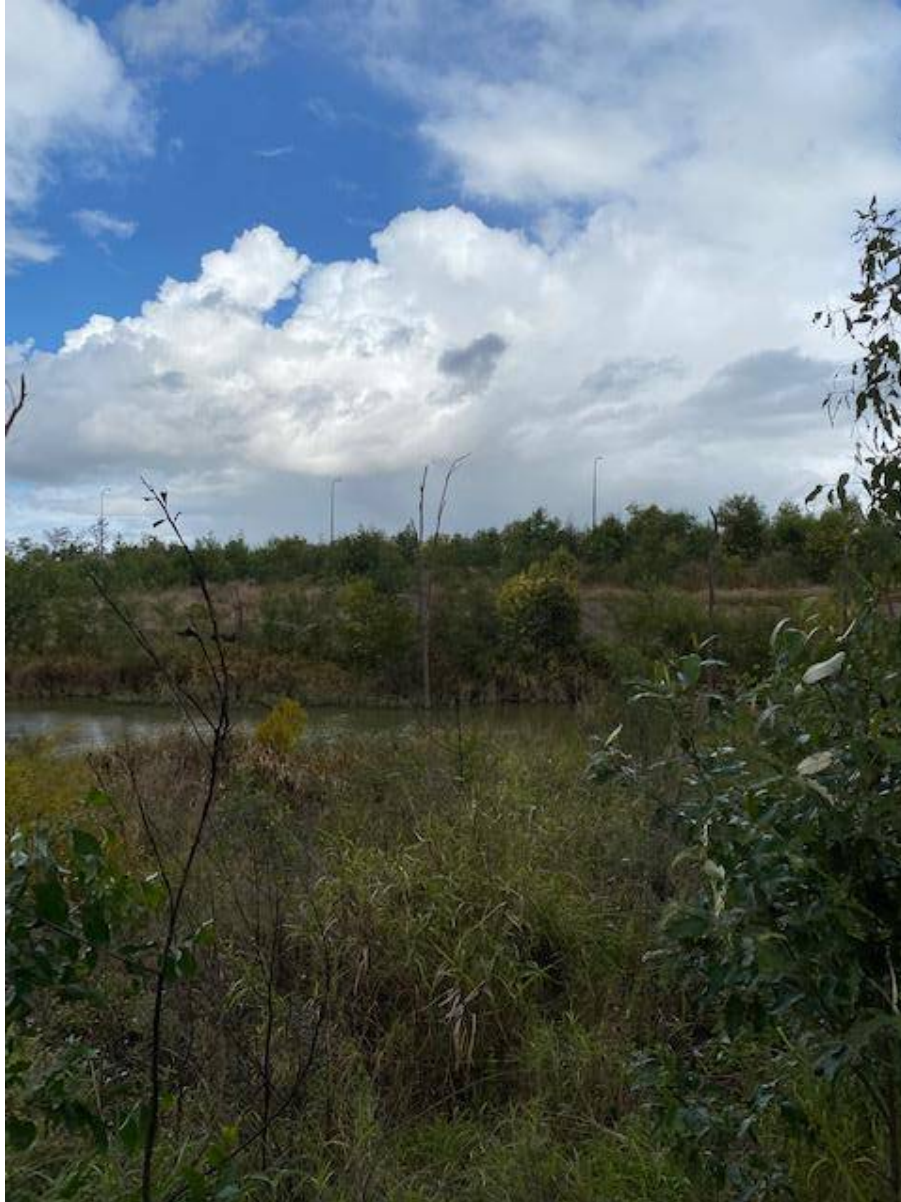
Water bodies were comprehensively checked and cleared.

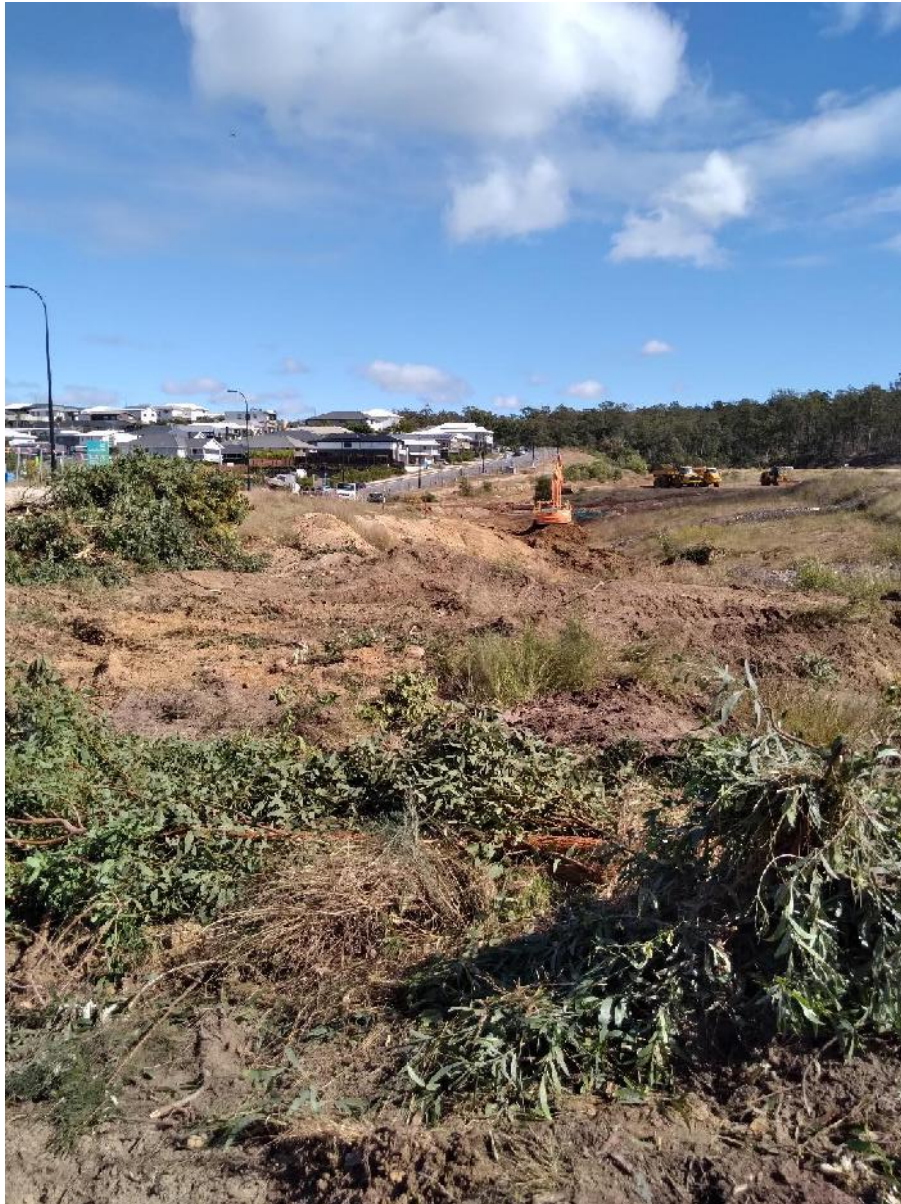
Aquatic vegetation assets will be checked and cleared.

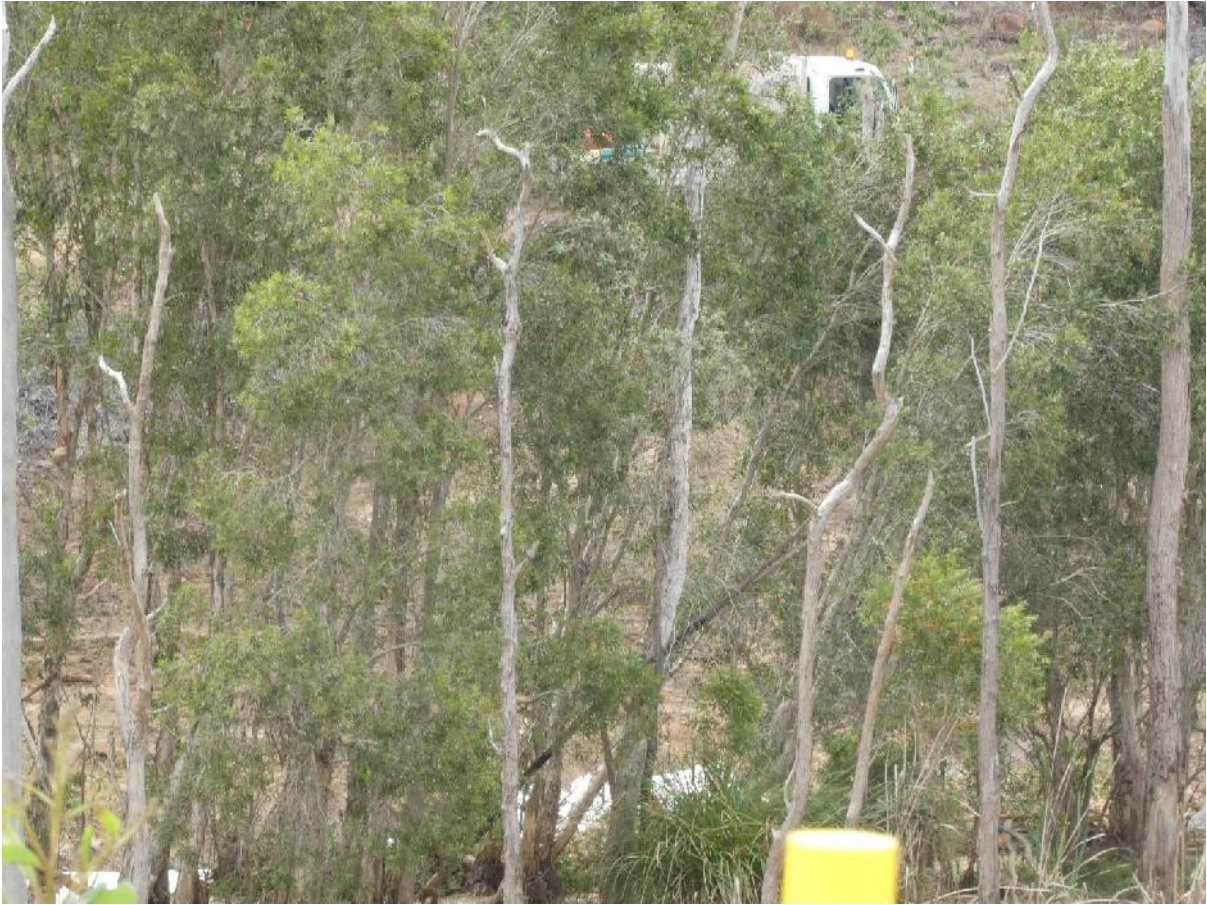
Stags within the water way did not contain hollow bearing natural assets.

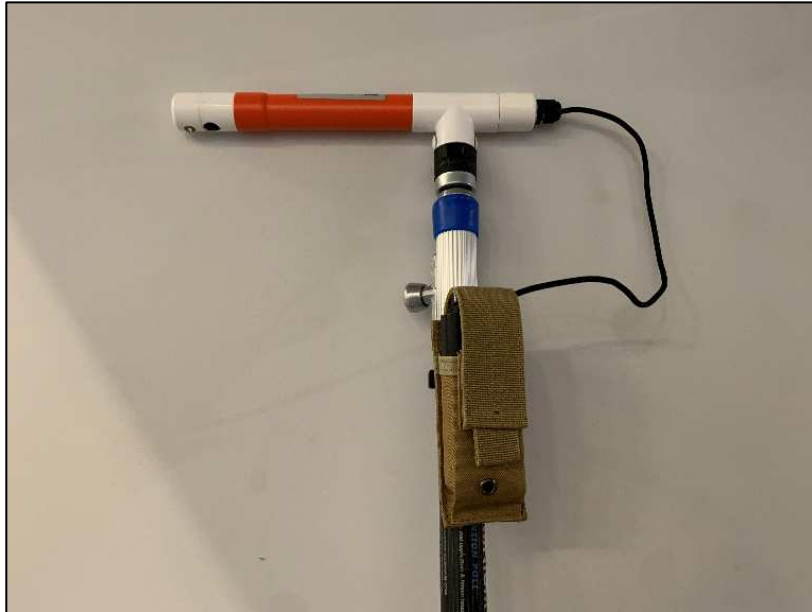
Photo 1: StarWeb Inspection Camera.

This audit inspection was completed using a wireless nest box inspection camera unit developed by StarWeb. The unit includes an LED illuminator that is wildlife eye safe and is ideal for minimising disturbance. The unit was secured to an extendable aluminium pole with reach of up to 4.5 metres (refer **Photo 1**).

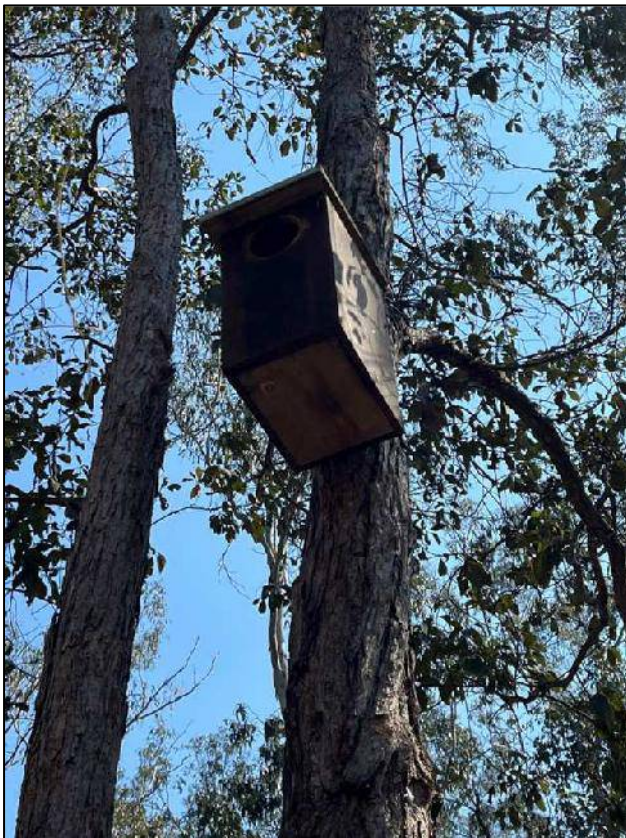
Nest Box Monitoring Sheet 2

Maintenance Checklist of Nest Box ID: Box 2	Correct	Incorrect	Other
1. Box is not occupied by pest species	✓		
2. Box is not vandalised or missing	✓		
3. Box is securely attached with slight lean forward	✓		
4. Box is located at optimal height	✓		
5. Box is not damaged or rotten	✓		
6. The foot holds/ladder in interior of box for young is intact	✓		
7. There are no blockages in drainage holes	✓		
8. Entrance hole is free from obstruction and not damaged or worn	✓		
9. Nesting materials have been replaced to cover floor of box	✓		
10. All soiled materials like old shavings, membrane, egg shells have been removed	✓		
11. Box is aligned away from prevailing winds, rain and excessive heat	✓

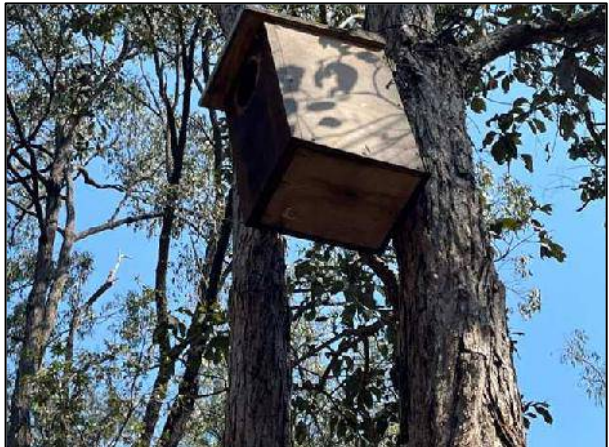
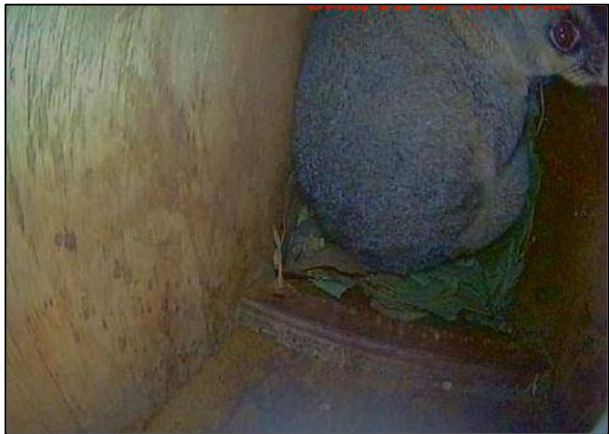
Maintenance Checklist of Nest Box ID: Box 1	Correct	Incorrect	Other
1. Box is not occupied by pest species	✓		
2. Box is not vandalised or missing	✓		
3. Box is securely attached with slight lean forward	✓		
4. Box is located at optimal height	✓		
5. Box is not damaged or rotten	✓		
6. The foot holds/ladder in interior of box for young is intact	✓		
7. There are no blockages in drainage holes	✓		
8. Entrance hole is free from obstruction and not damaged or worn	✓		
9. Nesting materials have been replaced to cover floor of box	✓		
10. All soiled materials like old shavings, membrane, egg shells have been removed	✓		
11. Box is aligned away from prevailing winds, rain and excessive heat	✓

Leaf litter present.

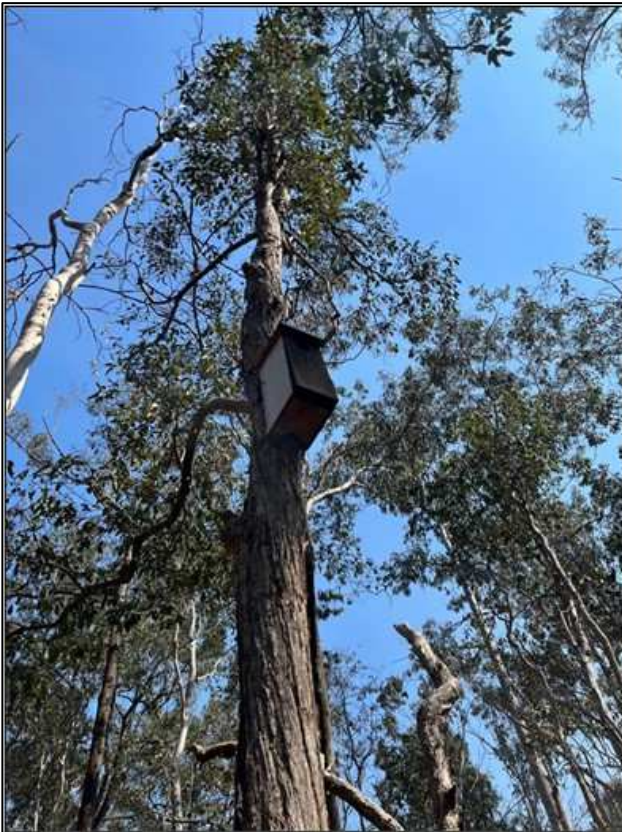
Nest Box Monitoring Sheet 2

Maintenance Checklist of Nest Box ID: Box 3	Correct	Incorrect	Other
1. Box is not occupied by pest species	✓		
2. Box is not vandalised or missing	✓		
3. Box is securely attached with slight lean forward	✓		
4. Box is located at optimal height	✓		
5. Box is not damaged or rotten	✓		
6. The foot holds/ladder in interior of box for young is intact	✓		
7. There are no blockages in drainage holes	✓		
8. Entrance hole is free from obstruction and not damaged or worn	✓		
9. Nesting materials have been replaced to cover floor of box	✓		
10. All soiled materials like old shavings, membrane, egg shells have been removed	✓		
11. Box is aligned away from prevailing winds, rain and excessive heat	✓

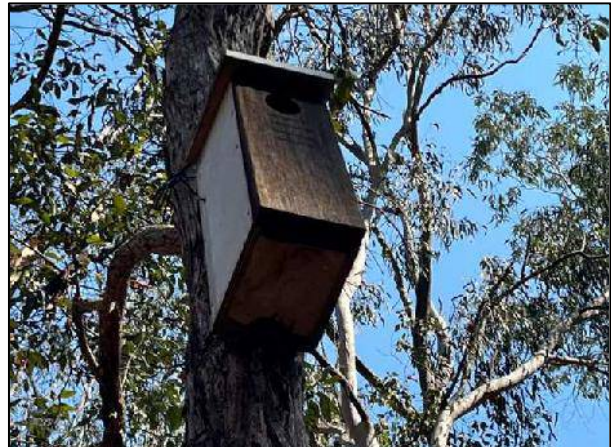
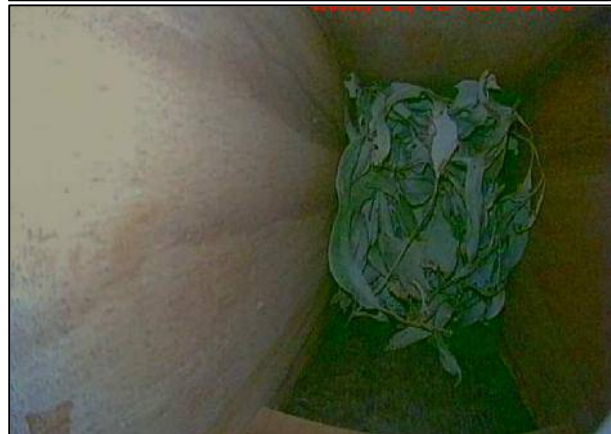
Leaf litter present. Caterpillar nest present on underside of box.

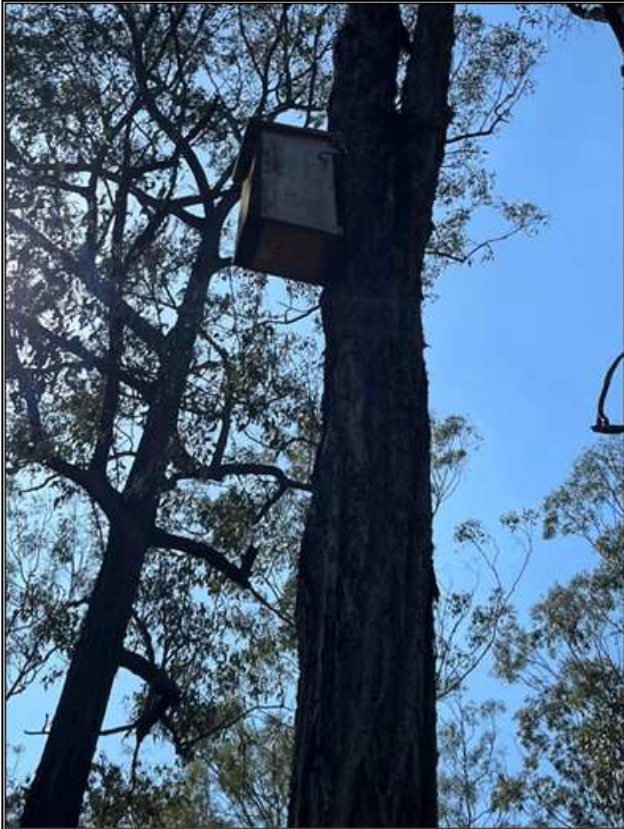
Nest Box Monitoring Sheet 2

Maintenance Checklist of Nest Box ID: Box 4	Correct	Incorrect	Other
1. Box is not occupied by pest species	✓		
2. Box is not vandalised or missing	✓		
3. Box is securely attached with slight lean forward	✓		
4. Box is located at optimal height	✓		
5. Box is not damaged or rotten	✓		
6. The foot holds/ladder in interior of box for young is intact	✓		
7. There are no blockages in drainage holes	✓		
8. Entrance hole is free from obstruction and not damaged or worn	✓		
9. Nesting materials have been replaced to cover floor of box	✓		
10. All soiled materials like old shavings, membrane, egg shells have been removed	✓		
11. Box is aligned away from prevailing winds, rain and excessive heat	✓

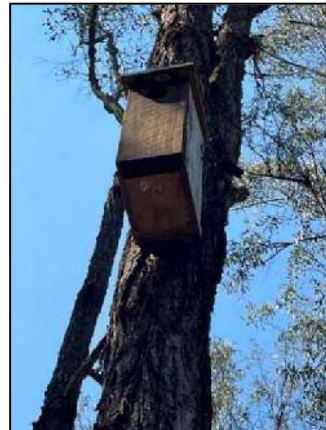
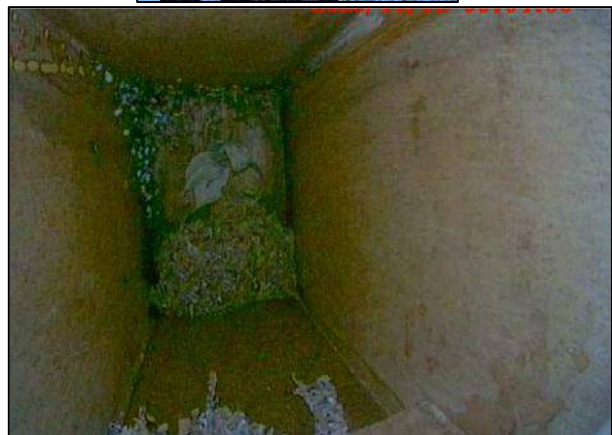
Saw shavings present.

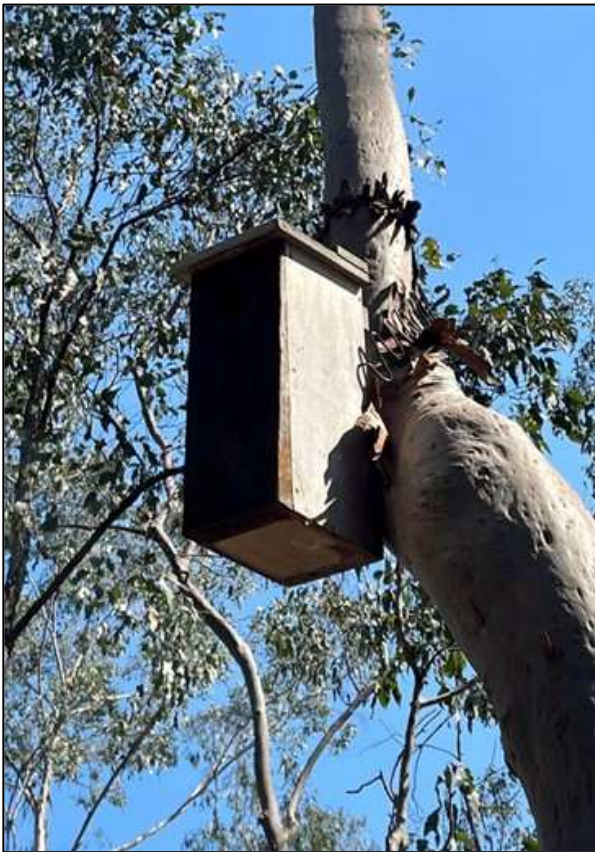
Nest Box Monitoring Sheet 2

Maintenance Checklist of Nest Box ID: Box 5	Correct	Incorrect	Other
1. Box is not occupied by pest species	✓		
2. Box is not vandalised or missing	✓		
3. Box is securely attached with slight lean forward	✓		
4. Box is located at optimal height	✓		
5. Box is not damaged or rotten	✓		
6. The foot holds/ladder in interior of box for young is intact	✓		
7. There are no blockages in drainage holes	✓		
8. Entrance hole is free from obstruction and not damaged or worn	✓		
9. Nesting materials have been replaced to cover floor of box	✓		
10. All soiled materials like old shavings, membrane, egg shells have been removed	✓		
11. Box is aligned away from prevailing winds, rain and excessive heat	✓

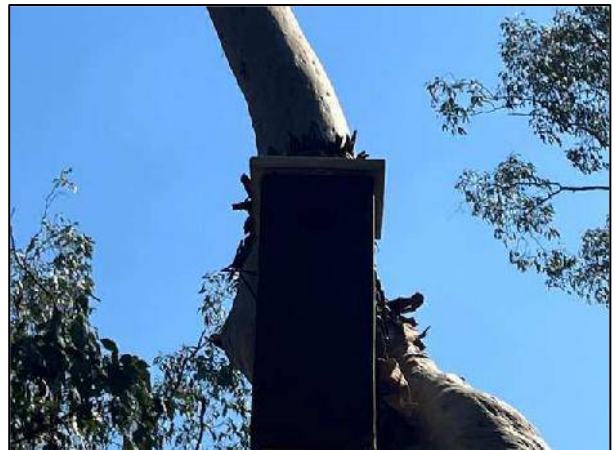
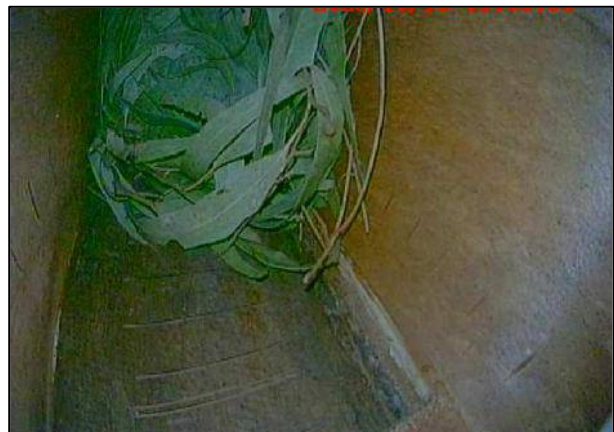
Leaf litter present.

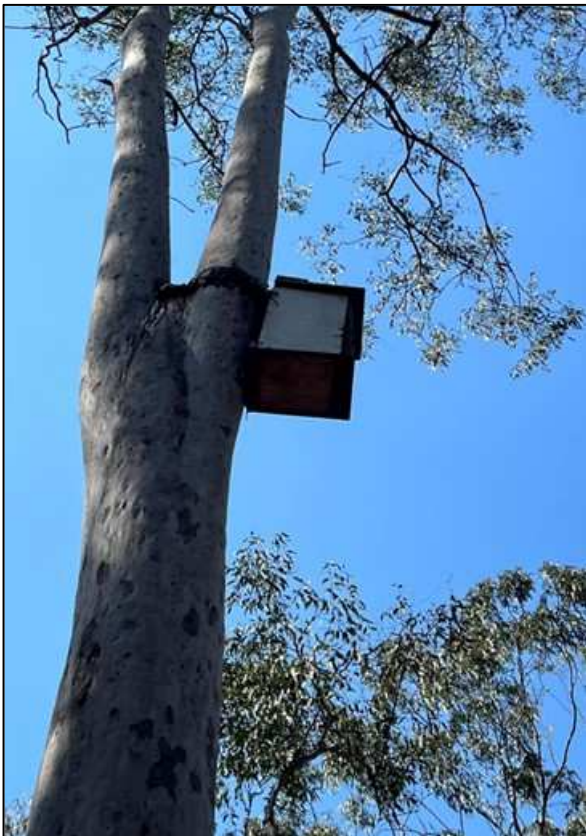
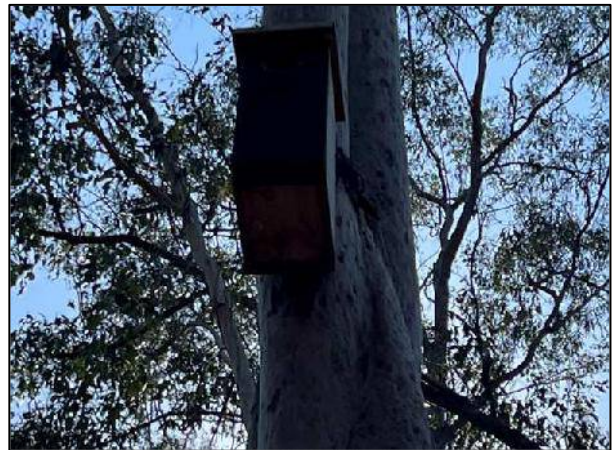
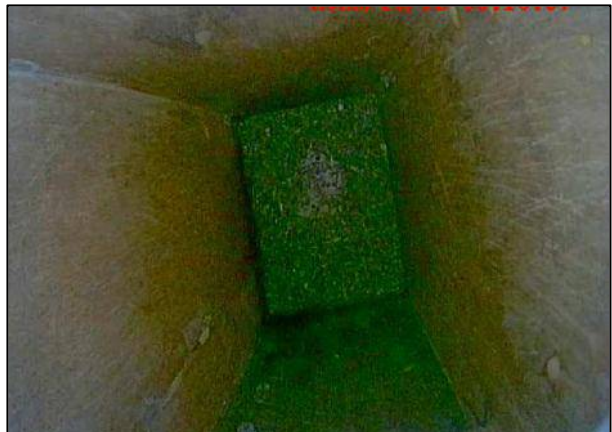
Saw shavings present.

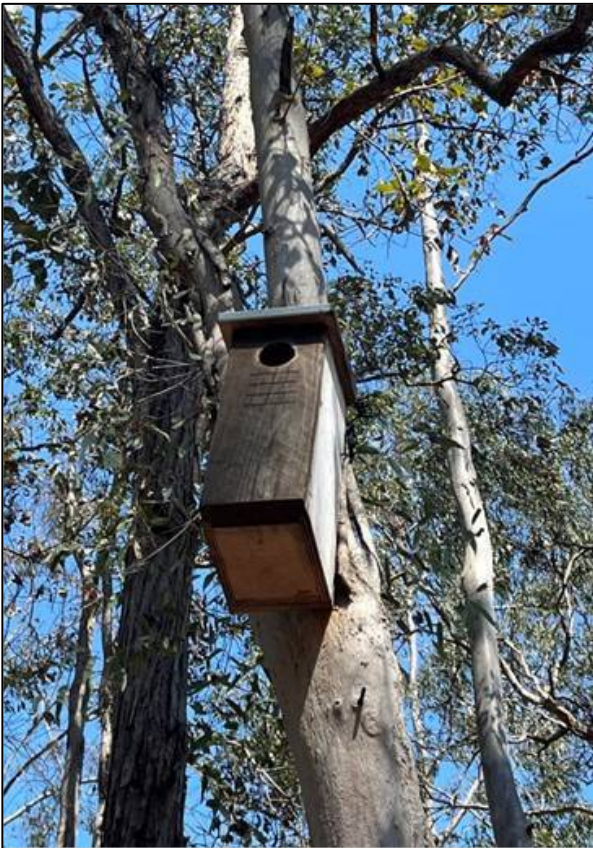
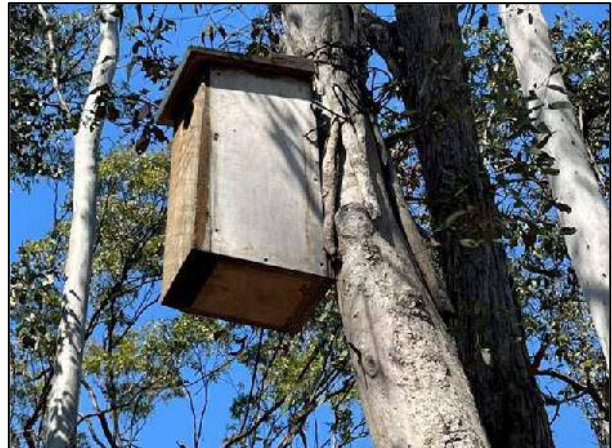
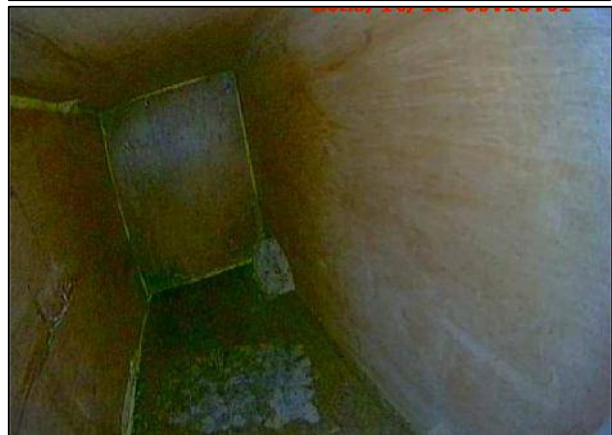
Maintenance Checklist of Nest Box ID: Box 6	Correct	Incorrect	Other
1. Box is not occupied by pest species	✓		
2. Box is not vandalised or missing	✓		
3. Box is securely attached with slight lean forward	✓		
4. Box is located at optimal height	✓		
5. Box is not damaged or rotten	✓		
6. The foot holds/ladder in interior of box for young is intact	✓		
7. There are no blockages in drainage holes	✓		
8. Entrance hole is free from obstruction and not damaged or worn	✓		
9. Nesting materials have been replaced to cover floor of box		✓	
10. All soiled materials like old shavings, membrane, egg shells have been removed	✓		
11. Box is aligned away from prevailing winds, rain and excessive heat	✓

Insect mud nest present within nest box. No nesting material present covering the floor of the box

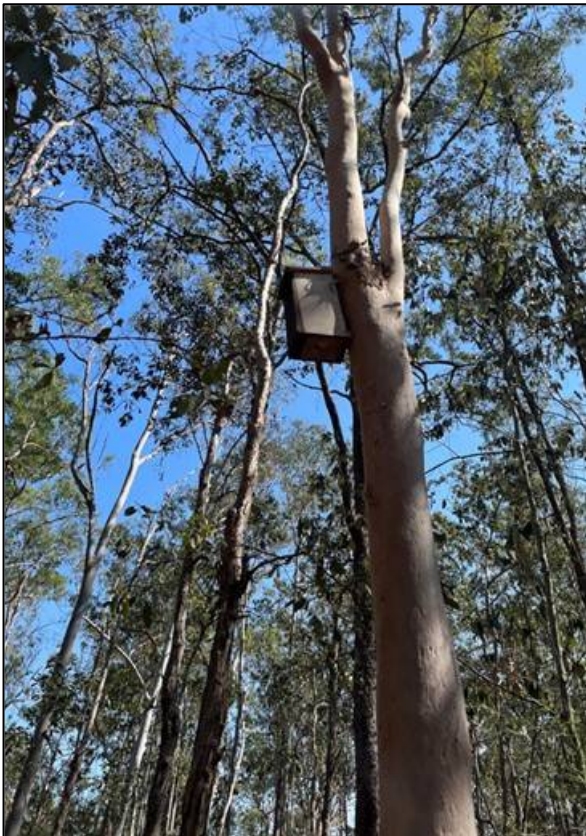
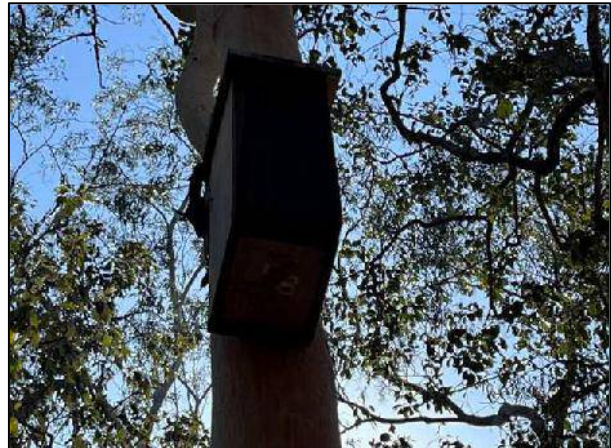
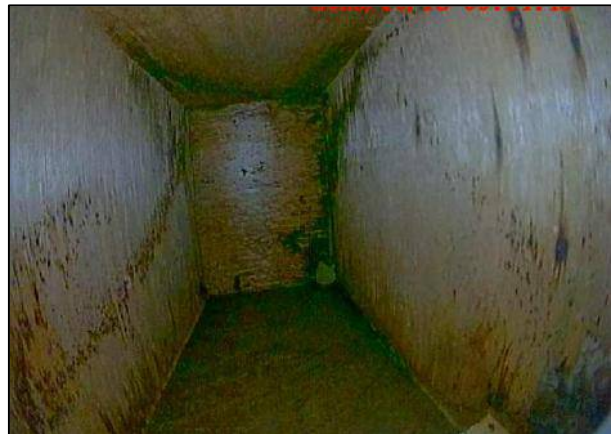
Maintenance Checklist of Nest Box ID: Box 7	Correct	Incorrect	Other
1. Box is not occupied by pest species	✓		
2. Box is not vandalised or missing	✓		
3. Box is securely attached with slight lean forward	✓		
4. Box is located at optimal height	✓		
5. Box is not damaged or rotten	✓		
6. The foot holds/ladder in interior of box for young is intact	✓		
7. There are no blockages in drainage holes	✓		
8. Entrance hole is free from obstruction and not damaged or worn	✓		
9. Nesting materials have been replaced to cover floor of box		✓	
10. All soiled materials like old shavings, membrane, egg shells have been removed	✓		
11. Box is aligned away from prevailing winds, rain and excessive heat	✓

No nesting material present covering the floor of the box.

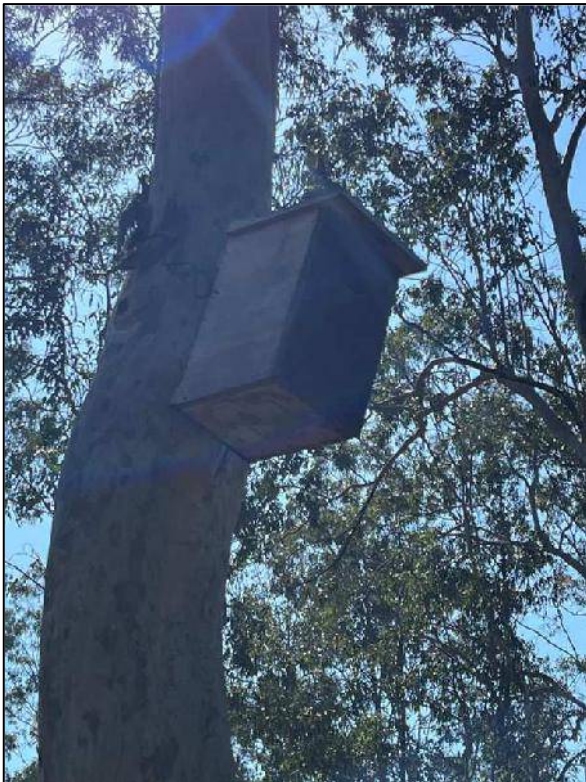
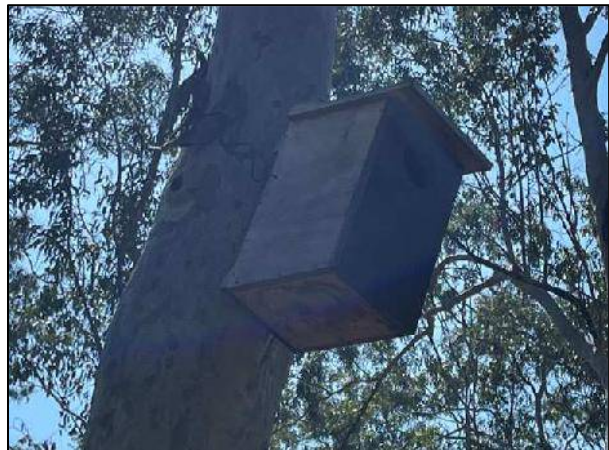
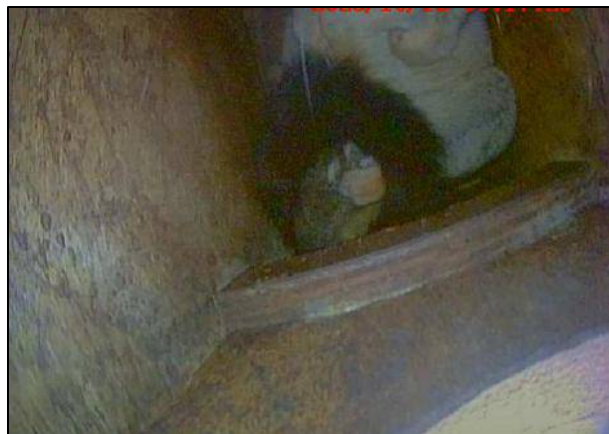
Maintenance Checklist of Nest Box ID: Box 8	Correct	Incorrect	Other
1. Box is not occupied by pest species	✓		
2. Box is not vandalised or missing	✓		
3. Box is securely attached with slight lean forward	✓		
4. Box is located at optimal height	✓		
5. Box is not damaged or rotten	✓		
6. The foot holds/ladder in interior of box for young is intact	✓		
7. There are no blockages in drainage holes	✓		
8. Entrance hole is free from obstruction and not damaged or worn	✓		
9. Nesting materials have been replaced to cover floor of box	✓		
10. All soiled materials like old shavings, membrane, egg shells have been removed	✓		
11. Box is aligned away from prevailing winds, rain and excessive heat	✓

Brushtail Possum.

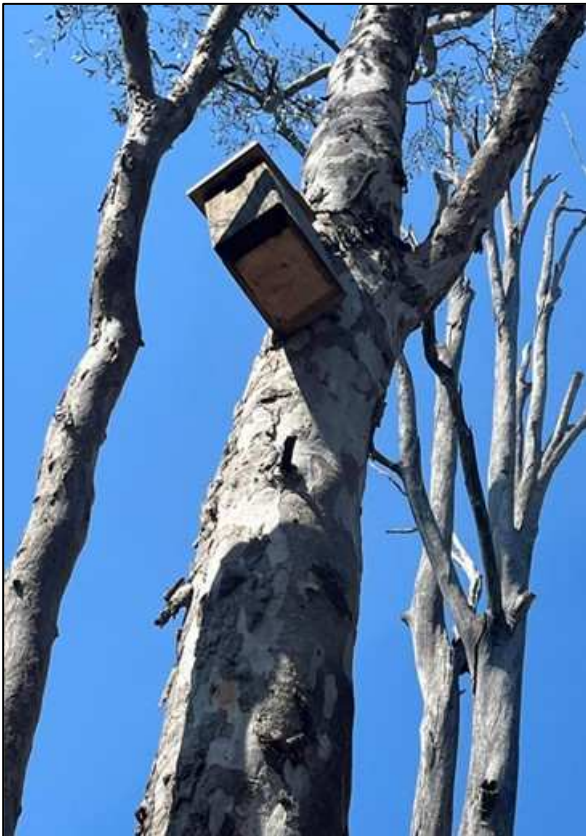
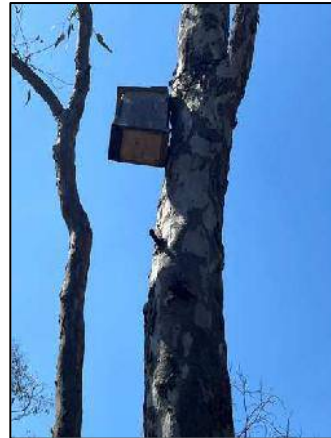
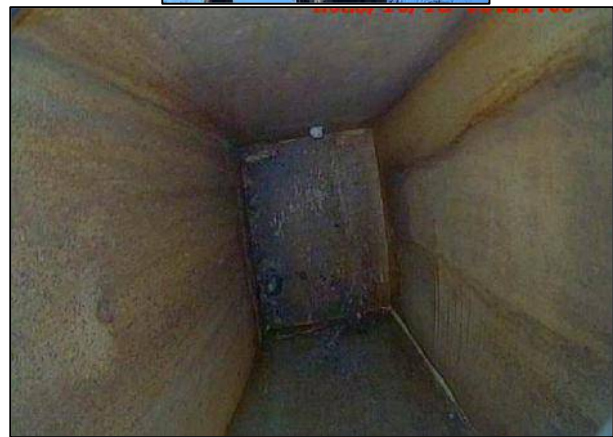
Maintenance Checklist of Nest Box ID: Box 9	Correct	Incorrect	Other
1. Box is not occupied by pest species	✓		
2. Box is not vandalised or missing	✓		
3. Box is securely attached with slight lean forward	✓		
4. Box is located at optimal height	✓		
5. Box is not damaged or rotten	✓		
6. The foot holds/ladder in interior of box for young is intact	✓		
7. There are no blockages in drainage holes	✓		
8. Entrance hole is free from obstruction and not damaged or worn	✓		
9. Nesting materials have been replaced to cover floor of box		✓	
10. All soiled materials like old shavings, membrane, egg shells have been removed	✓		
11. Box is aligned away from prevailing winds, rain and excessive heat	✓

No nesting material present.

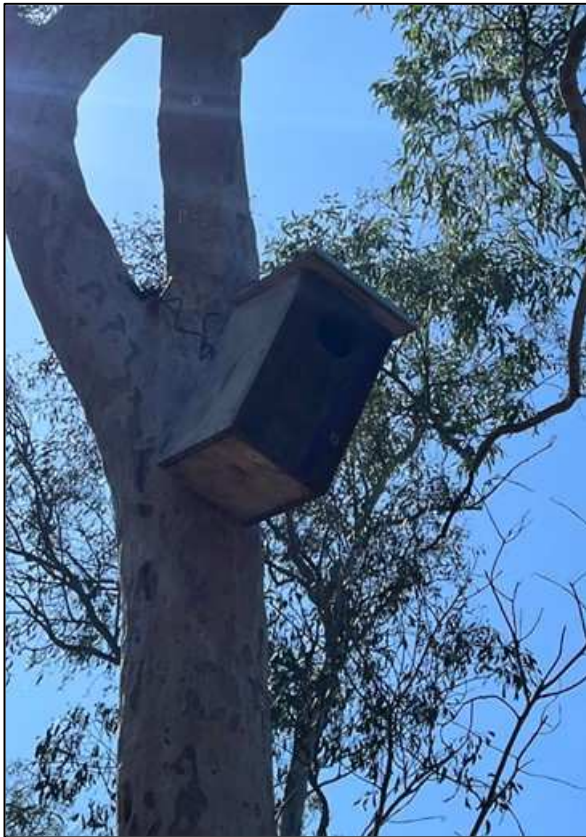
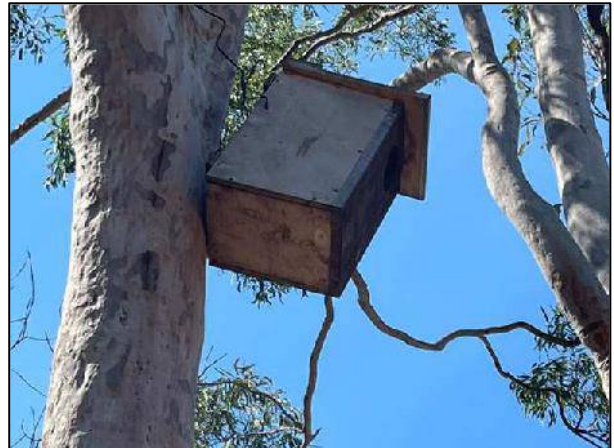
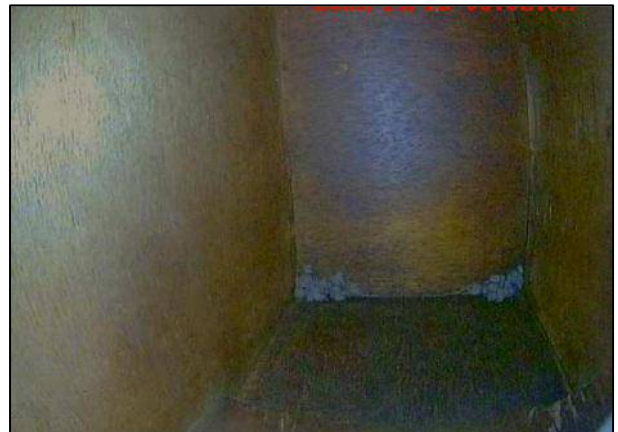
Maintenance Checklist of Nest Box ID: Box 10	Correct	Incorrect	Other
1. Box is not occupied by pest species	✓		
2. Box is not vandalised or missing	✓		
3. Box is securely attached with slight lean forward	✓		
4. Box is located at optimal height	✓		
5. Box is not damaged or rotten	✓		
6. The foot holds/ladder in interior of box for young is intact	✓		
7. There are no blockages in drainage holes	✓		
8. Entrance hole is free from obstruction and not damaged or worn	✓		
9. Nesting materials have been replaced to cover floor of box		✓	
10. All soiled materials like old shavings, membrane, egg shells have been removed	✓		
11. Box is aligned away from prevailing winds, rain and excessive heat	✓

No nesting material present.

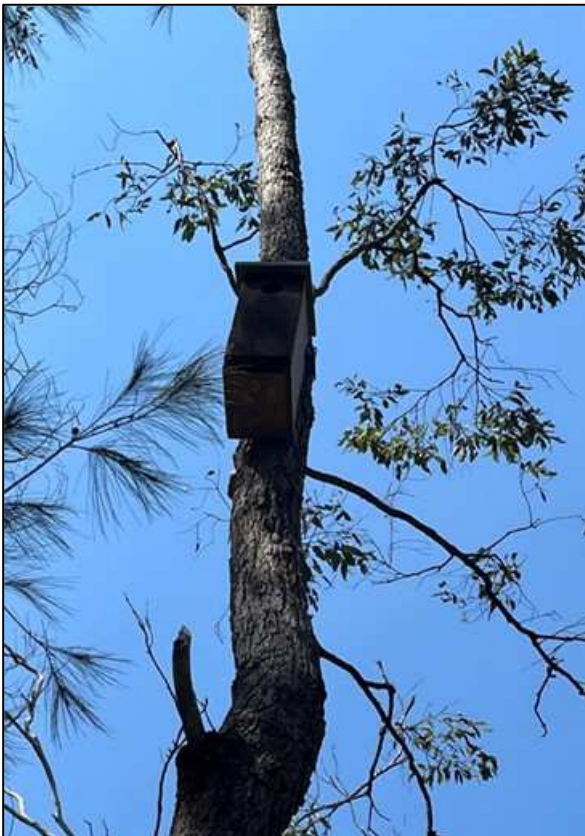
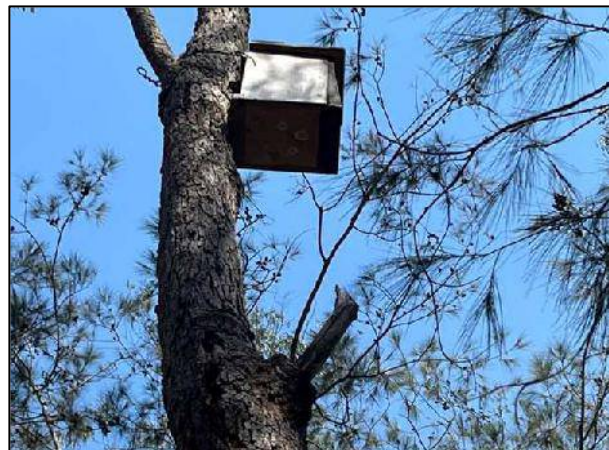
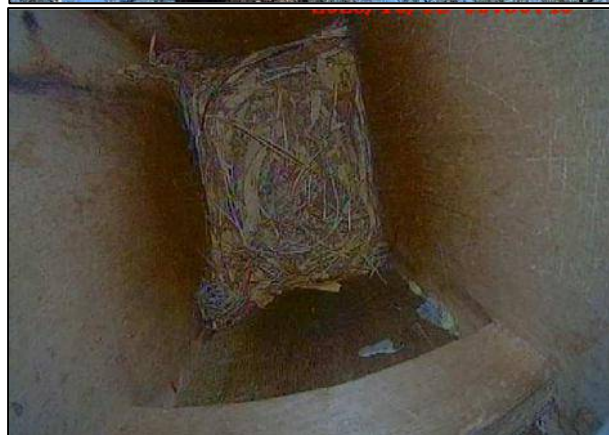
Maintenance Checklist of Nest Box ID: Box 11	Correct	Incorrect	Other
1. Box is not occupied by pest species	✓		
2. Box is not vandalised or missing	✓		
3. Box is securely attached with slight lean forward	✓		
4. Box is located at optimal height	✓		
5. Box is not damaged or rotten	✓		
6. The foot holds/ladder in interior of box for young is intact	✓		
7. There are no blockages in drainage holes	✓		
8. Entrance hole is free from obstruction and not damaged or worn	✓		
9. Nesting materials have been replaced to cover floor of box	✓		
10. All soiled materials like old shavings, membrane, egg shells have been removed	✓		
11. Box is aligned away from prevailing winds, rain and excessive heat	✓

Leaf litter present.
