Annual Compliance Report

17 October 2022 to 16 October 2023 EPBC 2013/7057
Spring Mountain Mixed Use Master Planned Community
Development, Spring Mountain, Queensland

Prepared for Lendlease Communities (Springfield) Pty Limited
9 January 2024

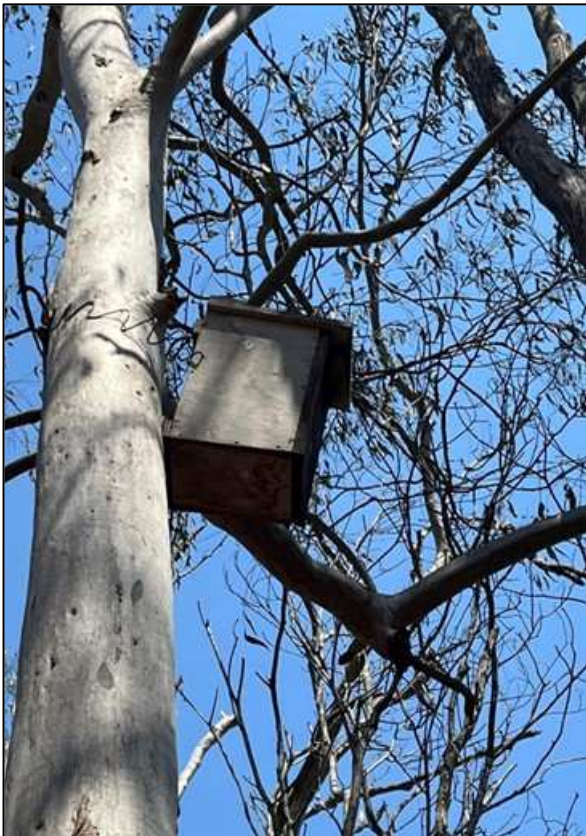
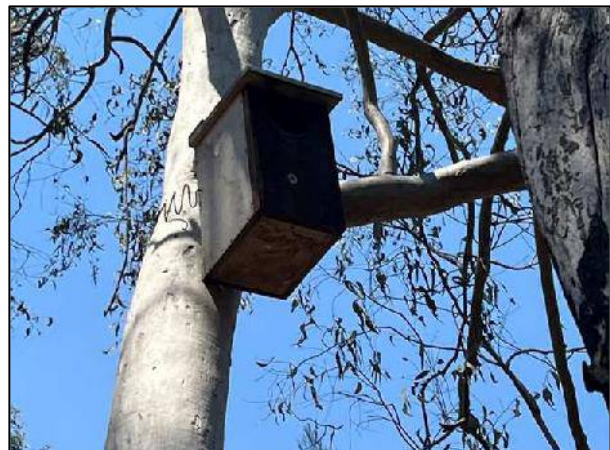
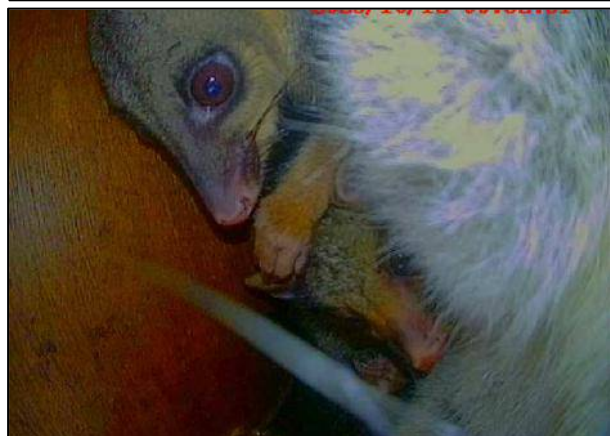
Maintenance Checklist of Nest Box ID: Box 12	Correct	Incorrect	Other
1. Box is not occupied by pest species	✓		
2. Box is not vandalised or missing	✓		
3. Box is securely attached with slight lean forward	✓		
4. Box is located at optimal height	✓		
5. Box is not damaged or rotten	✓		
6. The foot holds/ladder in interior of box for young is intact	✓		
7. There are no blockages in drainage holes	✓		
8. Entrance hole is free from obstruction and not damaged or worn	✓		
9. Nesting materials have been replaced to cover floor of box	✓		
10. All soiled materials like old shavings, membrane, egg shells have been removed	✓		
11. Box is aligned away from prevailing winds, rain and excessive heat	✓

Brushtail Possum.

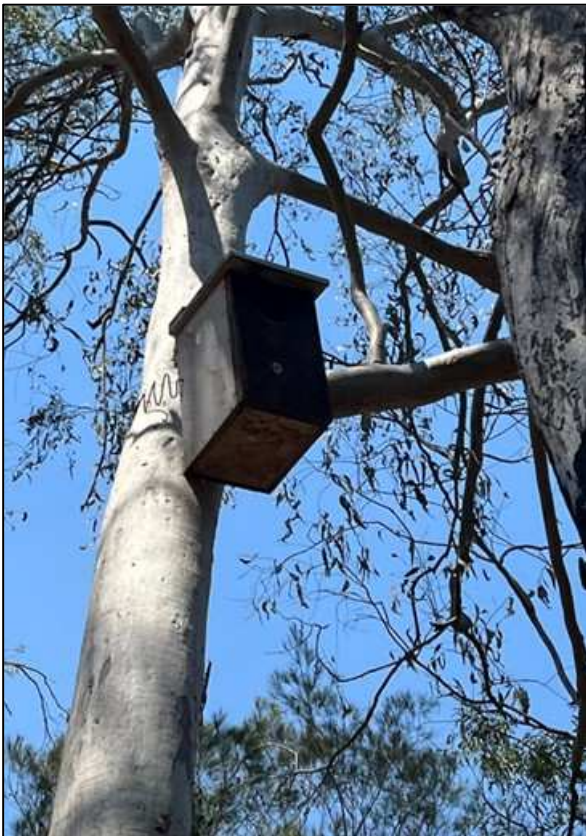
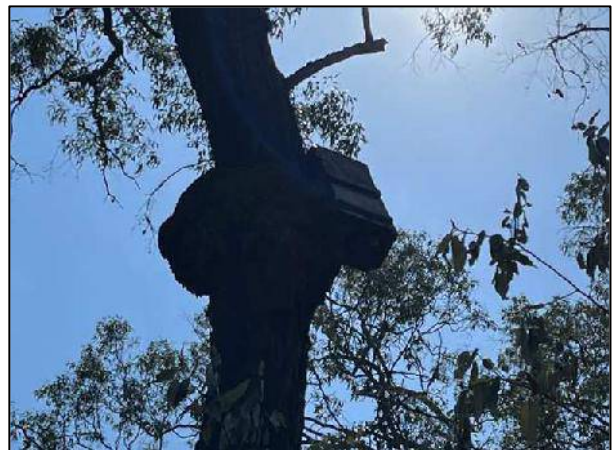
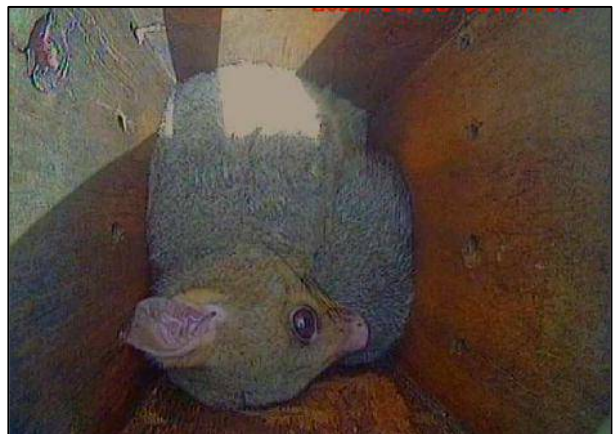
Maintenance Checklist of Nest Box ID: Box 13	Correct	Incorrect	Other
1. Box is not occupied by pest species	✓		
2. Box is not vandalised or missing	✓		
3. Box is securely attached with slight lean forward	✓		
4. Box is located at optimal height	✓		
5. Box is not damaged or rotten	✓		
6. The foot holds/ladder in interior of box for young is intact	✓		
7. There are no blockages in drainage holes	✓		
8. Entrance hole is free from obstruction and not damaged or worn	✓		
9. Nesting materials have been replaced to cover floor of box	✓		
10. All soiled materials like old shavings, membrane, egg shells have been removed	✓		
11. Box is aligned away from prevailing winds, rain and excessive heat	✓

Brushtail Possum.

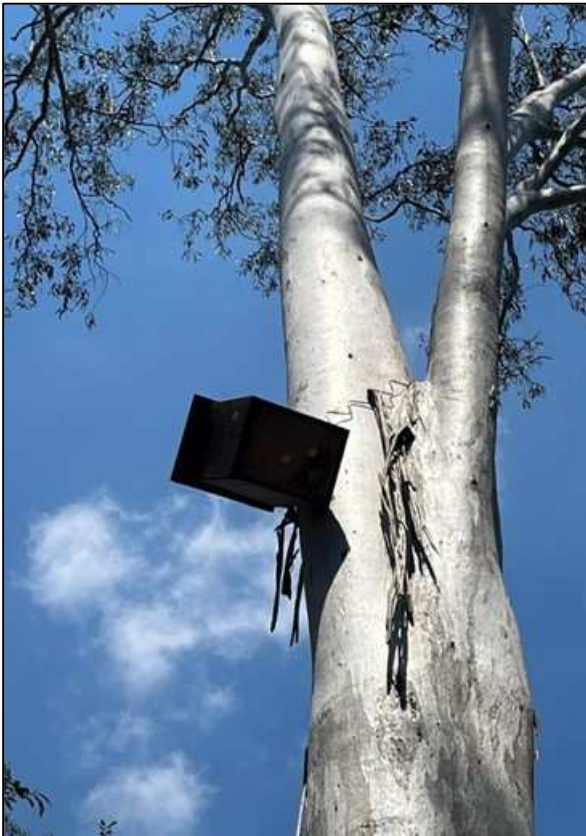
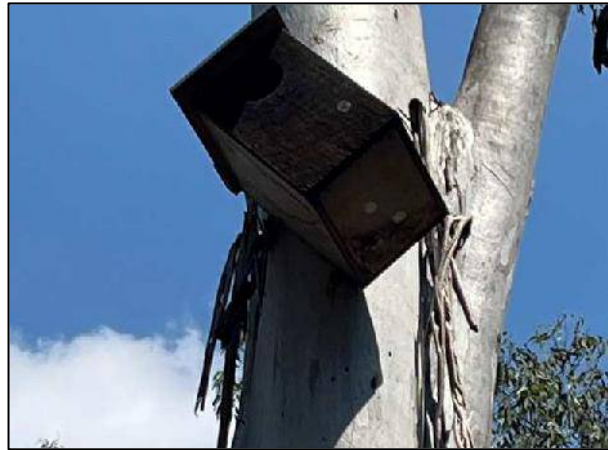
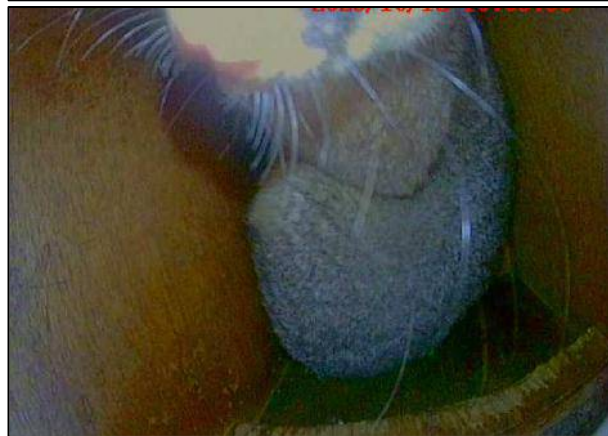
Maintenance Checklist of Nest Box ID: Box 14	Correct	Incorrect	Other
1. Box is not occupied by pest species	✓		
2. Box is not vandalised or missing	✓		
3. Box is securely attached with slight lean forward		✓	Reposition
4. Box is located at optimal height	✓		
5. Box is not damaged or rotten	✓		
6. The foot holds/ladder in interior of box for young is intact	✓		
7. There are no blockages in drainage holes	✓		
8. Entrance hole is free from obstruction and not damaged or worn	✓		
9. Nesting materials have been replaced to cover floor of box	✓		
10. All soiled materials like old shavings, membrane, egg shells have been removed	✓		
11. Box is aligned away from prevailing winds, rain and excessive heat	✓

Brushtail Possum.

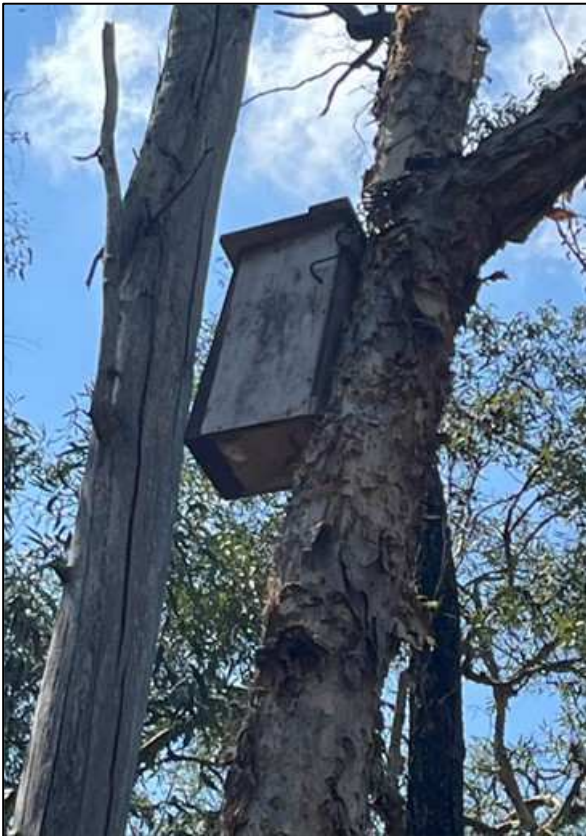
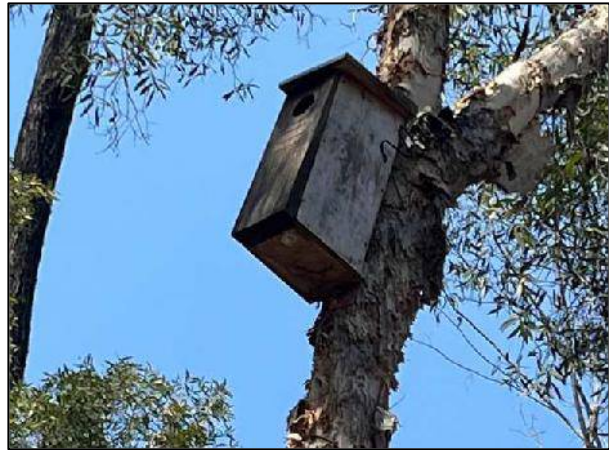
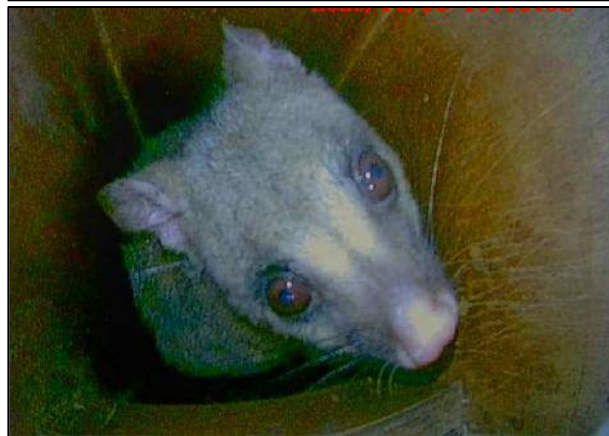
Maintenance Checklist of Nest Box ID: Box 15	Correct	Incorrect	Other
1. Box is not occupied by pest species	✓		
2. Box is not vandalised or missing	✓		
3. Box is securely attached with slight lean forward	✓		
4. Box is located at optimal height	✓		
5. Box is not damaged or rotten	✓		
6. The foot holds/ladder in interior of box for young is intact	✓		
7. There are no blockages in drainage holes	✓		
8. Entrance hole is free from obstruction and not damaged or worn	✓		
9. Nesting materials have been replaced to cover floor of box	✓		
10. All soiled materials like old shavings, membrane, egg shells have been removed	✓		
11. Box is aligned away from prevailing winds, rain and excessive heat	✓

Brushtail Possum.

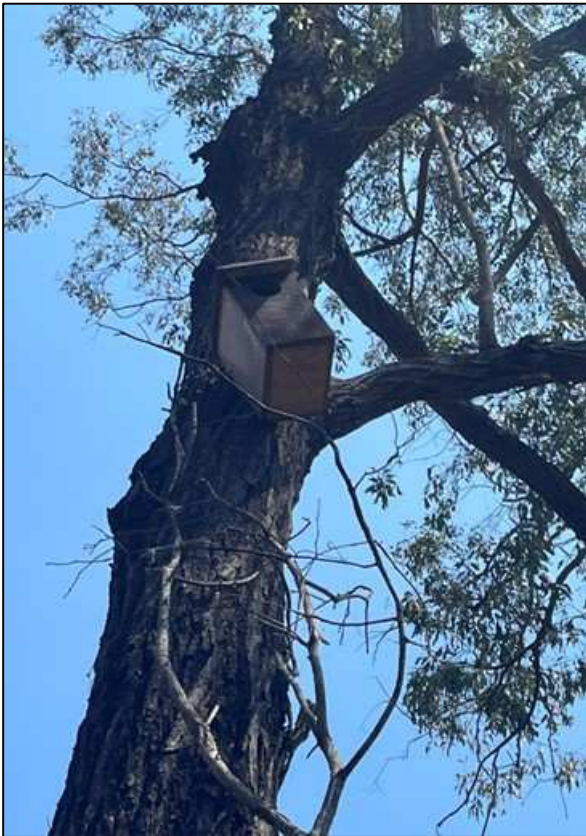
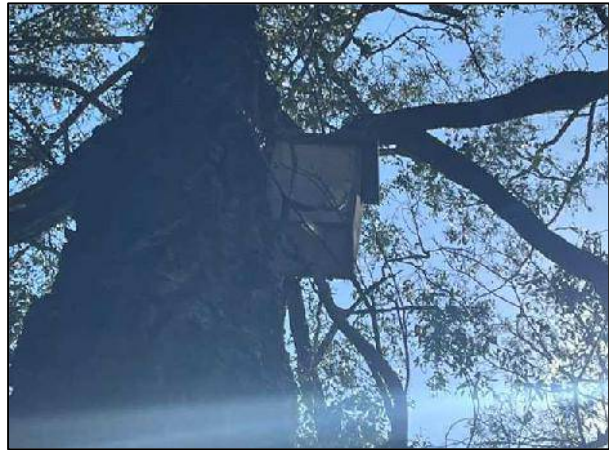
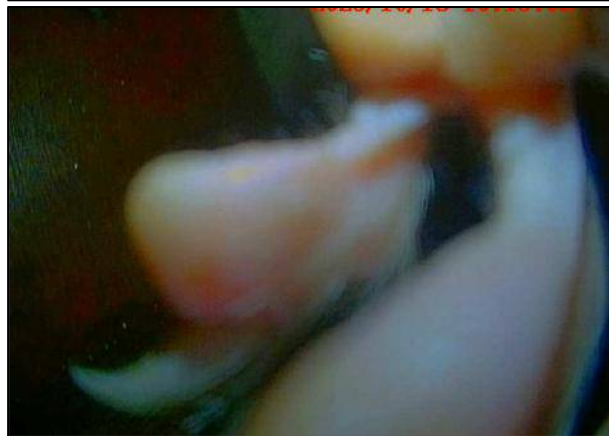
Maintenance Checklist of Nest Box ID: Box 16	Correct	Incorrect	Other
1. Box is not occupied by pest species	✓		
2. Box is not vandalised or missing	✓		
3. Box is securely attached with slight lean forward		✓	Reposition
4. Box is located at optimal height	✓		
5. Box is not damaged or rotten	✓		
6. The foot holds/ladder in interior of box for young is intact	✓		
7. There are no blockages in drainage holes	✓		
8. Entrance hole is free from obstruction and not damaged or worn	✓		
9. Nesting materials have been replaced to cover floor of box	✓		
10. All soiled materials like old shavings, membrane, egg shells have been removed	✓		
11. Box is aligned away from prevailing winds, rain and excessive heat	✓

Brushtail Possum.

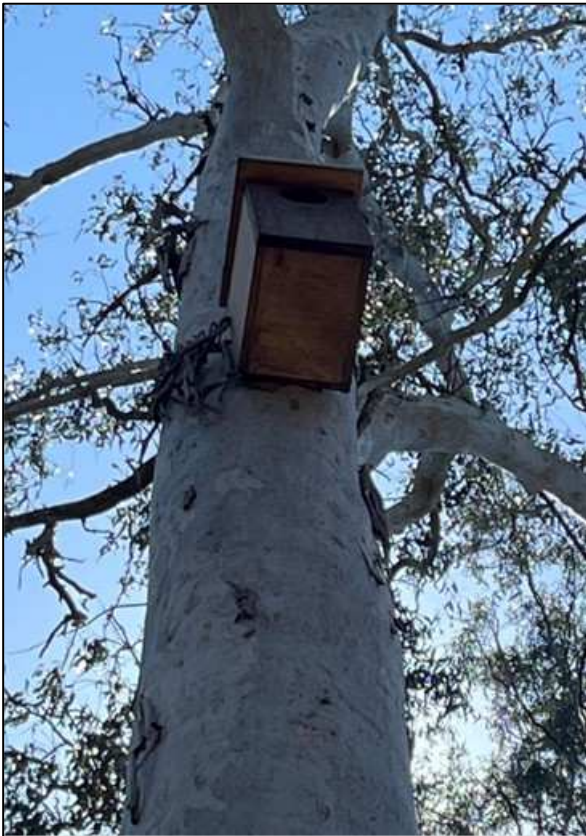
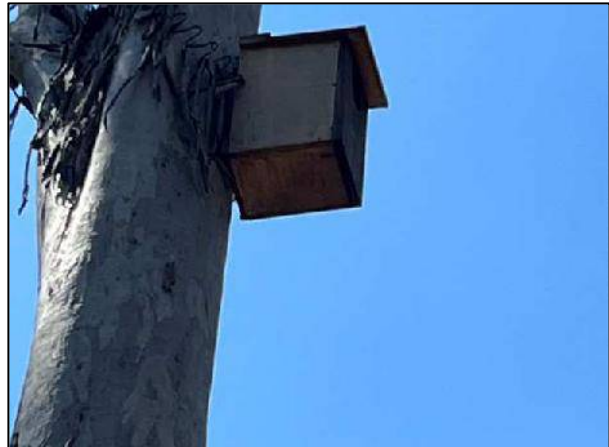
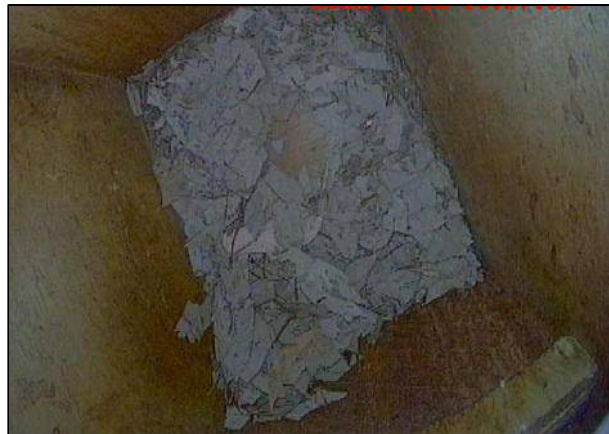
Maintenance Checklist of Nest Box ID: Box 17	Correct	Incorrect	Other
1. Box is not occupied by pest species	✓		
2. Box is not vandalised or missing	✓		
3. Box is securely attached with slight lean forward	✓		
4. Box is located at optimal height	✓		
5. Box is not damaged or rotten	✓		
6. The foot holds/ladder in interior of box for young is intact	✓		
7. There are no blockages in drainage holes	✓		
8. Entrance hole is free from obstruction and not damaged or worn	✓		
9. Nesting materials have been replaced to cover floor of box	✓		
10. All soiled materials like old shavings, membrane, egg shells have been removed	✓		
11. Box is aligned away from prevailing winds, rain and excessive heat	✓

Leaf litter present.

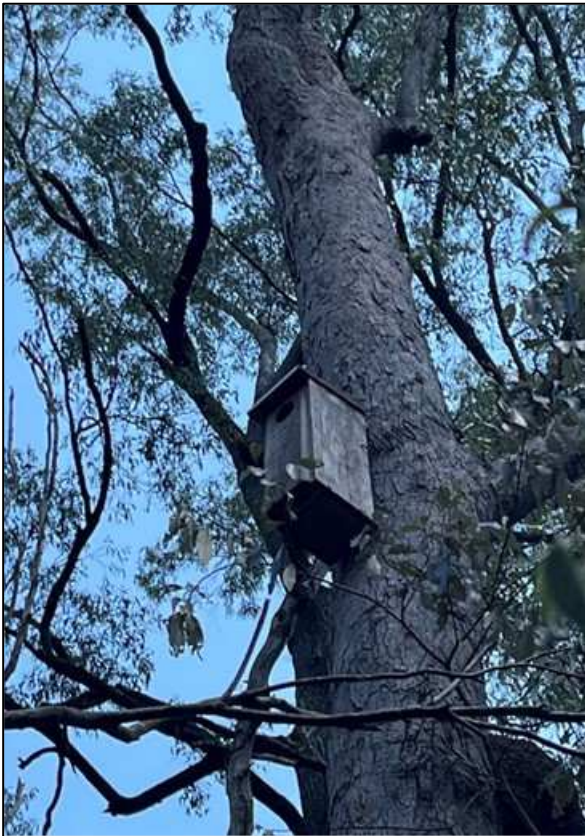
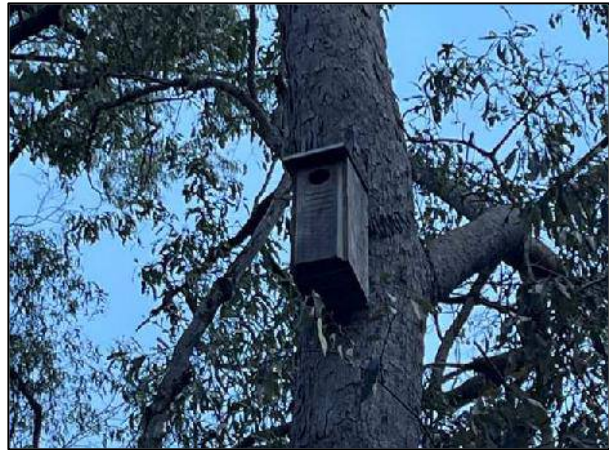
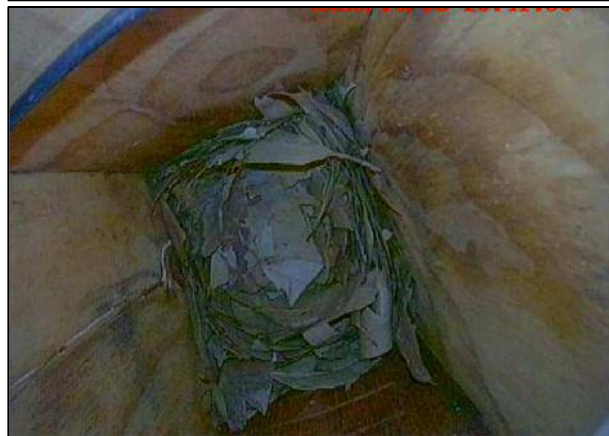
Maintenance Checklist of Nest Box ID: Box 18	Correct	Incorrect	Other
1. Box is not occupied by pest species	✓		
2. Box is not vandalised or missing	✓		
3. Box is securely attached with slight lean forward	✓		
4. Box is located at optimal height	✓		
5. Box is not damaged or rotten	✓		
6. The foot holds/ladder in interior of box for young is intact	✓		
7. There are no blockages in drainage holes	✓		
8. Entrance hole is free from obstruction and not damaged or worn	✓		
9. Nesting materials have been replaced to cover floor of box	✓		
10. All soiled materials like old shavings, membrane, egg shells have been removed	✓		
11. Box is aligned away from prevailing winds, rain and excessive heat	✓

Leaf litter present.

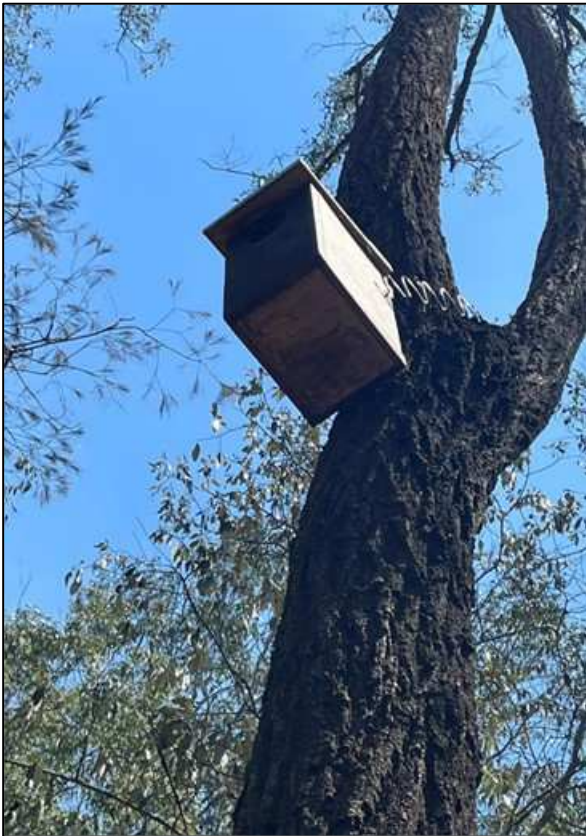
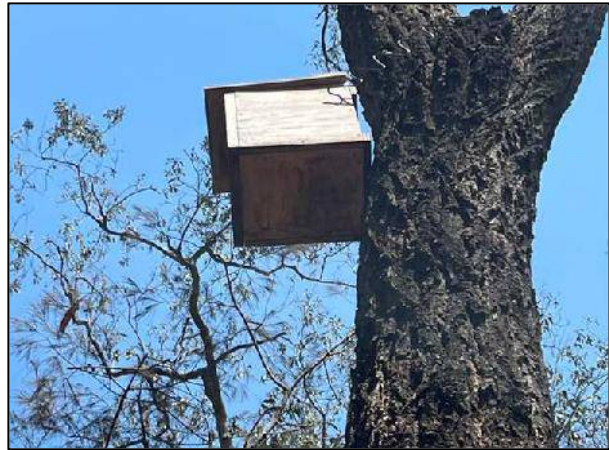
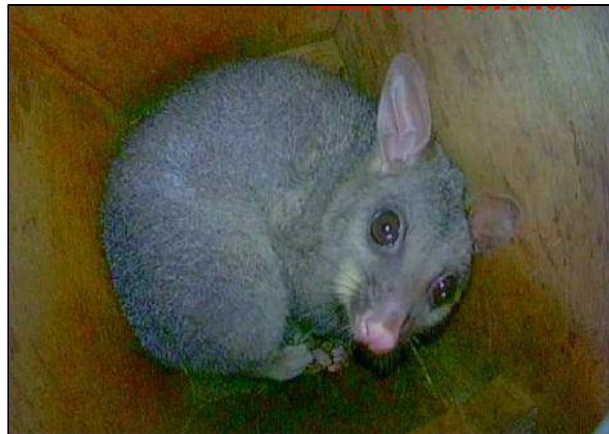
Maintenance Checklist of Nest Box ID: Box 19	Correct	Incorrect	Other
1. Box is not occupied by pest species	✓		
2. Box is not vandalised or missing	✓		
3. Box is securely attached with slight lean forward	✓		
4. Box is located at optimal height	✓		
5. Box is not damaged or rotten	✓		
6. The foot holds/ladder in interior of box for young is intact	✓		
7. There are no blockages in drainage holes	✓		
8. Entrance hole is free from obstruction and not damaged or worn	✓		
9. Nesting materials have been replaced to cover floor of box	✓		
10. All soiled materials like old shavings, membrane, egg shells have been removed	✓		
11. Box is aligned away from prevailing winds, rain and excessive heat	✓

Brushtail Possum. No leaf litter present.

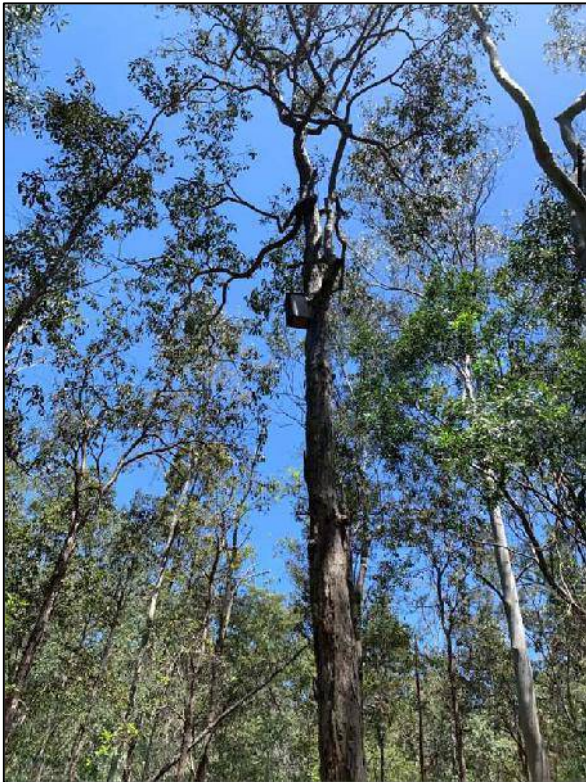
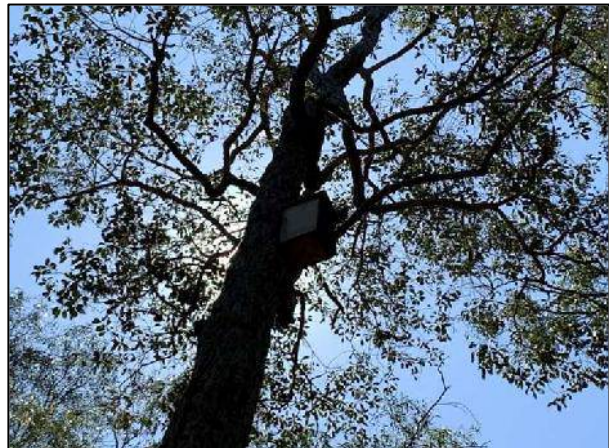
Maintenance Checklist of Nest Box ID: Box 20	Correct	Incorrect	Other
1. Box is not occupied by pest species	✓		
2. Box is not vandalised or missing	✓		
3. Box is securely attached with slight lean forward	✓		
4. Box is located at optimal height	✓		
5. Box is not damaged or rotten	✓		
6. The foot holds/ladder in interior of box for young is intact	✓		
7. There are no blockages in drainage holes	✓		
8. Entrance hole is free from obstruction and not damaged or worn	✓		
9. Nesting materials have been replaced to cover floor of box	n/a		
10. All soiled materials like old shavings, membrane, egg shells have been removed	n/a		
11. Box is aligned away from prevailing winds, rain and excessive heat	✓

Unreachable due to erosion at base of tree. Box appears in good condition from outside.

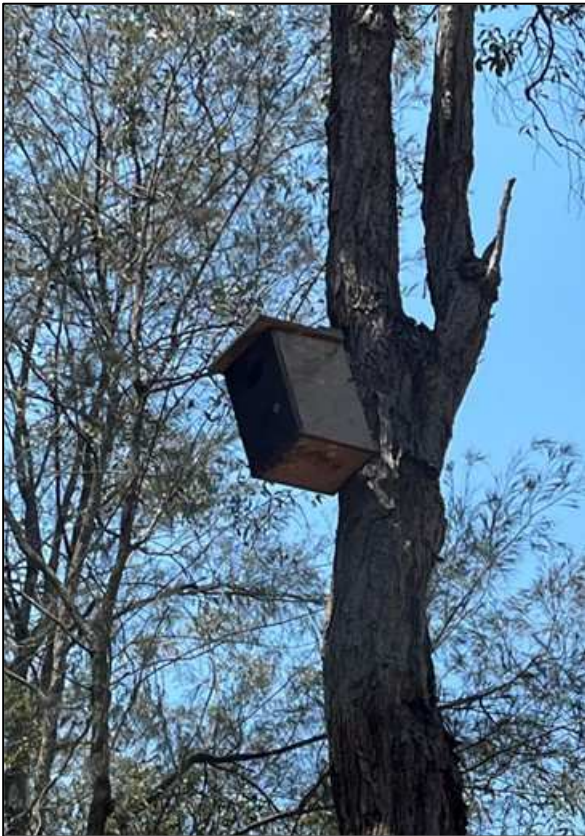
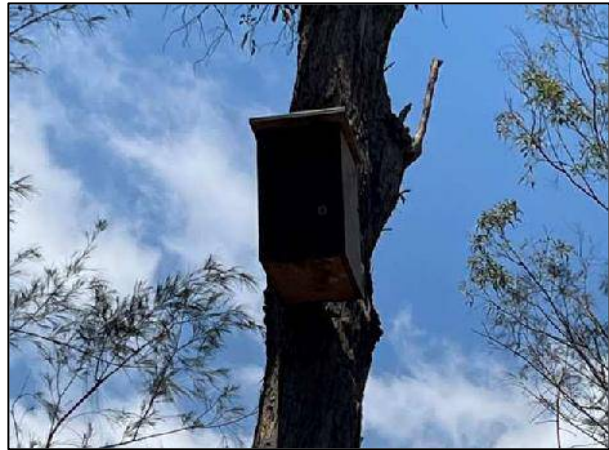
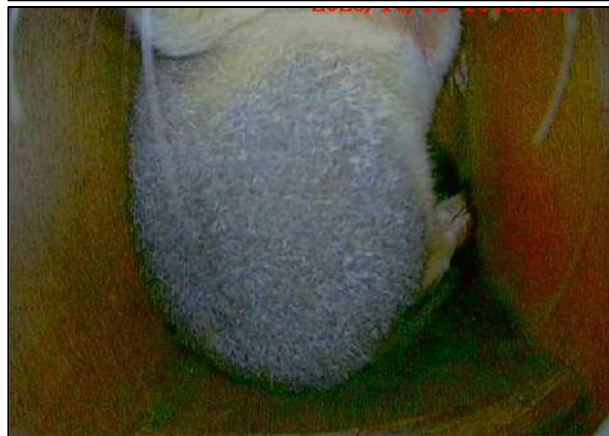
Maintenance Checklist of Nest Box ID: Box 21	Correct	Incorrect	Other
1. Box is not occupied by pest species	✓		
2. Box is not vandalised or missing	✓		
3. Box is securely attached with slight lean forward	✓		
4. Box is located at optimal height	✓		
5. Box is not damaged or rotten	✓		
6. The foot holds/ladder in interior of box for young is intact	✓		
7. There are no blockages in drainage holes	✓		
8. Entrance hole is free from obstruction and not damaged or worn	✓		
9. Nesting materials have been replaced to cover floor of box	✓		
10. All soiled materials like old shavings, membrane, egg shells have been removed	✓		
11. Box is aligned away from prevailing winds, rain and excessive heat	✓

Brushtail Possum.

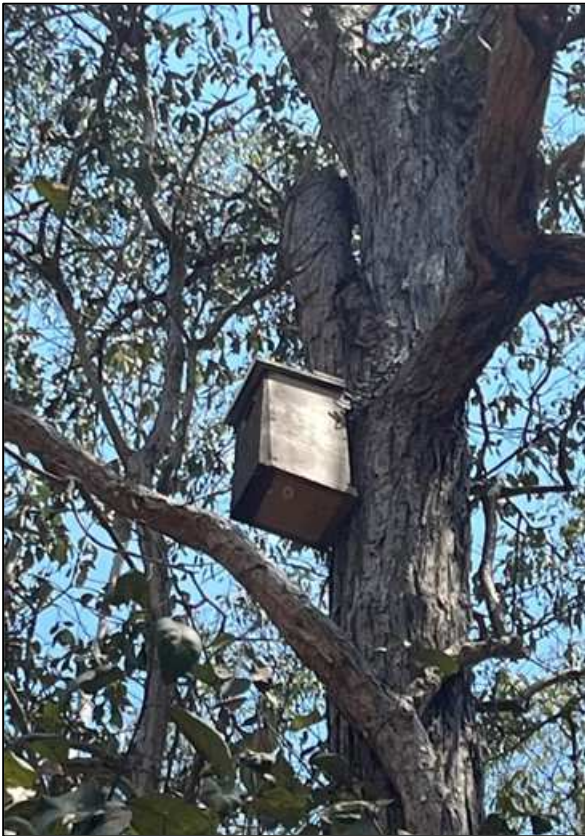
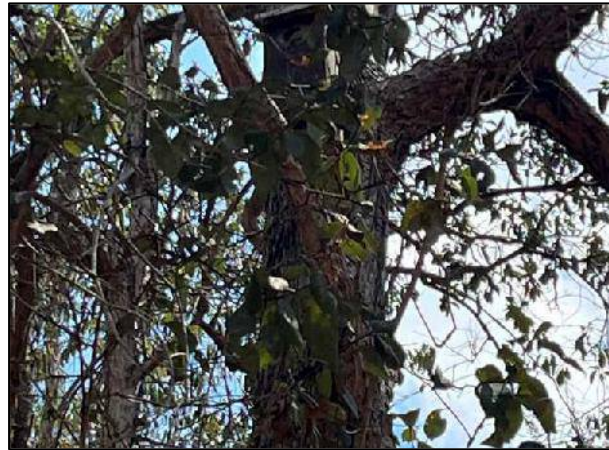
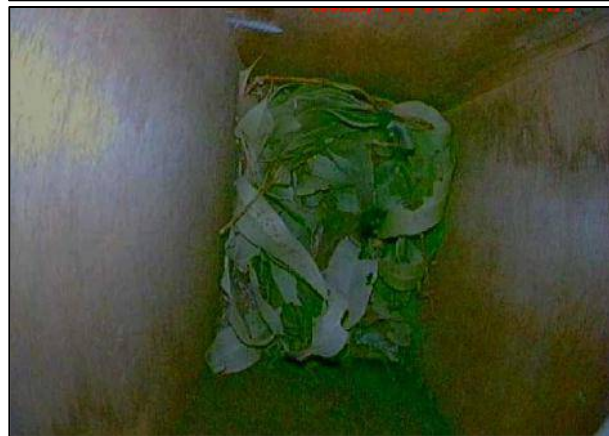
Maintenance Checklist of Nest Box ID: Box 22	Correct	Incorrect	Other
1. Box is not occupied by pest species	✓		
2. Box is not vandalised or missing	✓		
3. Box is securely attached with slight lean forward	✓		
4. Box is located at optimal height	✓		
5. Box is not damaged or rotten	✓		
6. The foot holds/ladder in interior of box for young is intact	✓		
7. There are no blockages in drainage holes	✓		
8. Entrance hole is free from obstruction and not damaged or worn	✓		
9. Nesting materials have been replaced to cover floor of box	✓		
10. All soiled materials like old shavings, membrane, egg shells have been removed	✓		
11. Box is aligned away from prevailing winds, rain and excessive heat	✓

Leaf litter present. Internally exposed screw.

It is recommended that nest boxes requiring attention are seen to prior to September 2024.

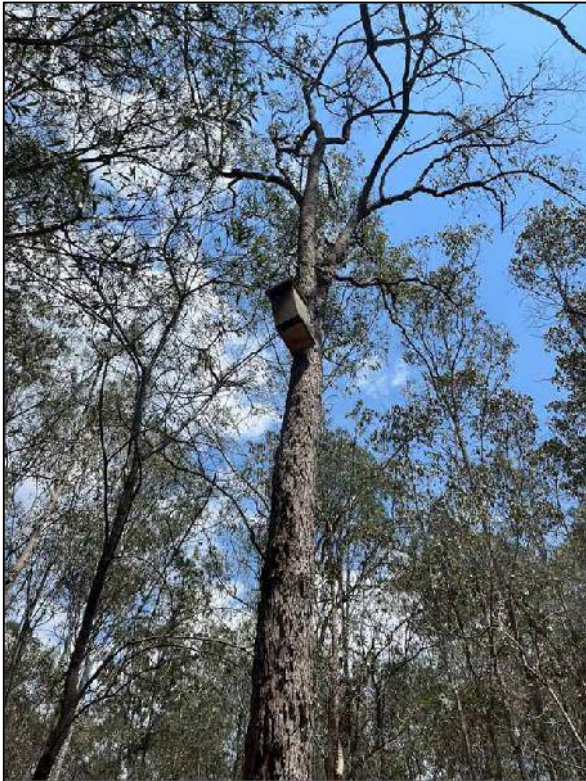
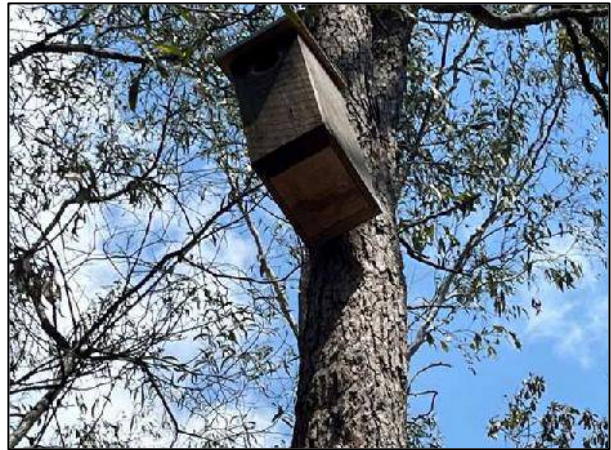
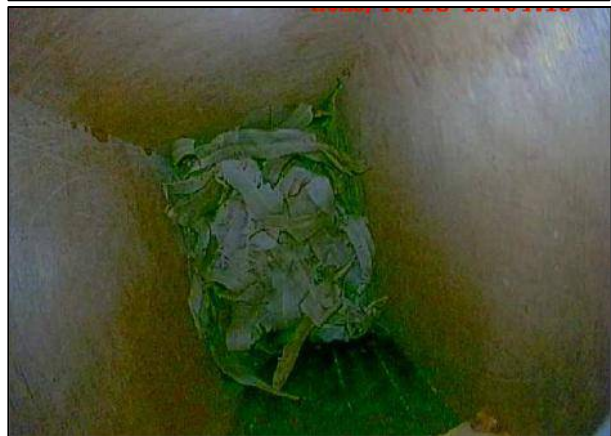
Maintenance Checklist of Nest Box ID: Box 23	Correct	Incorrect	Other
1. Box is not occupied by pest species	✓		
2. Box is not vandalised or missing	✓		
3. Box is securely attached with slight lean forward	✓		
4. Box is located at optimal height	✓		
5. Box is not damaged or rotten	✓		
6. The foot holds/ladder in interior of box for young is intact	✓		
7. There are no blockages in drainage holes	✓		
8. Entrance hole is free from obstruction and not damaged or worn	✓		
9. Nesting materials have been replaced to cover floor of box	✓		
10. All soiled materials like old shavings, membrane, egg shells have been removed	✓		
11. Box is aligned away from prevailing winds, rain and excessive heat	✓

Leaf litter present.

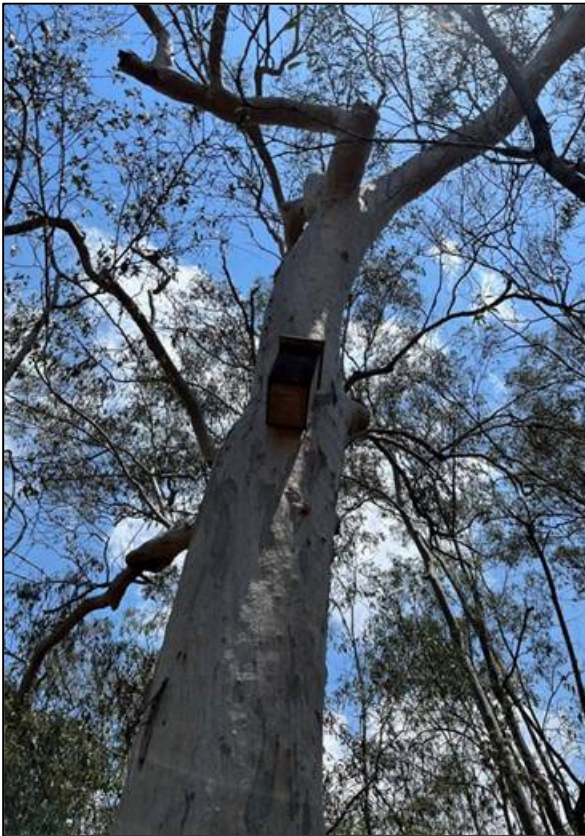
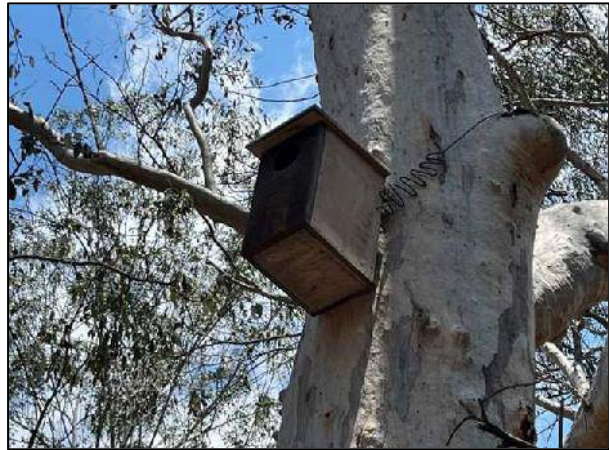
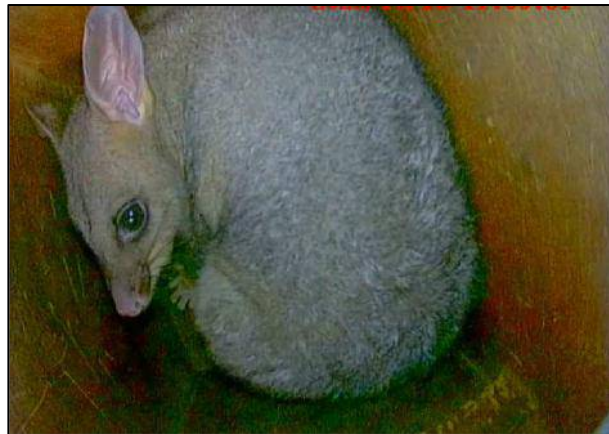
Brushtail Possum.

Maintenance Checklist of Nest Box ID: Box 25	Correct	Incorrect	Other
1. Box is not occupied by pest species	✓		
2. Box is not vandalised or missing	✓		
3. Box is securely attached with slight lean forward	✓		
4. Box is located at optimal height	✓		
5. Box is not damaged or rotten	✓		
6. The foot holds/ladder in interior of box for young is intact	✓		
7. There are no blockages in drainage holes	✓		
8. Entrance hole is free from obstruction and not damaged or worn	✓		
9. Nesting materials have been replaced to cover floor of box	✓		
10. All soiled materials like old shavings, membrane, egg shells have been removed	✓		
11. Box is aligned away from prevailing winds, rain and excessive heat	✓

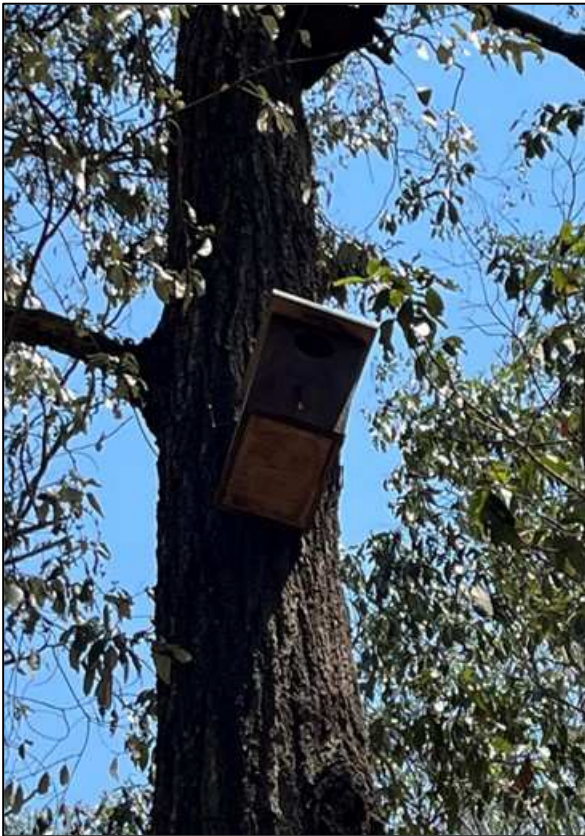
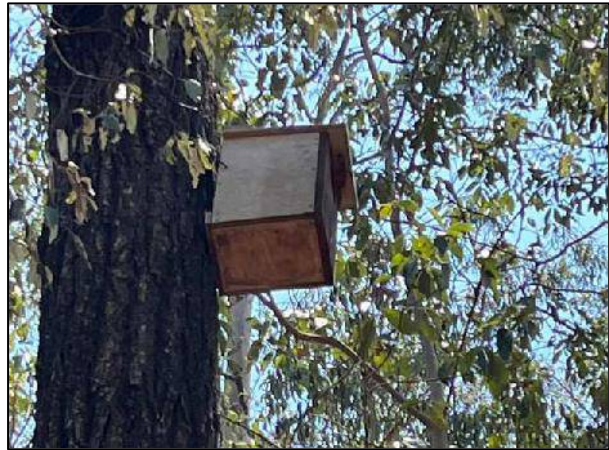
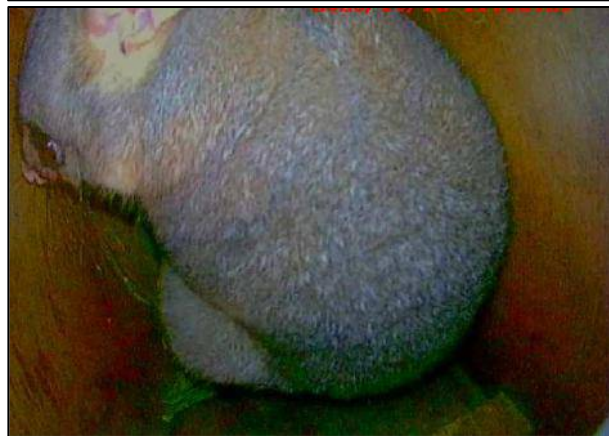
Brushtail Possum.

Maintenance Checklist of Nest Box ID: Box 26	Correct	Incorrect	Other
1. Box is not occupied by pest species	✓		
2. Box is not vandalised or missing	✓		
3. Box is securely attached with slight lean forward	✓		
4. Box is located at optimal height	✓		
5. Box is not damaged or rotten	✓		
6. The foot holds/ladder in interior of box for young is intact	✓		
7. There are no blockages in drainage holes	✓		
8. Entrance hole is free from obstruction and not damaged or worn	✓		
9. Nesting materials have been replaced to cover floor of box	✓		
10. All soiled materials like old shavings, membrane, egg shells have been removed	✓		
11. Box is aligned away from prevailing winds, rain and excessive heat	✓

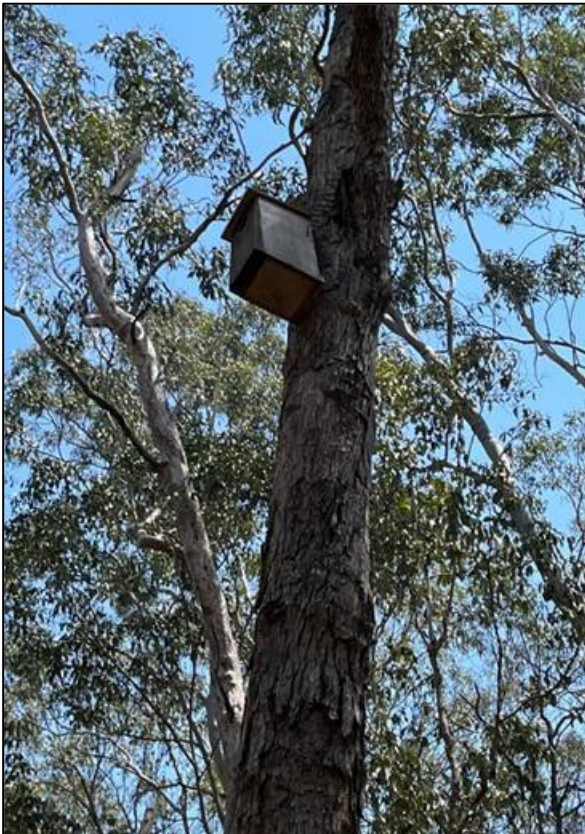
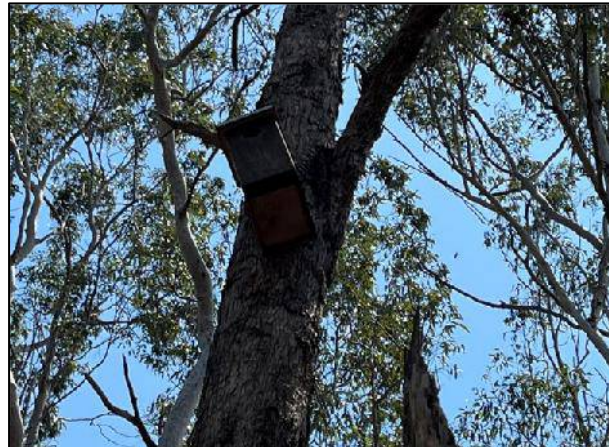
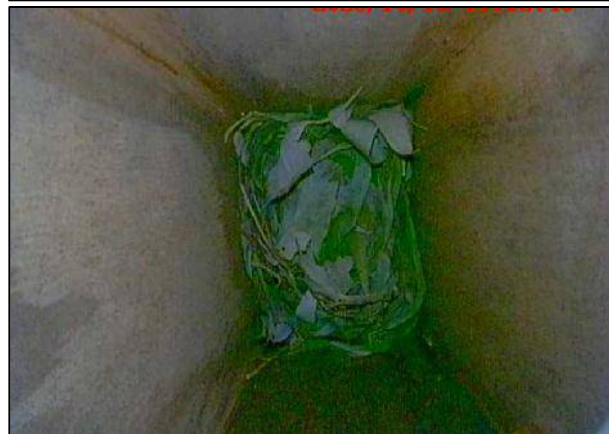
Leaf litter present.

Maintenance Checklist of Nest Box ID: Box 27	Correct	Incorrect	Other
1. Box is not occupied by pest species	✓		
2. Box is not vandalised or missing	✓		
3. Box is securely attached with slight lean forward	✓		
4. Box is located at optimal height	✓		
5. Box is not damaged or rotten	✓		
6. The foot holds/ladder in interior of box for young is intact	✓		
7. There are no blockages in drainage holes	✓		
8. Entrance hole is free from obstruction and not damaged or worn	✓		
9. Nesting materials have been replaced to cover floor of box	✓		
10. All soiled materials like old shavings, membrane, egg shells have been removed	✓		
11. Box is aligned away from prevailing winds, rain and excessive heat	✓

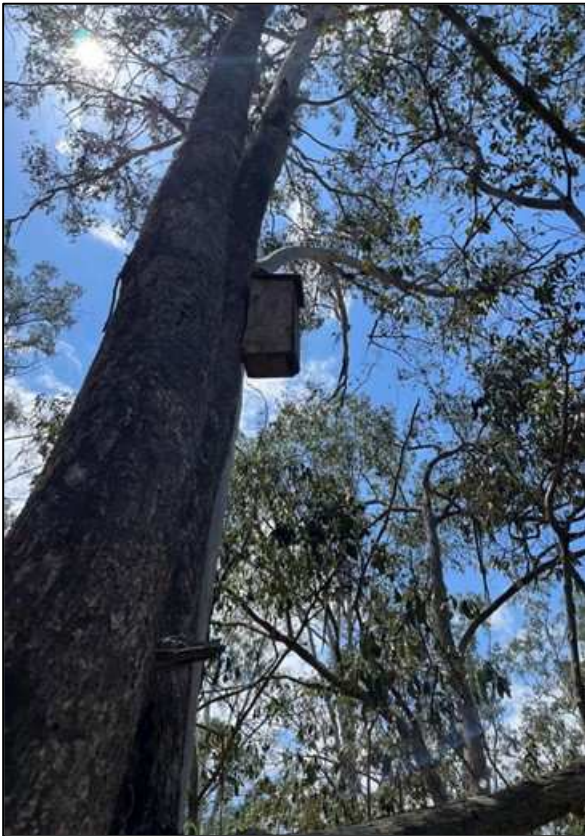
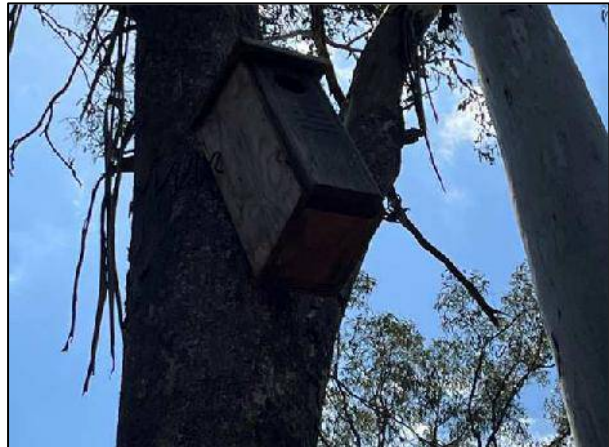
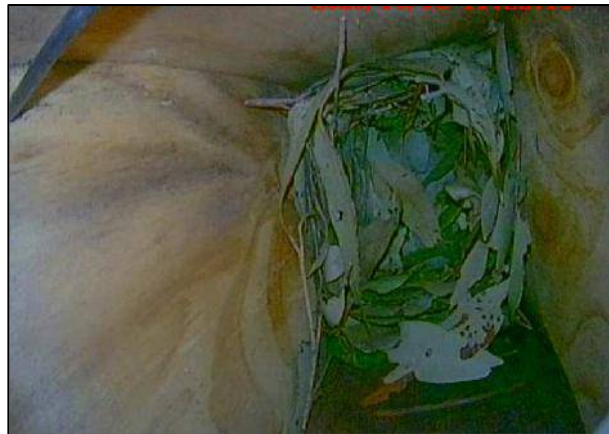
Leaf litter present.

Maintenance Checklist of Nest Box ID: Box 28 – Bat box	Correct	Incorrect	Other
1. Box is not occupied by pest species	✓		
2. Box is not vandalised or missing	✓		
3. Box is securely attached with slight lean forward	✓		
4. Box is located at optimal height	✓		
5. Box is not damaged or rotten	✓		
6. The foot holds/ladder in interior of box for young is intact	✓		
7. There are no blockages in drainage holes	✓		
8. Entrance hole is free from obstruction and not damaged or worn	✓		
9. Nesting materials have been replaced to cover floor of box	n/a		
10. All soiled materials like old shavings, membrane, egg shells have been removed	n/a		
11. Box is aligned away from prevailing winds, rain and excessive heat	✓

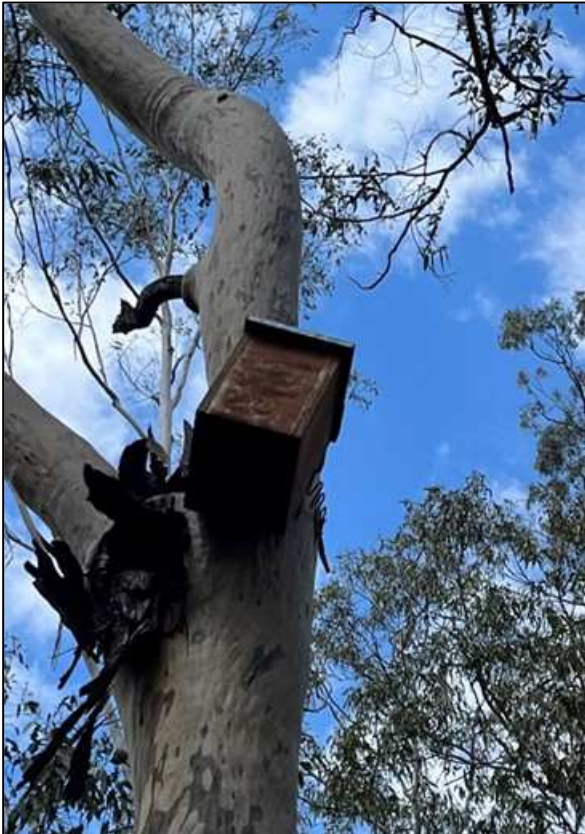
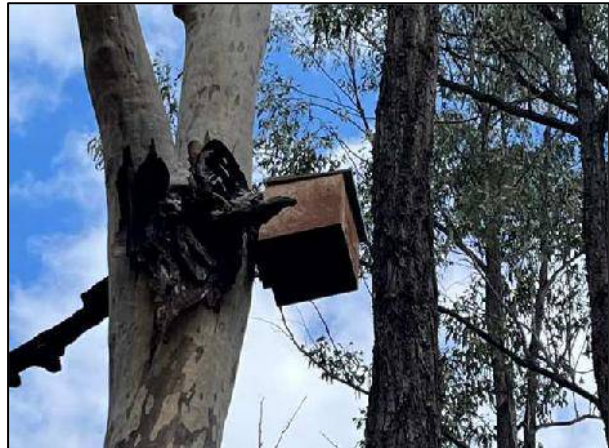
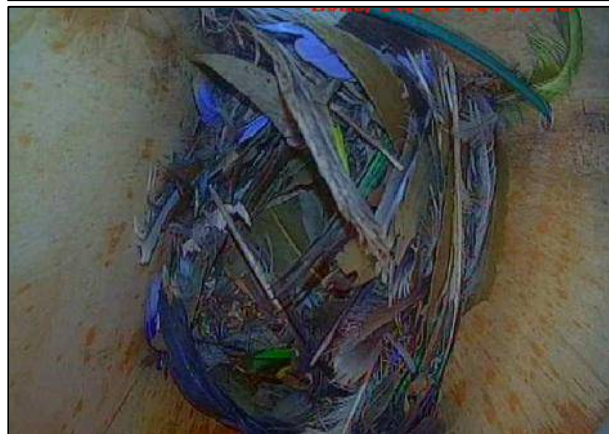
Leaf litter present. Loose feathers present.

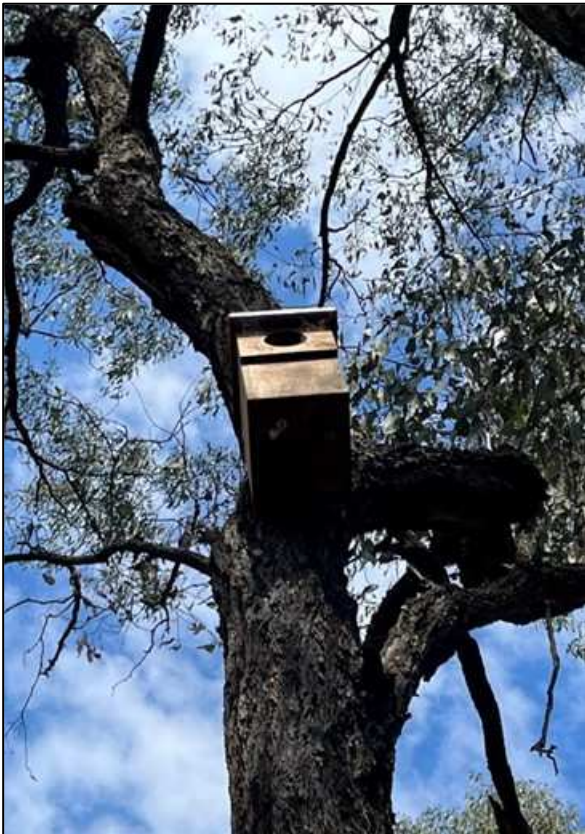
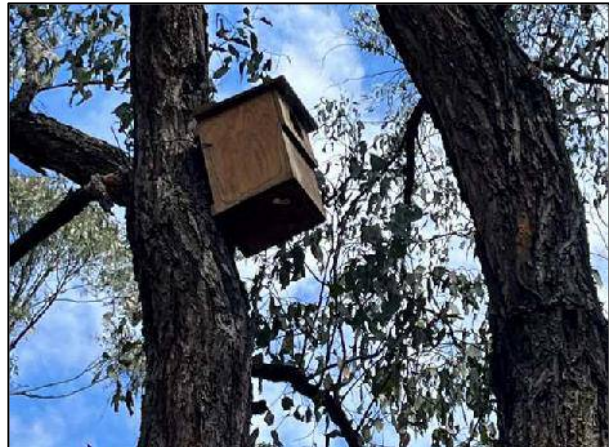
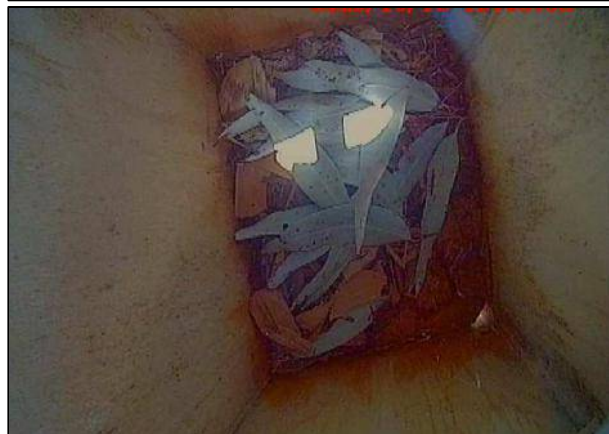
Leaf litter present. Spider-webs on entrance.

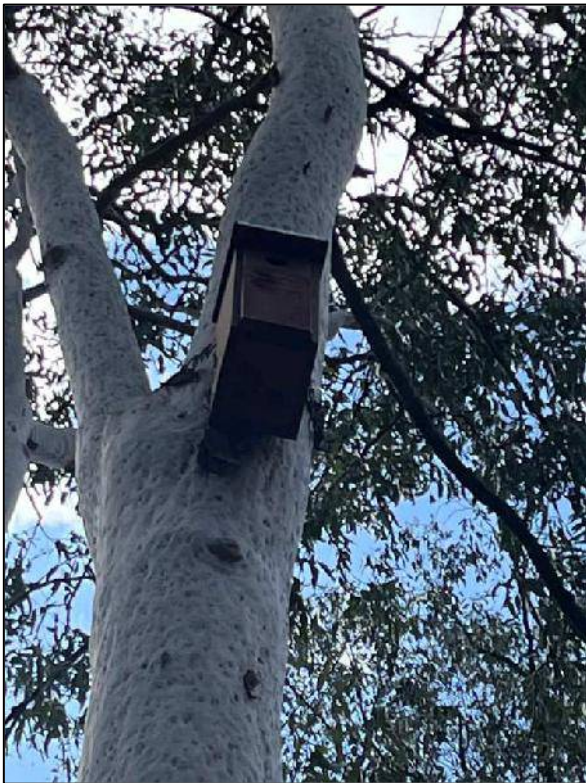
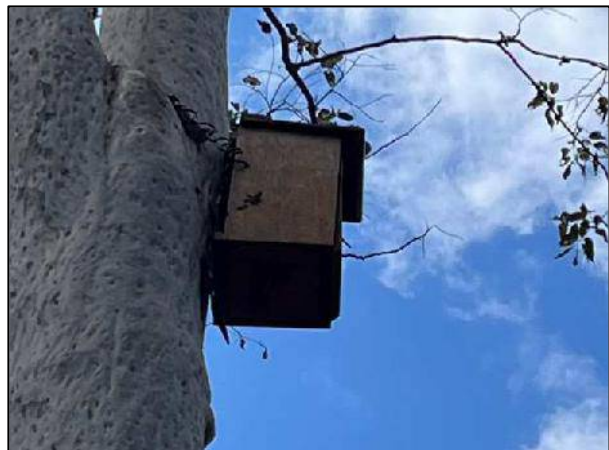
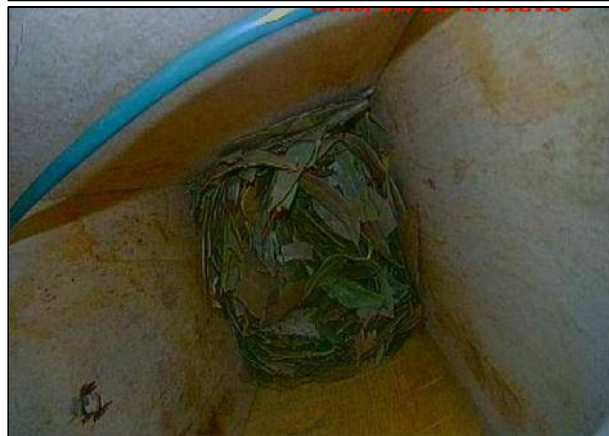
Leaf litter present.
