Annual Compliance Report

17 October 2022 to 16 October 2023 EPBC 2013/7057
Spring Mountain Mixed Use Master Planned Community
Development, Spring Mountain, Queensland

Prepared for Lendlease Communities (Springfield) Pty Limited
9 January 2024

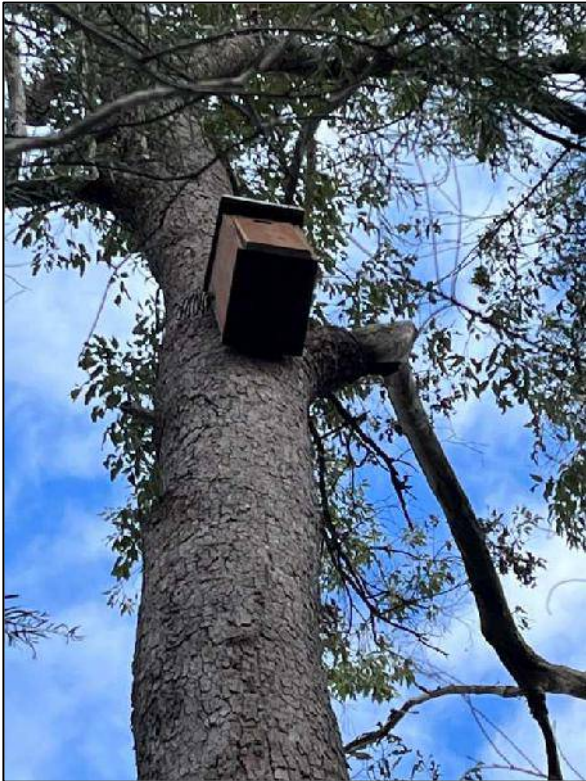
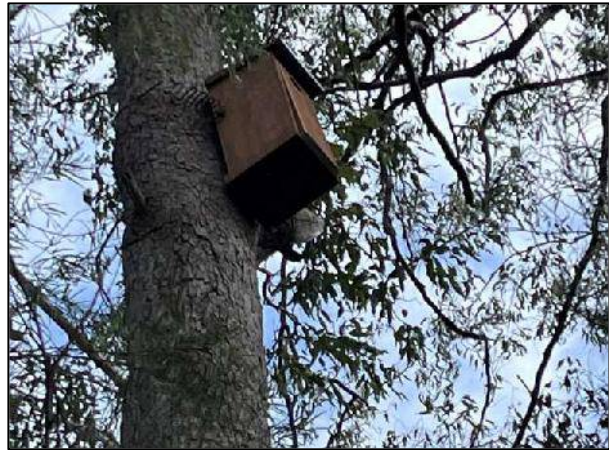
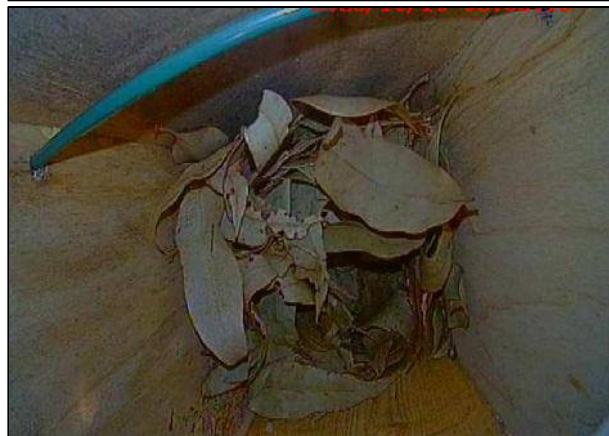
Leaf litter present.

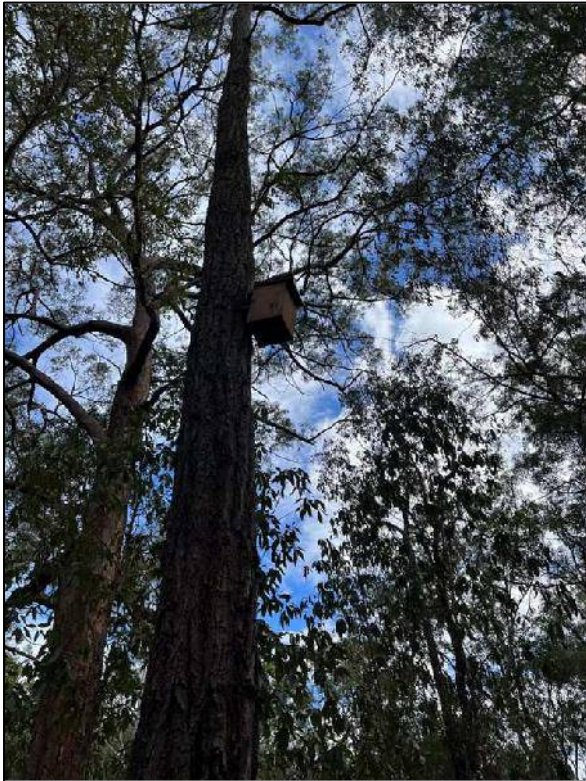
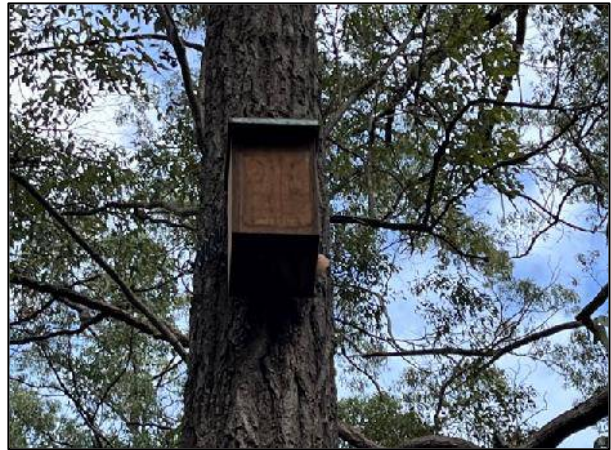
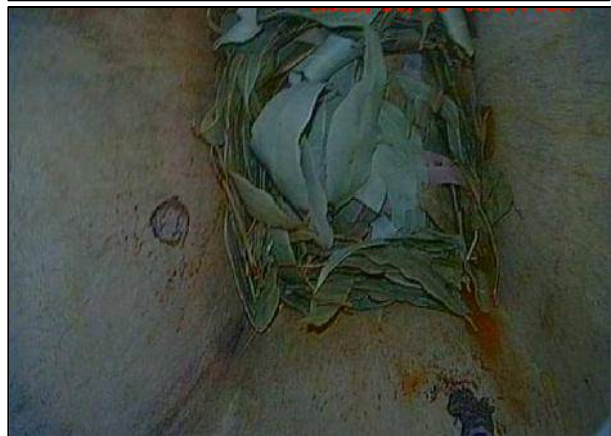
Leaf litter present.

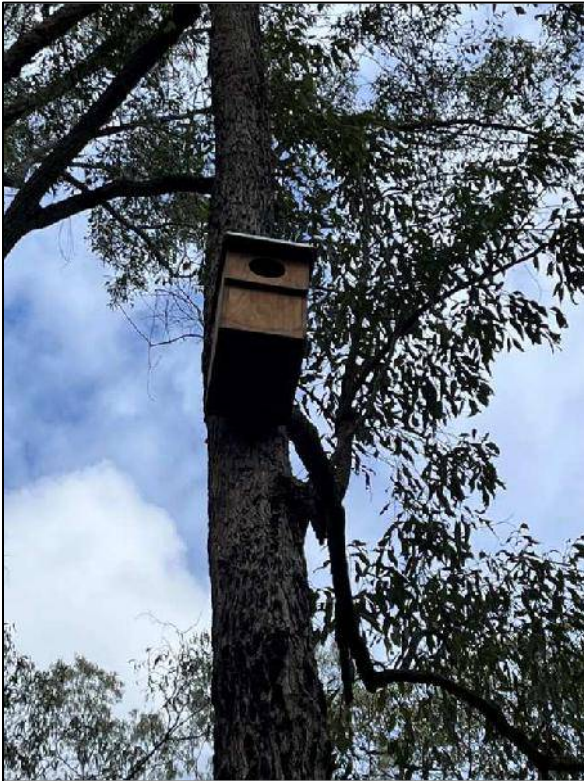
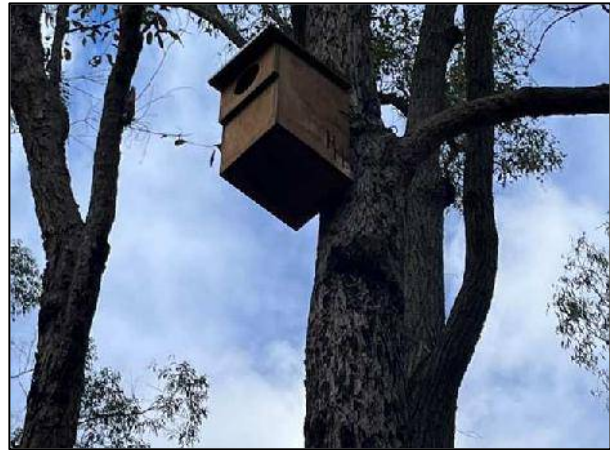
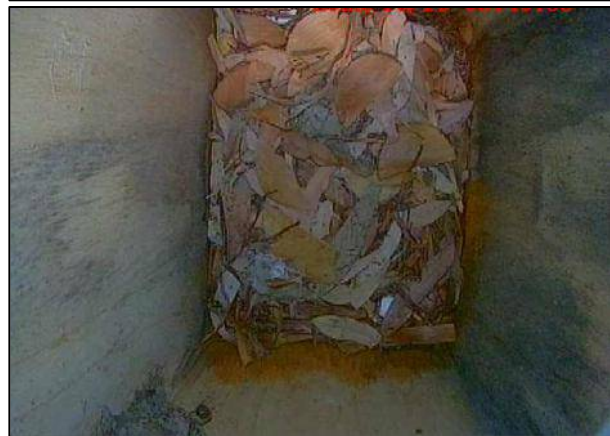
Leaf litter present.

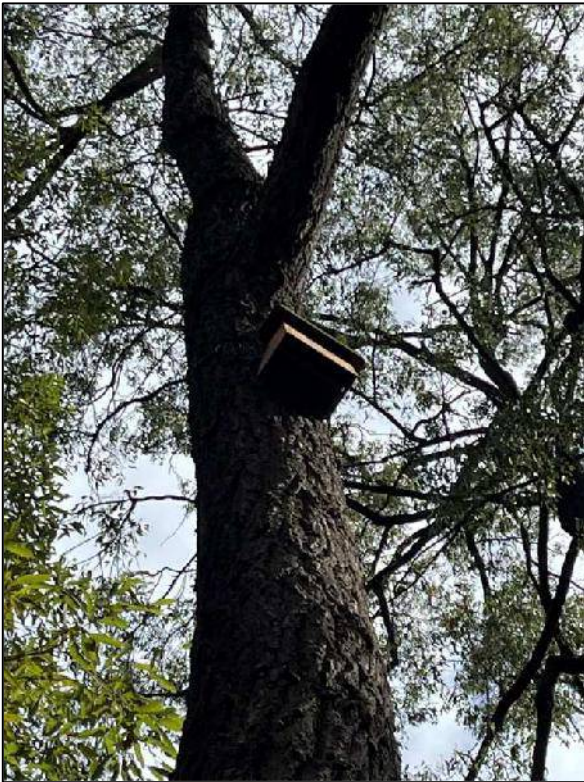
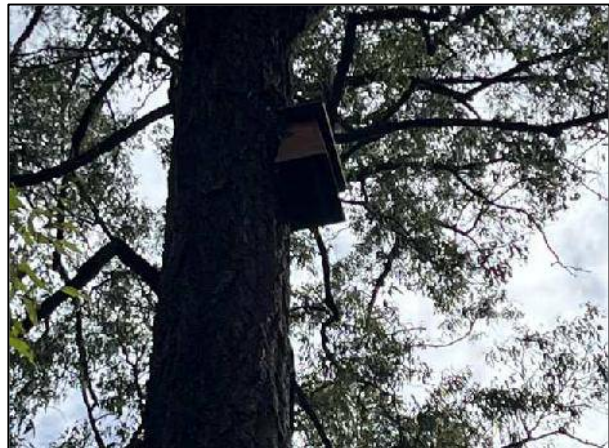
No nesting material present. Spider-webs and insect nests present.

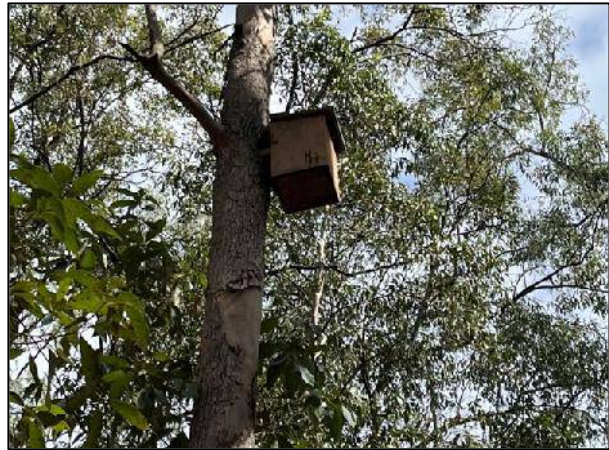
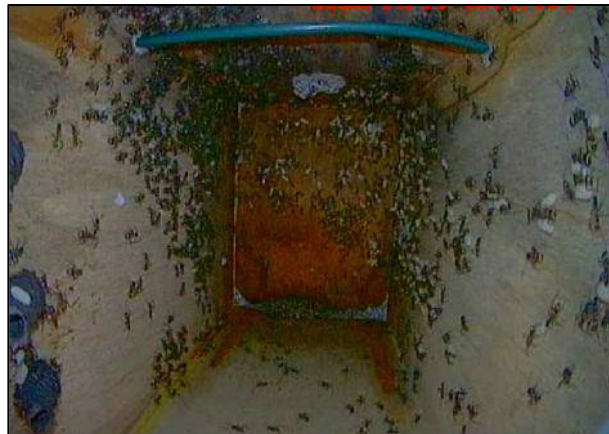
Ant infestation.

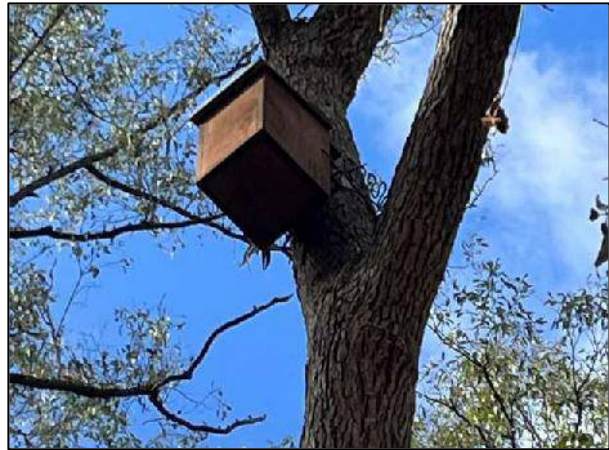
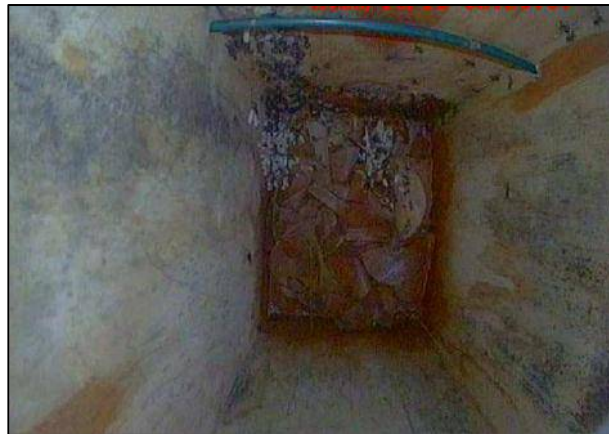
Leaf litter present. Nesting ants.

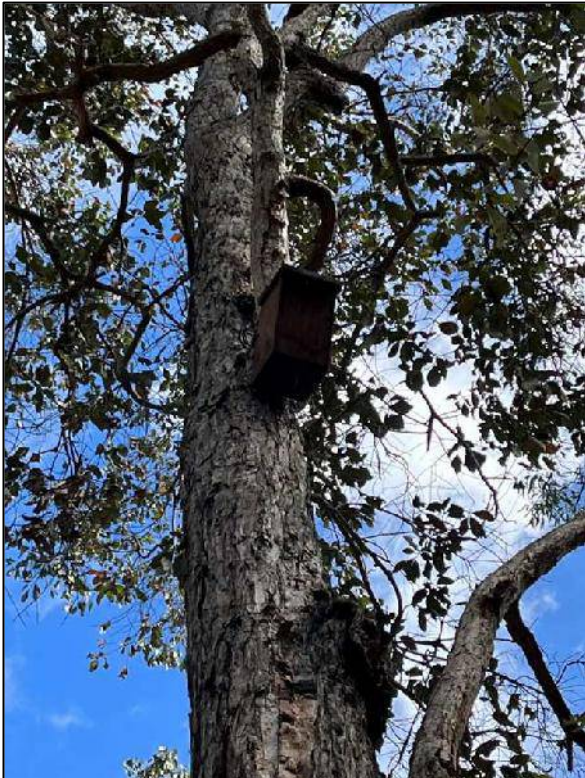
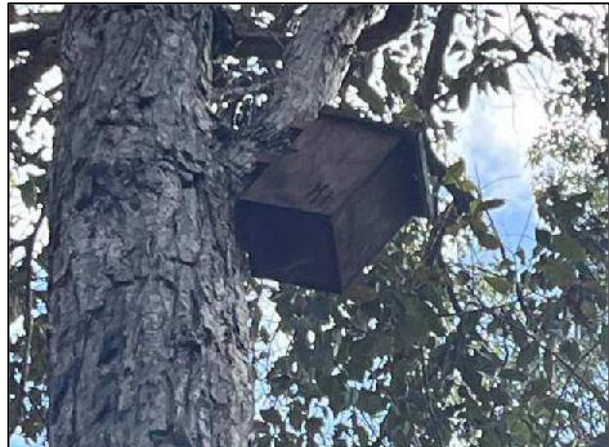
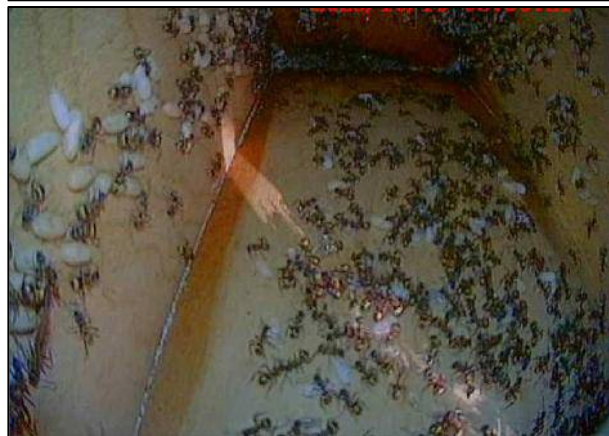
Ant infestation.

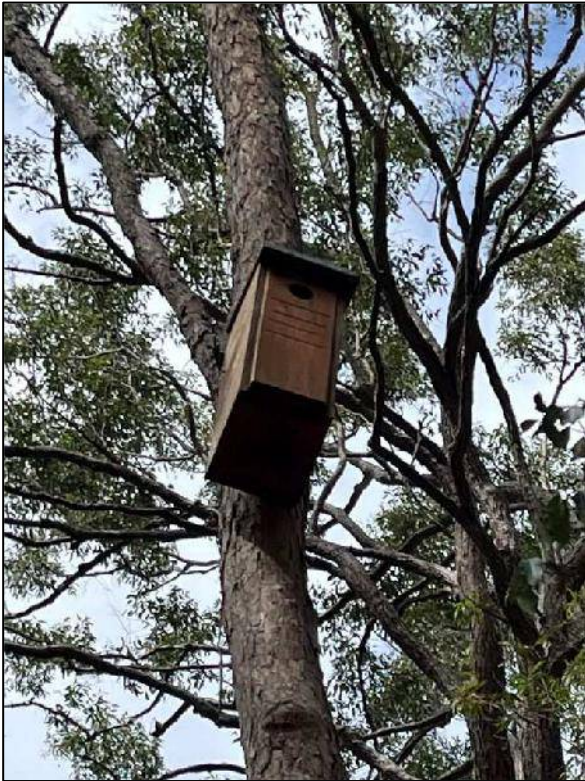
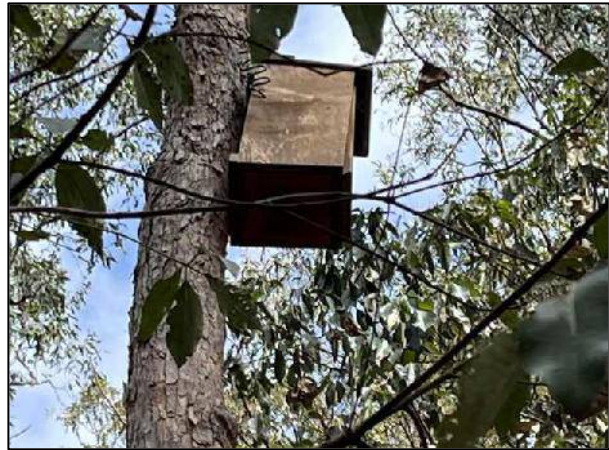
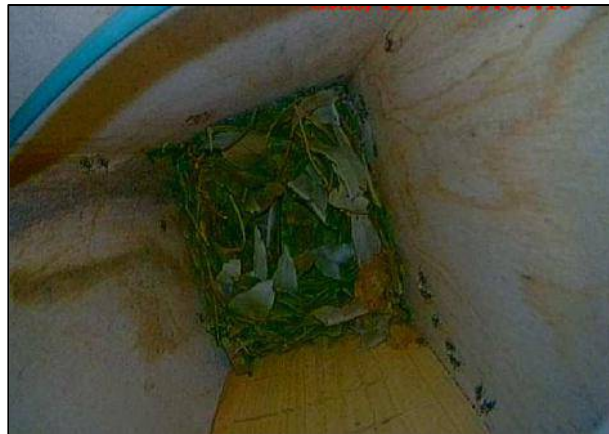
Maintenance Checklist of Nest Box ID: Box 39	Correct	Incorrect	Other
1. Box is not occupied by pest species	✓		
2. Box is not vandalised or missing	✓		
3. Box is securely attached with slight lean forward	✓		
4. Box is located at optimal height	✓		
5. Box is not damaged or rotten	✓		
6. The foot holds/ladder in interior of box for young is intact	✓		
7. There are no blockages in drainage holes	✓		
8. Entrance hole is free from obstruction and not damaged or worn	✓		
9. Nesting materials have been replaced to cover floor of box	✓		
10. All soiled materials like old shavings, membrane, egg shells have been removed	✓		
11. Box is aligned away from prevailing winds, rain and excessive heat	✓

Leaf litter present. Ants present.

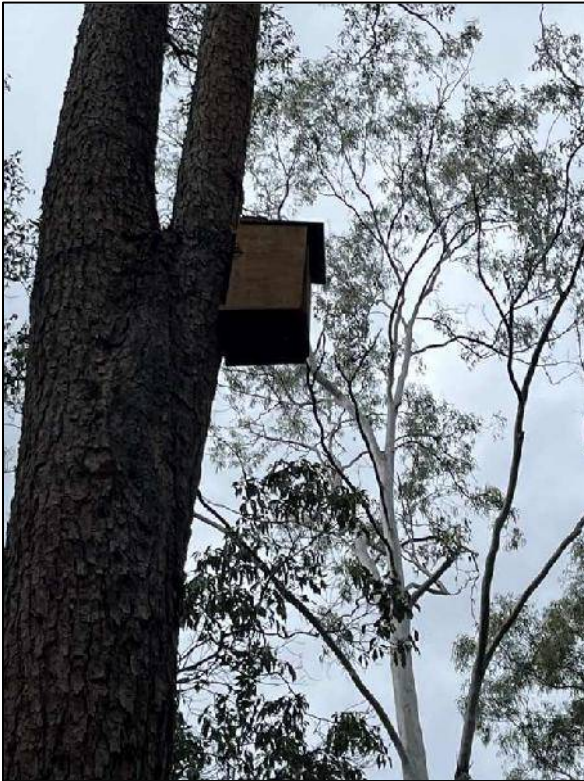
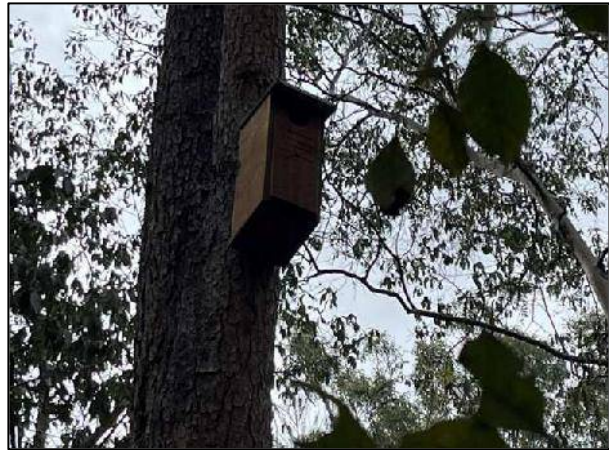
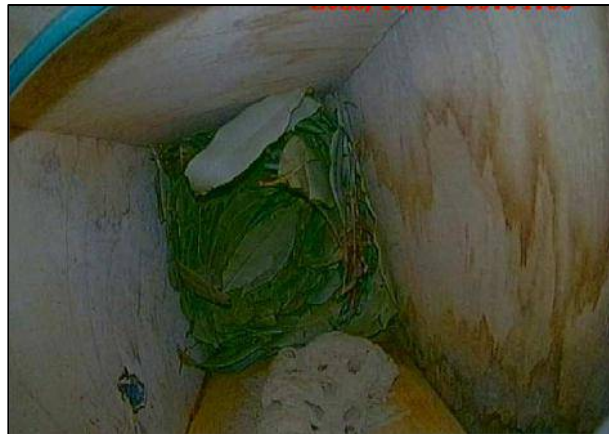
Maintenance Checklist of Nest Box ID: Box 40	Correct	Incorrect	Other
1. Box is not occupied by pest species	✓		
2. Box is not vandalised or missing	✓		
3. Box is securely attached with slight lean forward	✓		
4. Box is located at optimal height	✓		
5. Box is not damaged or rotten	✓		
6. The foot holds/ladder in interior of box for young is intact	✓		
7. There are no blockages in drainage holes	✓		
8. Entrance hole is free from obstruction and not damaged or worn	✓		
9. Nesting materials have been replaced to cover floor of box	✓		
10. All soiled materials like old shavings, membrane, egg shells have been removed	✓		
11. Box is aligned away from prevailing winds, rain and excessive heat	✓

Leaf litter present. Insect mud nest present.

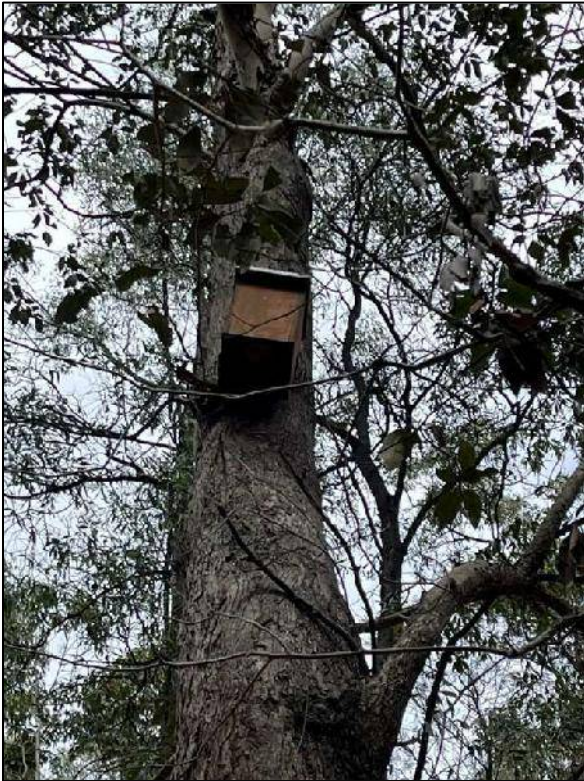
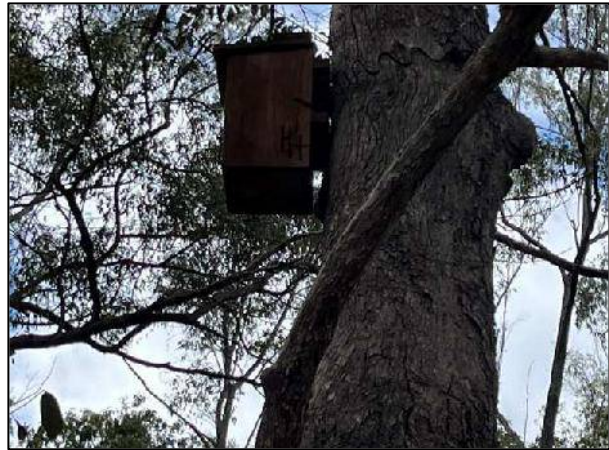
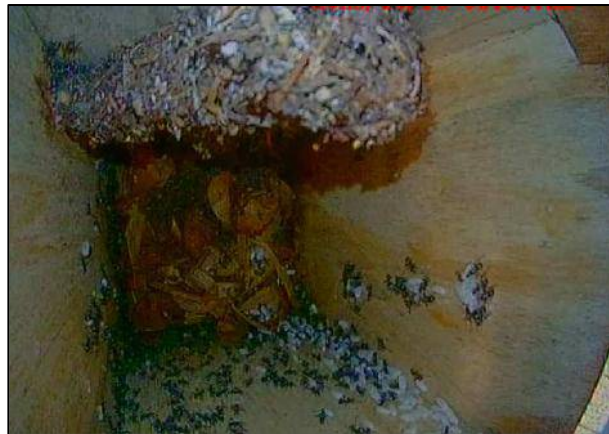
Maintenance Checklist of Nest Box ID: Box 41	Correct	Incorrect	Other
1. Box is not occupied by pest species	✓		
2. Box is not vandalised or missing	✓		
3. Box is securely attached with slight lean forward	✓		
4. Box is located at optimal height	✓		
5. Box is not damaged or rotten	✓		
6. The foot holds/ladder in interior of box for young is intact	✓		
7. There are no blockages in drainage holes	✓		
8. Entrance hole is free from obstruction and not damaged or worn	✓		
9. Nesting materials have been replaced to cover floor of box	✓		
10. All soiled materials like old shavings, membrane, egg shells have been removed	✓		
11. Box is aligned away from prevailing winds, rain and excessive heat	✓

Leaf litter present. Ant infestation.

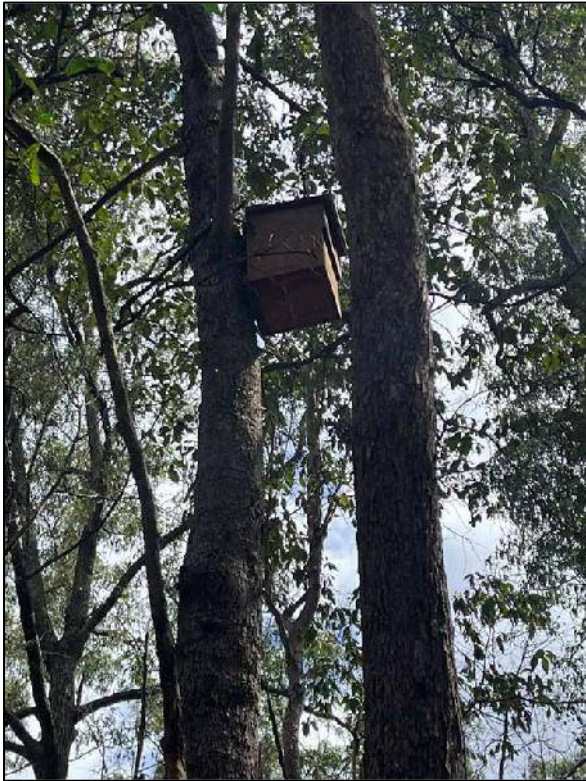
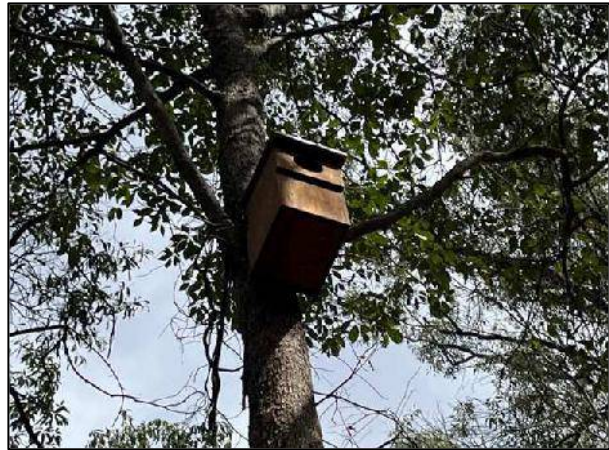
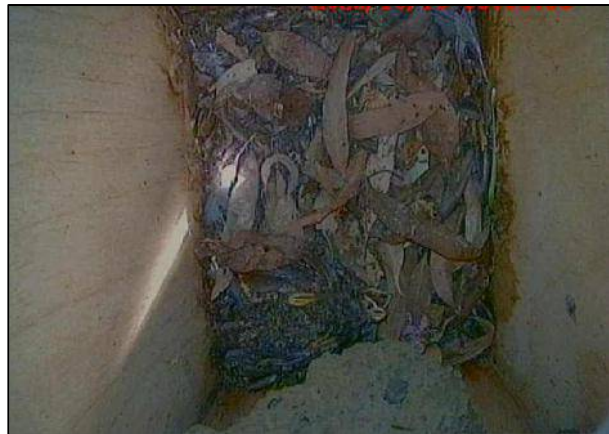
Maintenance Checklist of Nest Box ID: Box 42	Correct	Incorrect	Other
1. Box is not occupied by pest species	✓		
2. Box is not vandalised or missing	✓		
3. Box is securely attached with slight lean forward	✓		
4. Box is located at optimal height	✓		
5. Box is not damaged or rotten	✓		
6. The foot holds/ladder in interior of box for young is intact	✓		
7. There are no blockages in drainage holes	✓		
8. Entrance hole is free from obstruction and not damaged or worn	✓		
9. Nesting materials have been replaced to cover floor of box	✓		
10. All soiled materials like old shavings, membrane, egg shells have been removed	✓		
11. Box is aligned away from prevailing winds, rain and excessive heat	✓

Leaf litter present. Insect mud nest present.

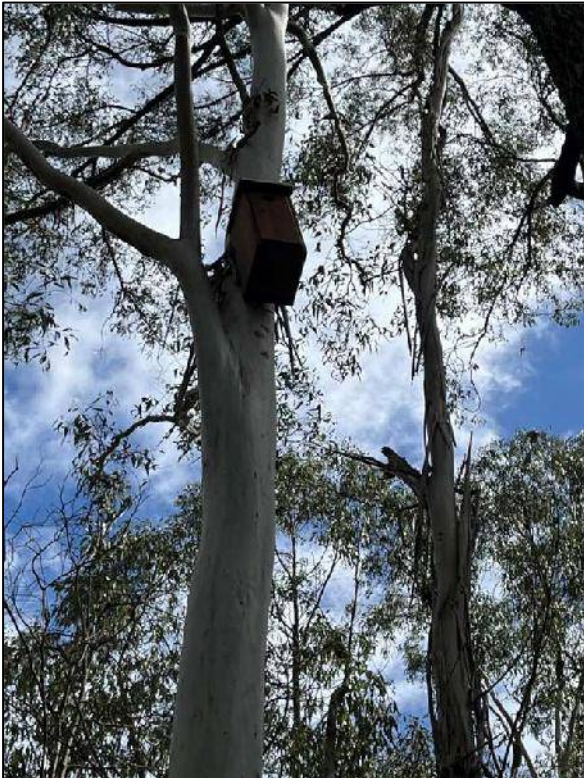
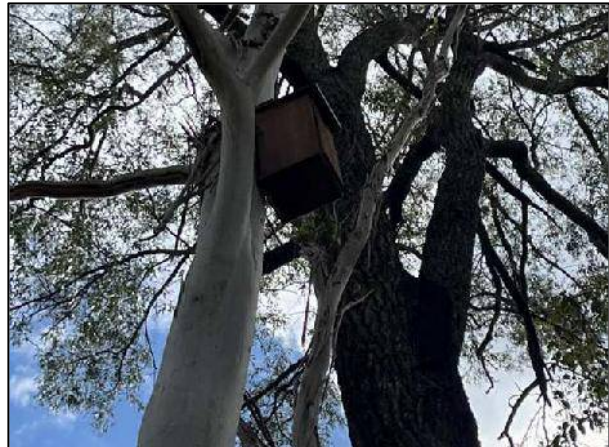
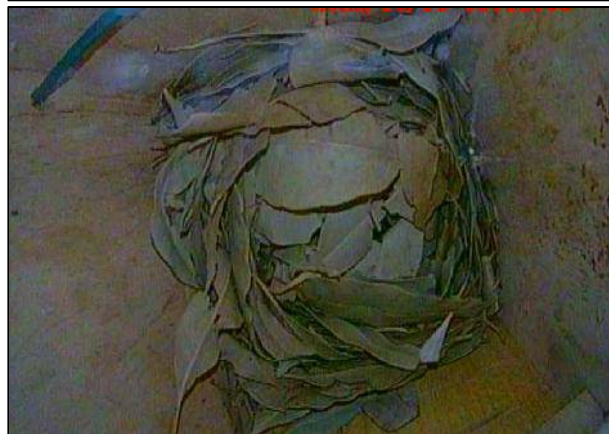
Maintenance Checklist of Nest Box ID: Box 43	Correct	Incorrect	Other
1. Box is not occupied by pest species	✓		
2. Box is not vandalised or missing	✓		
3. Box is securely attached with slight lean forward	✓		
4. Box is located at optimal height	✓		
5. Box is not damaged or rotten	✓		
6. The foot holds/ladder in interior of box for young is intact	✓		
7. There are no blockages in drainage holes	✓		
8. Entrance hole is free from obstruction and not damaged or worn	✓		
9. Nesting materials have been replaced to cover floor of box	✓		
10. All soiled materials like old shavings, membrane, egg shells have been removed	✓		
11. Box is aligned away from prevailing winds, rain and excessive heat	✓

Leaf litter present.

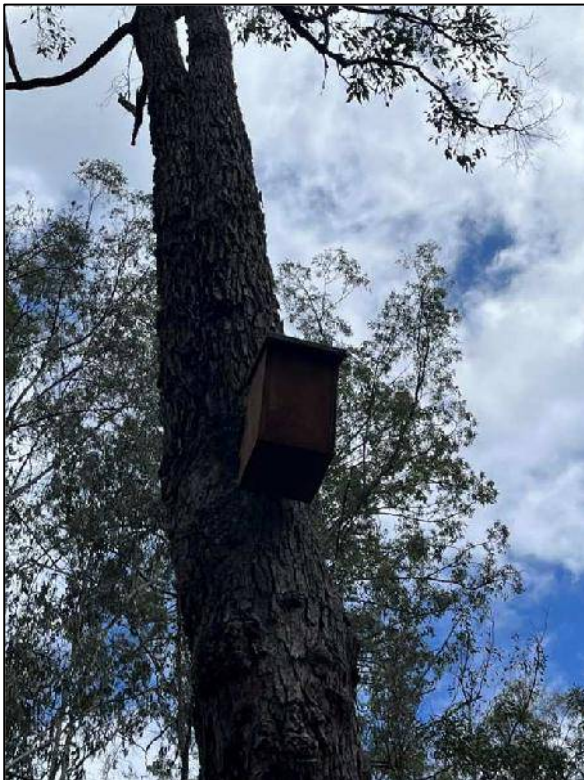
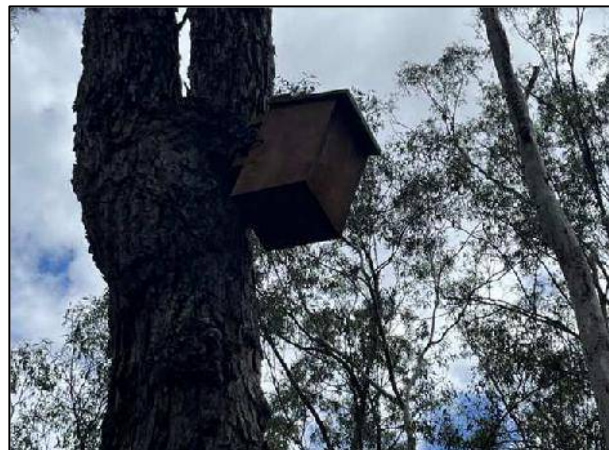
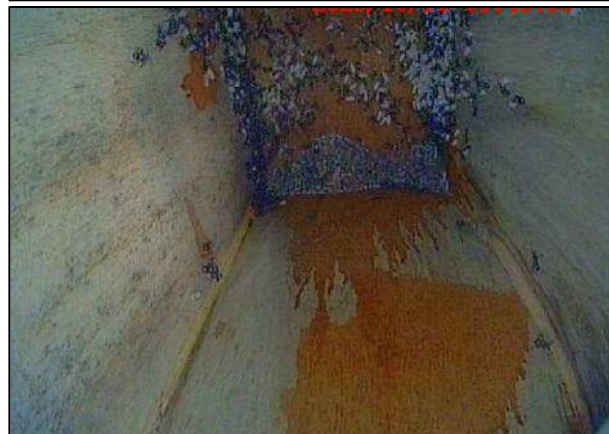
Maintenance Checklist of Nest Box ID: Box 44	Correct	Incorrect	Other
1. Box is not occupied by pest species	✓		
2. Box is not vandalised or missing	✓		
3. Box is securely attached with slight lean forward	✓		
4. Box is located at optimal height	✓		
5. Box is not damaged or rotten	✓		
6. The foot holds/ladder in interior of box for young is intact	✓		
7. There are no blockages in drainage holes	✓		
8. Entrance hole is free from obstruction and not damaged or worn	✓		
9. Nesting materials have been replaced to cover floor of box		✓	
10. All soiled materials like old shavings, membrane, egg shells have been removed	✓		
11. Box is aligned away from prevailing winds, rain and excessive heat	✓

Ant infestation.

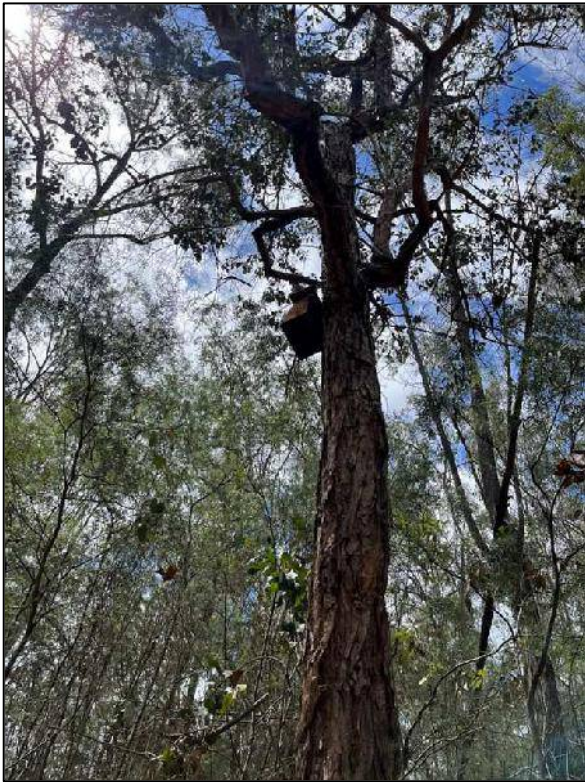
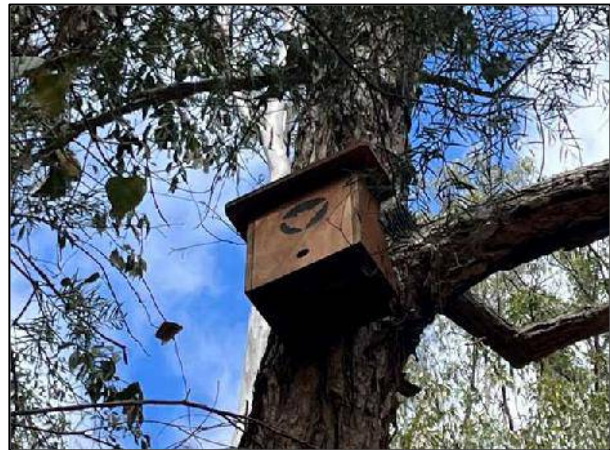
Maintenance Checklist of Nest Box ID: Box 45 – Bat box	Correct	Incorrect	Other
1. Box is not occupied by pest species	✓		
2. Box is not vandalised or missing	✓		
3. Box is securely attached with slight lean forward	✓		
4. Box is located at optimal height	✓		
5. Box is not damaged or rotten	✓		
6. The foot holds/ladder in interior of box for young is intact	✓		
7. There are no blockages in drainage holes	✓		
8. Entrance hole is free from obstruction and not damaged or worn	✓		
9. Nesting materials have been replaced to cover floor of box	n/a		
10. All soiled materials like old shavings, membrane, egg shells have been removed	n/a		
11. Box is aligned away from prevailing winds, rain and excessive heat	✓

Insect mud nest present.

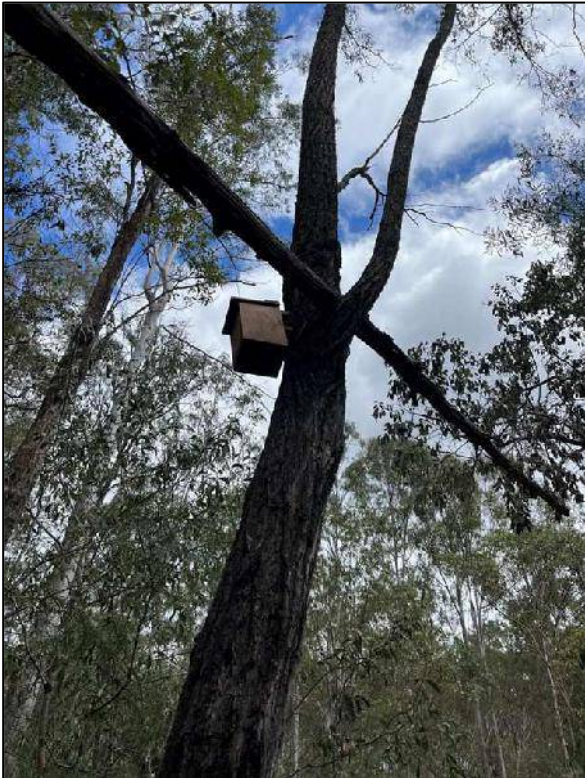
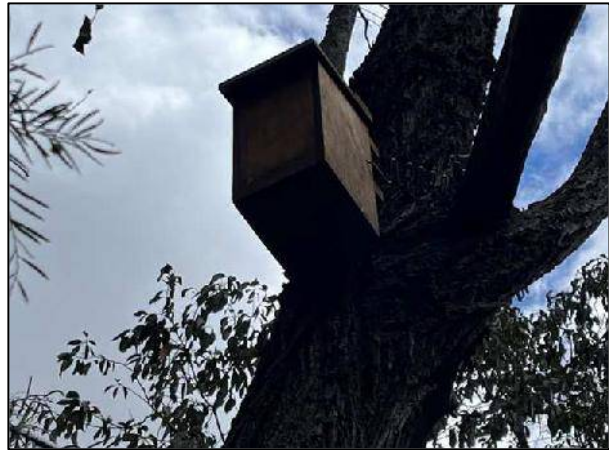
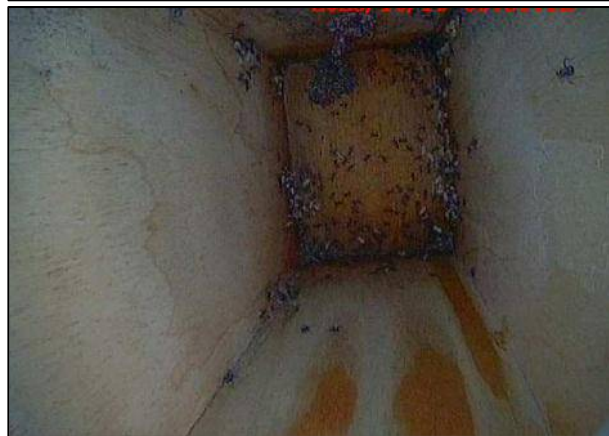
Maintenance Checklist of Nest Box ID: Box 46	Correct	Incorrect	Other
1. Box is not occupied by pest species	✓		
2. Box is not vandalised or missing	✓		
3. Box is securely attached with slight lean forward	✓		
4. Box is located at optimal height	✓		
5. Box is not damaged or rotten	✓		
6. The foot holds/ladder in interior of box for young is intact	✓		
7. There are no blockages in drainage holes	✓		
8. Entrance hole is free from obstruction and not damaged or worn	✓		
9. Nesting materials have been replaced to cover floor of box		✓	
10. All soiled materials like old shavings, membrane, egg shells have been removed	✓		
11. Box is aligned away from prevailing winds, rain and excessive heat	✓

Nesting ants.

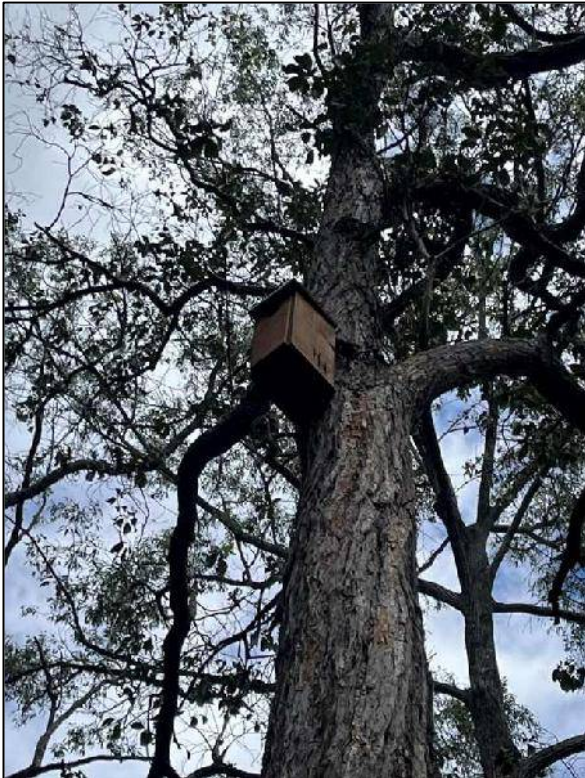
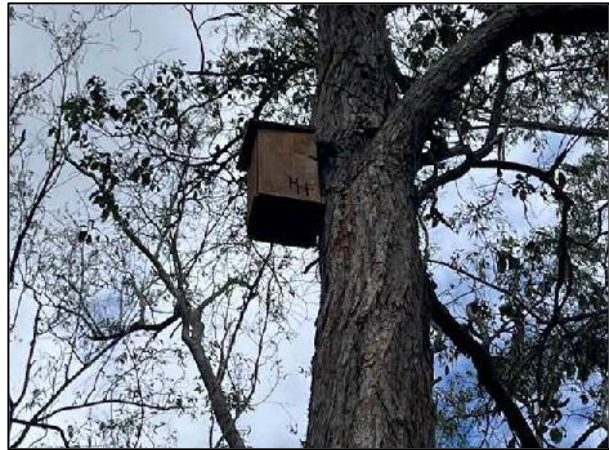
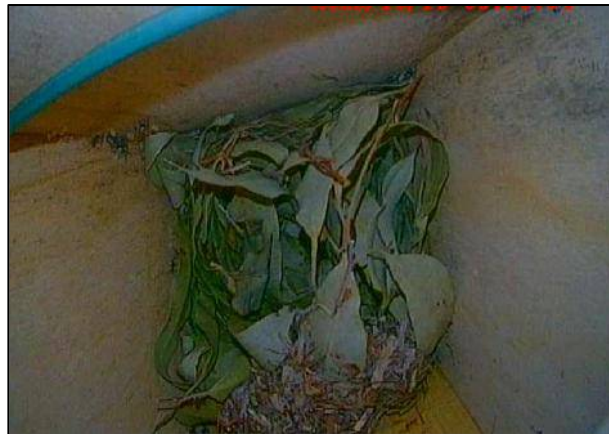
Maintenance Checklist of Nest Box ID: Box 47	Correct	Incorrect	Other
1. Box is not occupied by pest species	✓		
2. Box is not vandalised or missing	✓		
3. Box is securely attached with slight lean forward	✓		
4. Box is located at optimal height	✓		
5. Box is not damaged or rotten	✓		
6. The foot holds/ladder in interior of box for young is intact	✓		
7. There are no blockages in drainage holes	✓		
8. Entrance hole is free from obstruction and not damaged or worn	✓		
9. Nesting materials have been replaced to cover floor of box	✓		
10. All soiled materials like old shavings, membrane, egg shells have been removed	✓		
11. Box is aligned away from prevailing winds, rain and excessive heat	✓

Leaf litter present. Ants present.

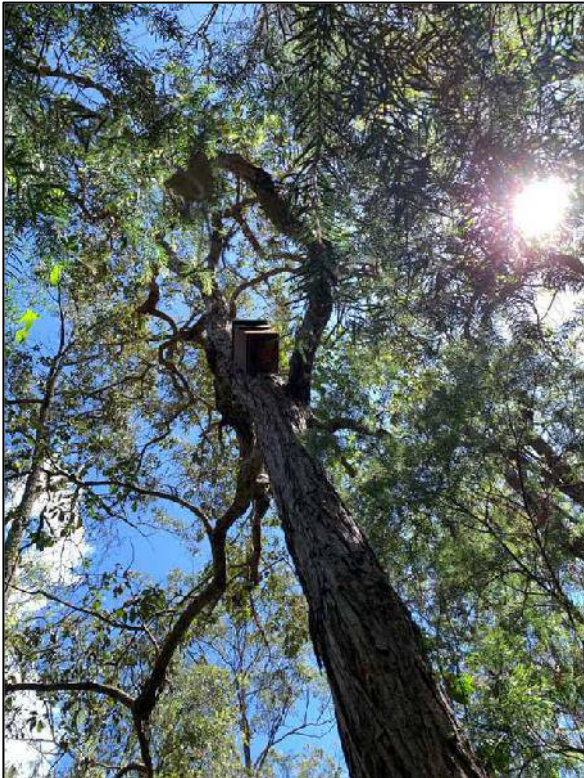
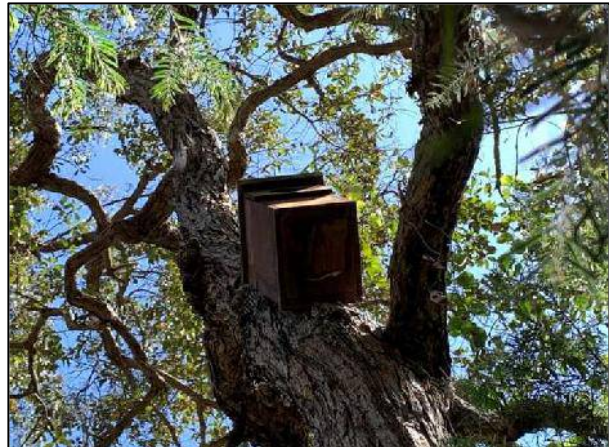
Maintenance Checklist of Nest Box ID: Box 48	Correct	Incorrect	Other
1. Box is not occupied by pest species	✓		
2. Box is not vandalised or missing	✓		
3. Box is securely attached with slight lean forward	✓		
4. Box is located at optimal height	✓		
5. Box is not damaged or rotten	✓		
6. The foot holds/ladder in interior of box for young is intact	✓		
7. There are no blockages in drainage holes	✓		
8. Entrance hole is free from obstruction and not damaged or worn	✓		
9. Nesting materials have been replaced to cover floor of box	✓		
10. All soiled materials like old shavings, membrane, egg shells have been removed	✓		
11. Box is aligned away from prevailing winds, rain and excessive heat	✓

Leaf litter present.

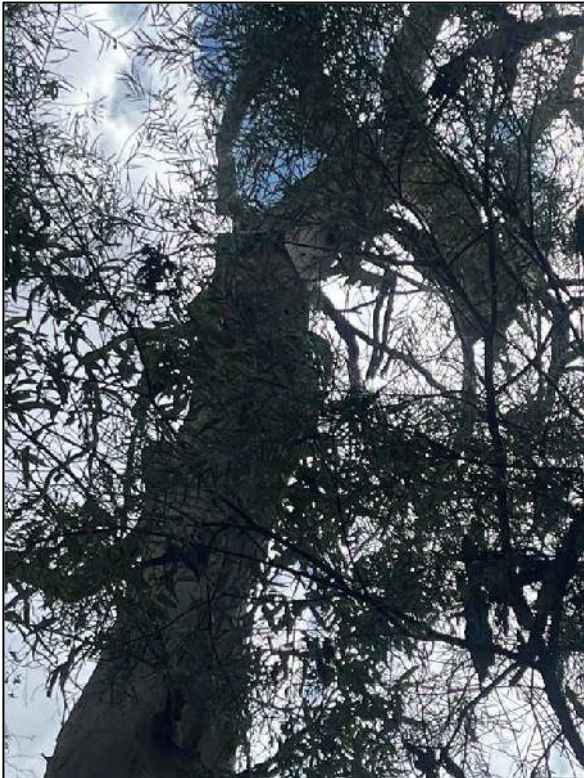
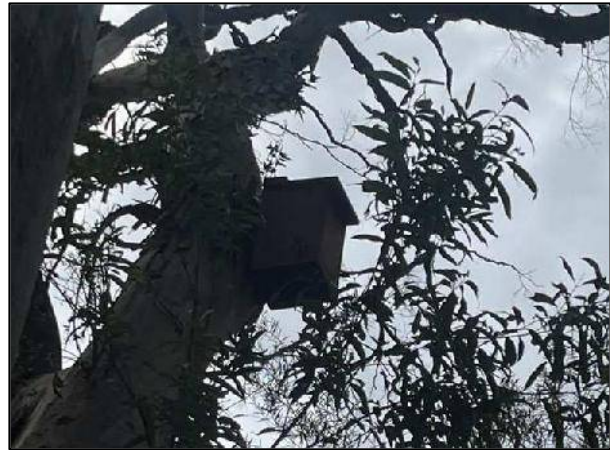
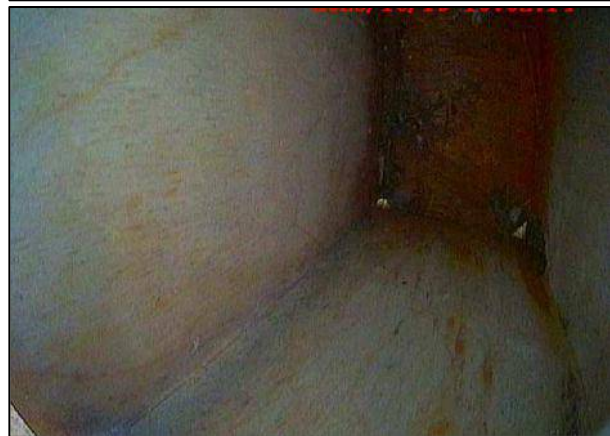
Maintenance Checklist of Nest Box ID: Box 49	Correct	Incorrect	Other
1. Box is not occupied by pest species	✓		
2. Box is not vandalised or missing	✓		
3. Box is securely attached with slight lean forward	✓		
4. Box is located at optimal height	✓		
5. Box is not damaged or rotten	✓		
6. The foot holds/ladder in interior of box for young is intact	✓		
7. There are no blockages in drainage holes	✓		
8. Entrance hole is free from obstruction and not damaged or worn	✓		
9. Nesting materials have been replaced to cover floor of box		✓	
10. All soiled materials like old shavings, membrane, egg shells have been removed	✓		
11. Box is aligned away from prevailing winds, rain and excessive heat	✓

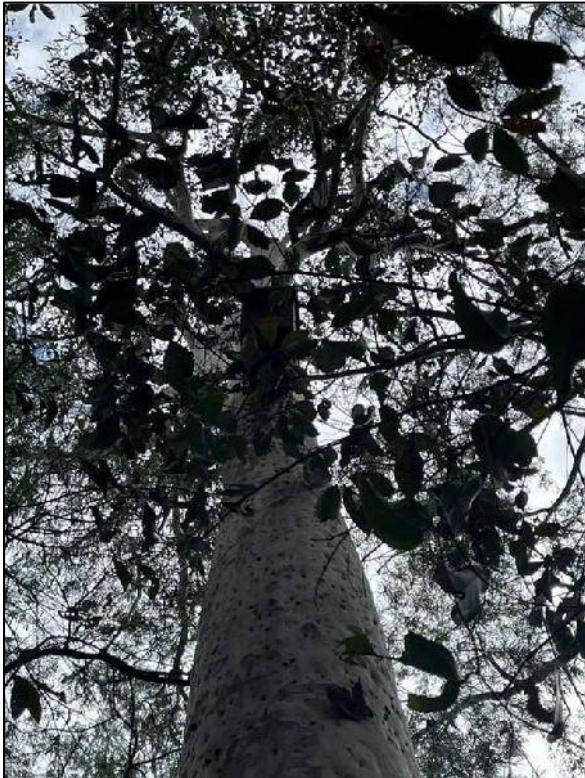
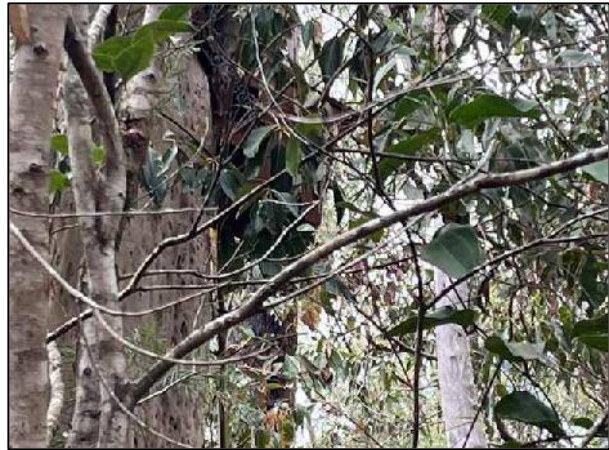
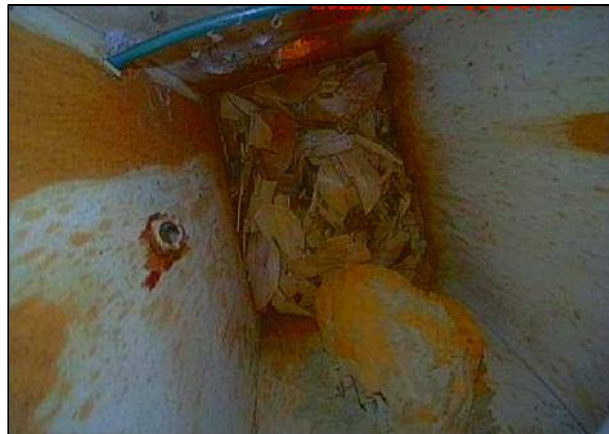
Maintenance Checklist of Nest Box ID: Box 50	Correct	Incorrect	Other
1. Box is not occupied by pest species	✓		
2. Box is not vandalised or missing	✓		
3. Box is securely attached with slight lean forward	✓		
4. Box is located at optimal height	✓		
5. Box is not damaged or rotten	✓		
6. The foot holds/ladder in interior of box for young is intact	✓		
7. There are no blockages in drainage holes	✓		
8. Entrance hole is free from obstruction and not damaged or worn	✓		
9. Nesting materials have been replaced to cover floor of box	✓		
10. All soiled materials like old shavings, membrane, egg shells have been removed	✓		
11. Box is aligned away from prevailing winds, rain and excessive heat	✓

Insect mud nest present. Leaf litter present.

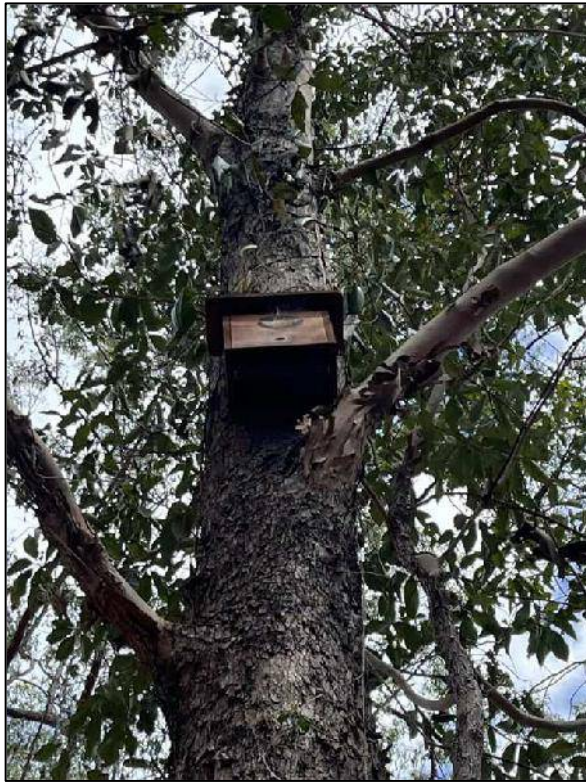
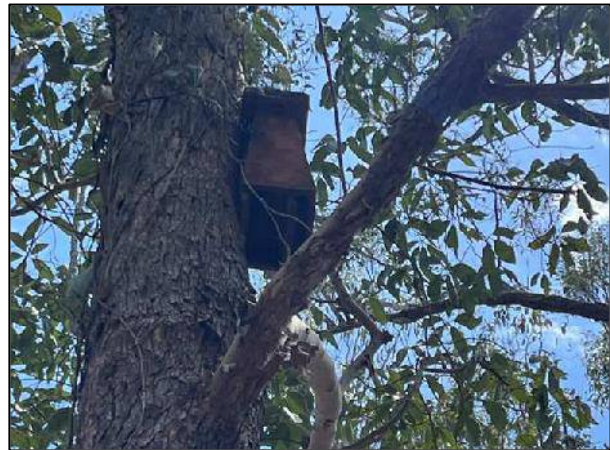
Maintenance Checklist of Nest Box ID: Box 51 – Bat box	Correct	Incorrect	Other
1. Box is not occupied by pest species	✓		
2. Box is not vandalised or missing	✓		
3. Box is securely attached with slight lean forward	✓		
4. Box is located at optimal height	✓		
5. Box is not damaged or rotten	✓		
6. The foot holds/ladder in interior of box for young is intact	✓		
7. There are no blockages in drainage holes	✓		
8. Entrance hole is free from obstruction and not damaged or worn	✓		
9. Nesting materials have been replaced to cover floor of box	n/a		
10. All soiled materials like old shavings, membrane, egg shells have been removed	n/a		
11. Box is aligned away from prevailing winds, rain and excessive heat	✓

Spider-web present

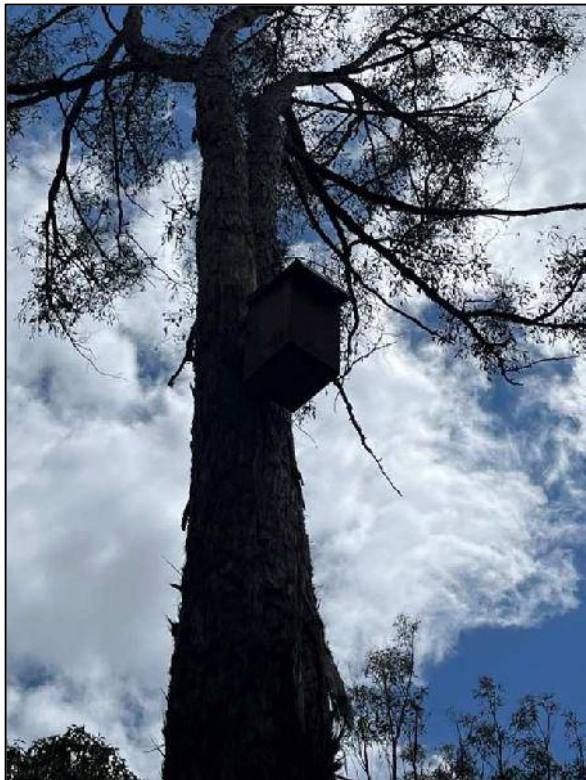
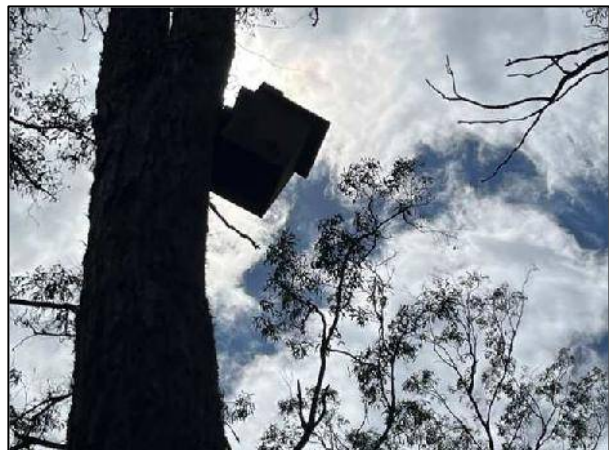
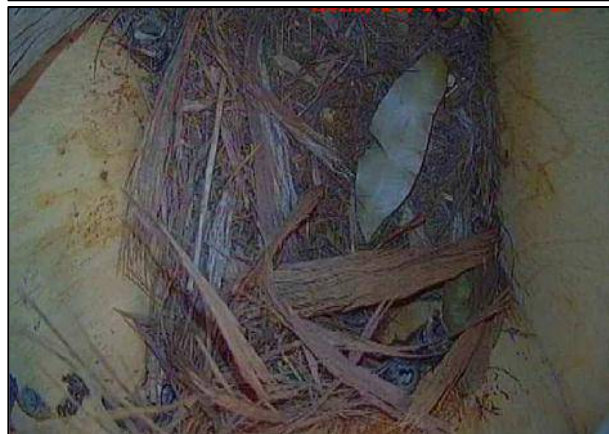
Maintenance Checklist of Nest Box ID: Box 52	Correct	Incorrect	Other
1. Box is not occupied by pest species	✓		
2. Box is not vandalised or missing	✓		
3. Box is securely attached with slight lean forward	✓		
4. Box is located at optimal height	✓		
5. Box is not damaged or rotten	✓		
6. The foot holds/ladder in interior of box for young is intact	✓		
7. There are no blockages in drainage holes	✓		
8. Entrance hole is free from obstruction and not damaged or worn	✓		
9. Nesting materials have been replaced to cover floor of box	✓		
10. All soiled materials like old shavings, membrane, egg shells have been removed	✓		
11. Box is aligned away from prevailing winds, rain and excessive heat	✓

Leaf litter present.

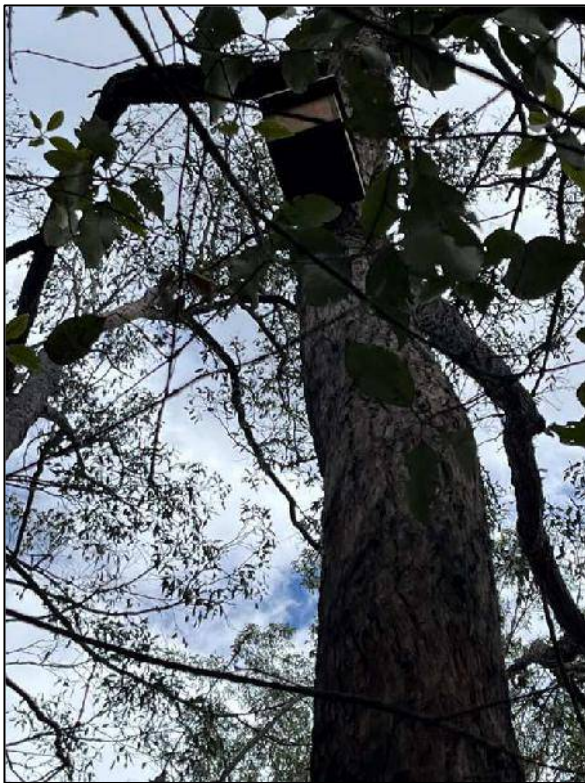
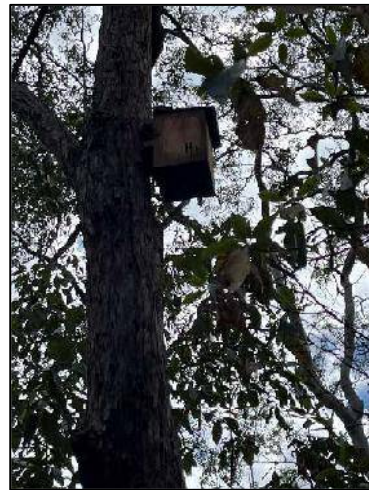
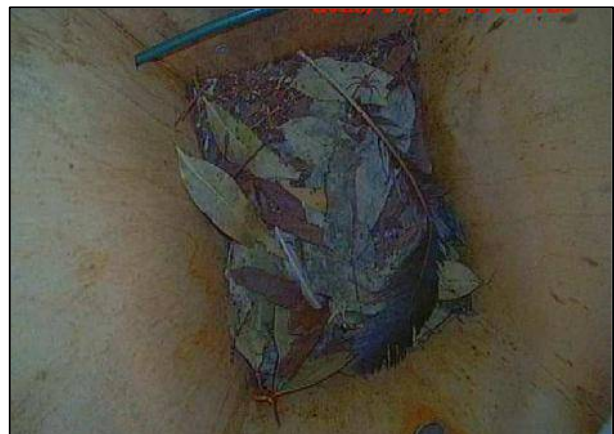
Maintenance Checklist of Nest Box ID: Box 53	Correct	Incorrect	Other
1. Box is not occupied by pest species	✓		
2. Box is not vandalised or missing	✓		
3. Box is securely attached with slight lean forward	✓		
4. Box is located at optimal height	✓		
5. Box is not damaged or rotten	✓		
6. The foot holds/ladder in interior of box for young is intact	✓		
7. There are no blockages in drainage holes	✓		
8. Entrance hole is free from obstruction and not damaged or worn	✓		
9. Nesting materials have been replaced to cover floor of box	✓		
10. All soiled materials like old shavings, membrane, egg shells have been removed	✓		
11. Box is aligned away from prevailing winds, rain and excessive heat	✓

Leaf litter present.
