Annual Compliance Report

17 October 2022 to 16 October 2023 EPBC 2013/7057
Spring Mountain Mixed Use Master Planned Community
Development, Spring Mountain, Queensland

Prepared for Lendlease Communities (Springfield) Pty Limited
9 January 2024

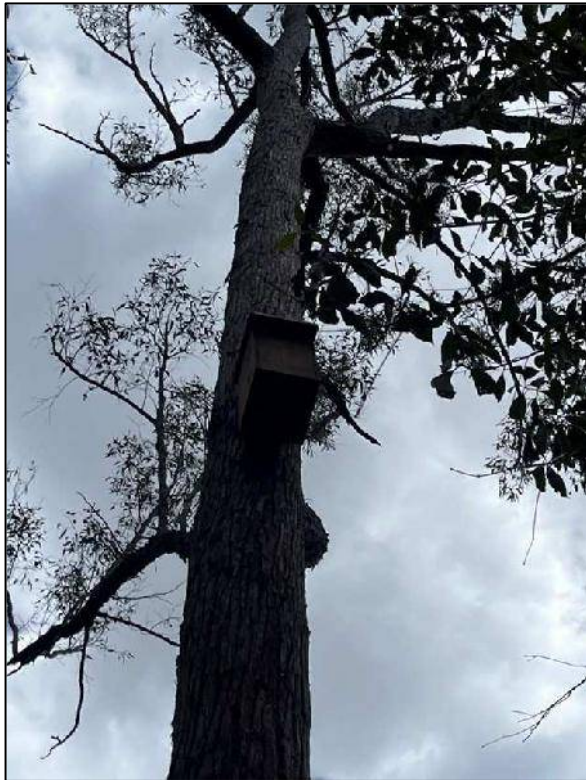
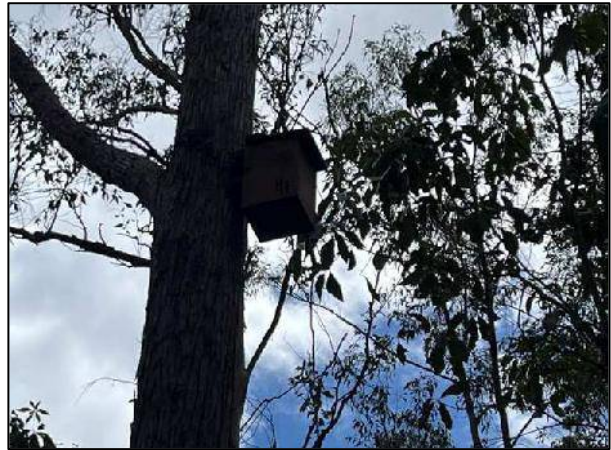
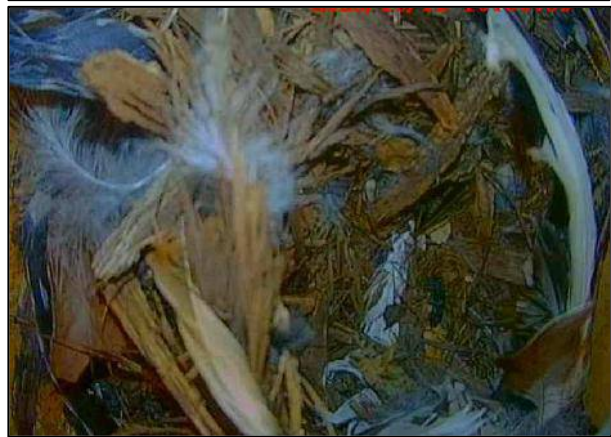
Maintenance Checklist of Nest Box ID: Box 54	Correct	Incorrect	Other
1. Box is not occupied by pest species	✓		
2. Box is not vandalised or missing	✓		
3. Box is securely attached with slight lean forward	✓		
4. Box is located at optimal height	✓		
5. Box is not damaged or rotten	✓		
6. The foot holds/ladder in interior of box for young is intact	✓		
7. There are no blockages in drainage holes	✓		
8. Entrance hole is free from obstruction and not damaged or worn	✓		
9. Nesting materials have been replaced to cover floor of box		✓	
10. All soiled materials like old shavings, membrane, egg shells have been removed		✓	
11. Box is aligned away from prevailing winds, rain and excessive heat	✓

High amount of nesting material present.

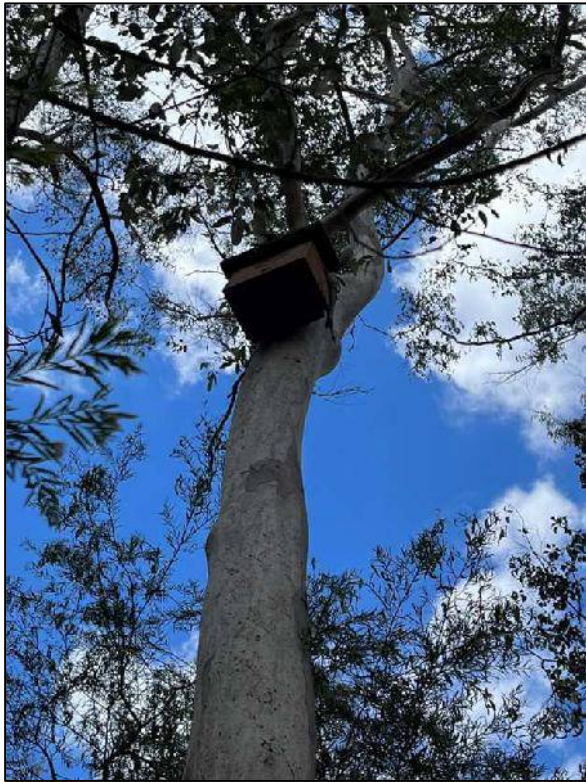
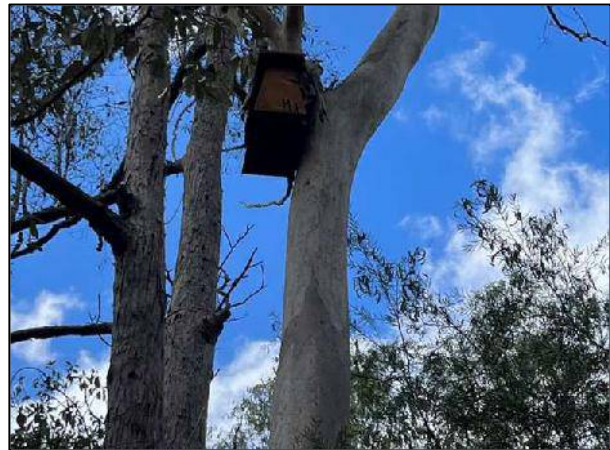
Maintenance Checklist of Nest Box ID: Box 55 – Bat box	Correct	Incorrect	Other
1. Box is not occupied by pest species	✓		
2. Box is not vandalised or missing	✓		
3. Box is securely attached with slight lean forward	✓		
4. Box is located at optimal height	✓		
5. Box is not damaged or rotten	✓		
6. The foot holds/ladder in interior of box for young is intact	✓		
7. There are no blockages in drainage holes	✓		
8. Entrance hole is free from obstruction and not damaged or worn	✓		
9. Nesting materials have been replaced to cover floor of box	n/a		
10. All soiled materials like old shavings, membrane, egg shells have been removed	n/a		
11. Box is aligned away from prevailing winds, rain and excessive heat	✓

No nesting material present.

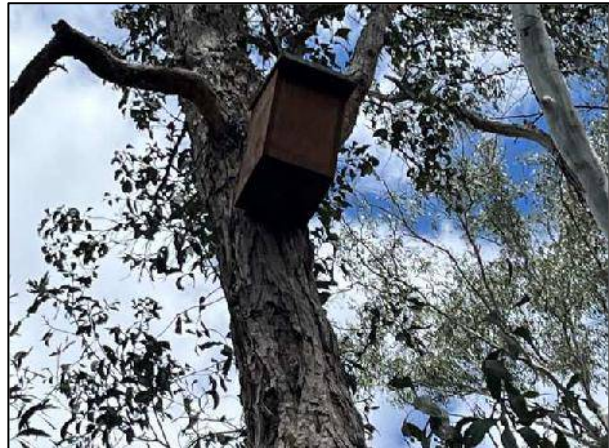
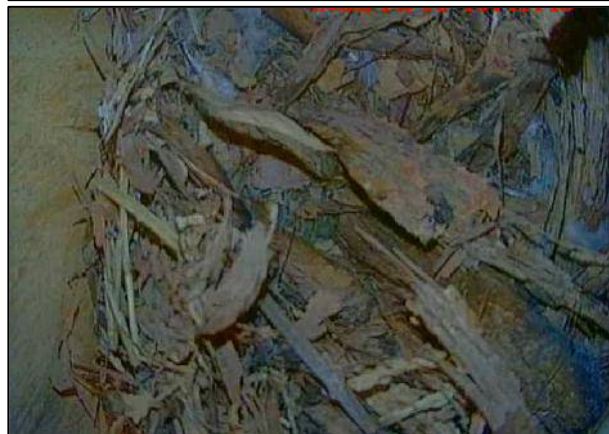
Maintenance Checklist of Nest Box ID: Box 56	Correct	Incorrect	Other
1. Box is not occupied by pest species	✓		
2. Box is not vandalised or missing	✓		
3. Box is securely attached with slight lean forward	✓		
4. Box is located at optimal height	✓		
5. Box is not damaged or rotten	✓		
6. The foot holds/ladder in interior of box for young is intact	✓		
7. There are no blockages in drainage holes	✓		
8. Entrance hole is free from obstruction and not damaged or worn	✓		
9. Nesting materials have been replaced to cover floor of box		✓	
10. All soiled materials like old shavings, membrane, egg shells have been removed		✓	
11. Box is aligned away from prevailing winds, rain and excessive heat	✓

High amount of nesting material present.

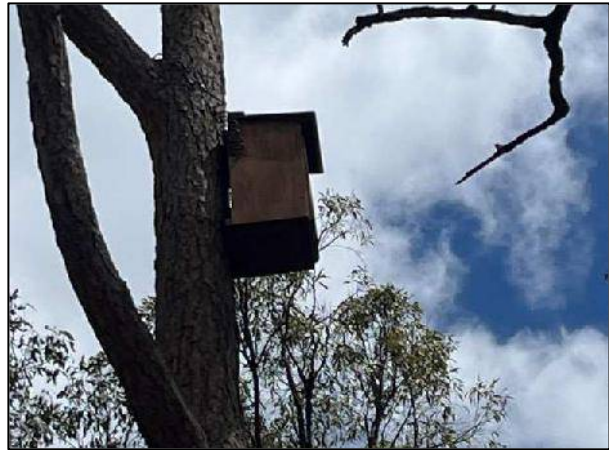
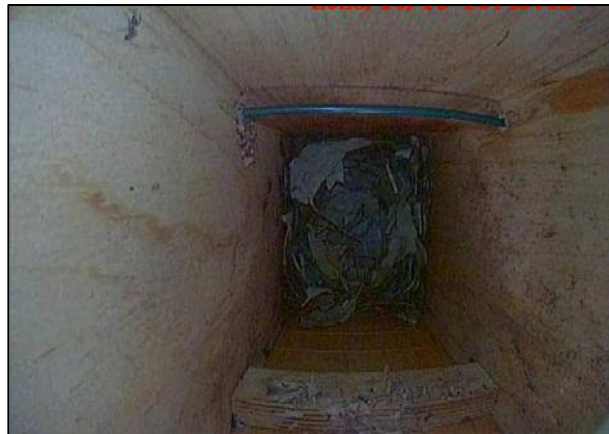
Maintenance Checklist of Nest Box ID: Box 57	Correct	Incorrect	Other
1. Box is not occupied by pest species	✓		
2. Box is not vandalised or missing	✓		
3. Box is securely attached with slight lean forward	✓		
4. Box is located at optimal height	✓		
5. Box is not damaged or rotten	✓		
6. The foot holds/ladder in interior of box for young is intact	✓		
7. There are no blockages in drainage holes	✓		
8. Entrance hole is free from obstruction and not damaged or worn	✓		
9. Nesting materials have been replaced to cover floor of box	✓		
10. All soiled materials like old shavings, membrane, egg shells have been removed	✓		
11. Box is aligned away from prevailing winds, rain and excessive heat	✓

Leaf litter present.

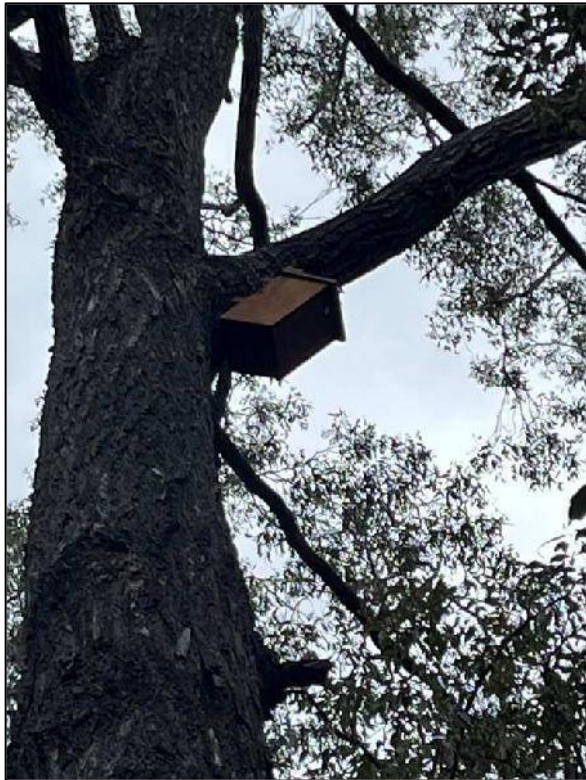
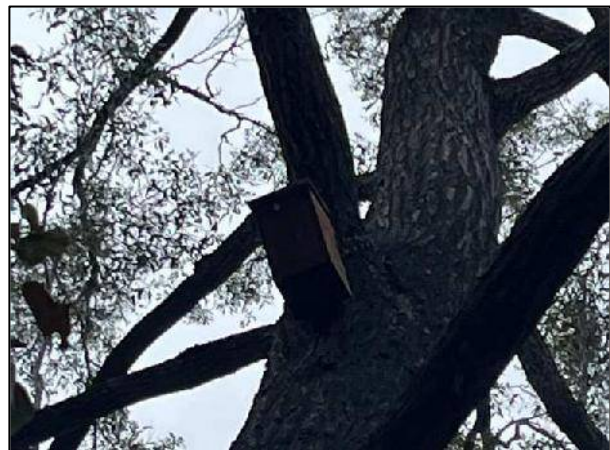
Maintenance Checklist of Nest Box ID: Box 58 – Bat box	Correct	Incorrect	Other
1. Box is not occupied by pest species	✓		
2. Box is not vandalised or missing	✓		
3. Box is securely attached with slight lean forward	✓		
4. Box is located at optimal height	✓		
5. Box is not damaged or rotten	✓		
6. The foot holds/ladder in interior of box for young is intact	✓		
7. There are no blockages in drainage holes	✓		
8. Entrance hole is free from obstruction and not damaged or worn	✓		
9. Nesting materials have been replaced to cover floor of box	n/a		
10. All soiled materials like old shavings, membrane, egg shells have been removed	n/a		
11. Box is aligned away from prevailing winds, rain and excessive heat	✓

Unreachable due to erosion at base of tree. Box appears in good condition from outside.

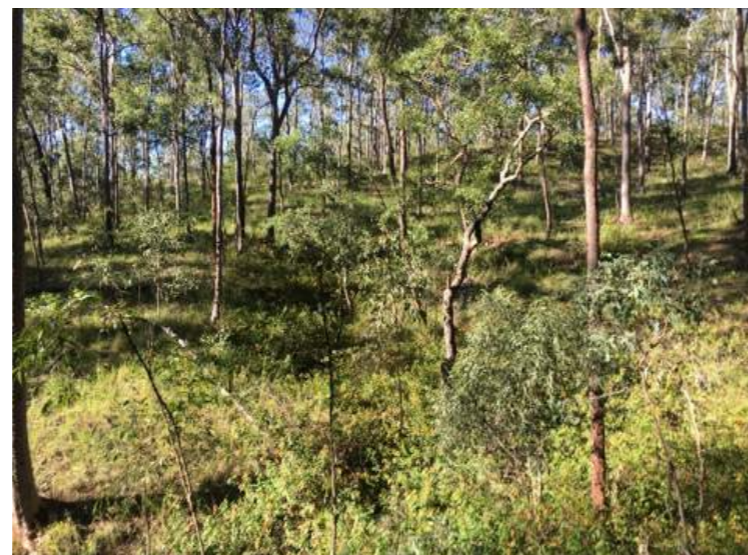
Photo: Gully infested with Lantana camara.

- Vegetation throughout the V17 site is dominated by Eucalypt and Corymbia species with weeds largely confined to the shrub and ground layers.
- Gully lines were infested with weeds, particularly Lantana camara (Lantana) up to 2m in height. The V17 area ajoins Tully Gully to the east which is mapped as a green (low risk) waterway for waterway barrier works by Fisheries however is not a regulated watercourse for the purposes of the Water Act. Infestations of Lantana and evidence of scour and sedimentation were noted.

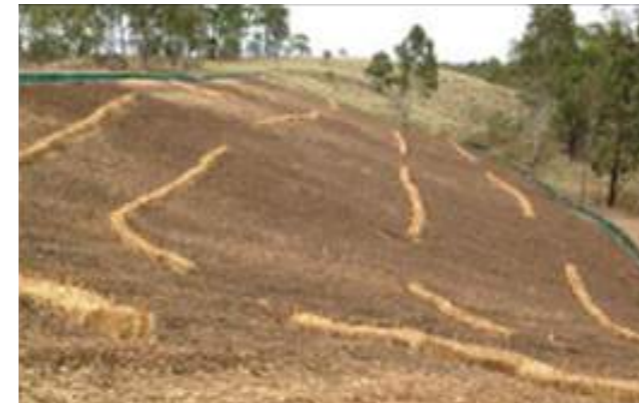
Photo: Erosion control to cleared batter

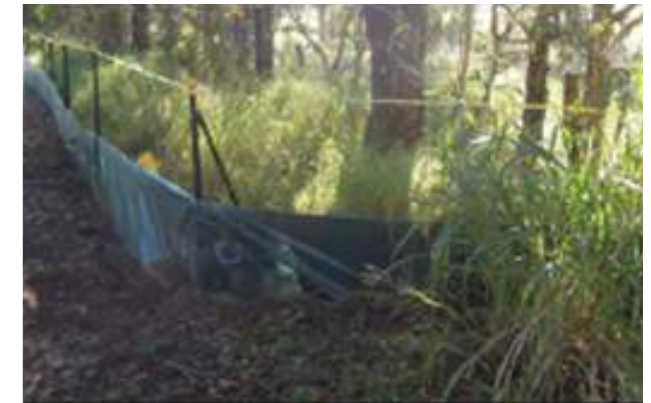
Photo: Tree protection and erosion fence

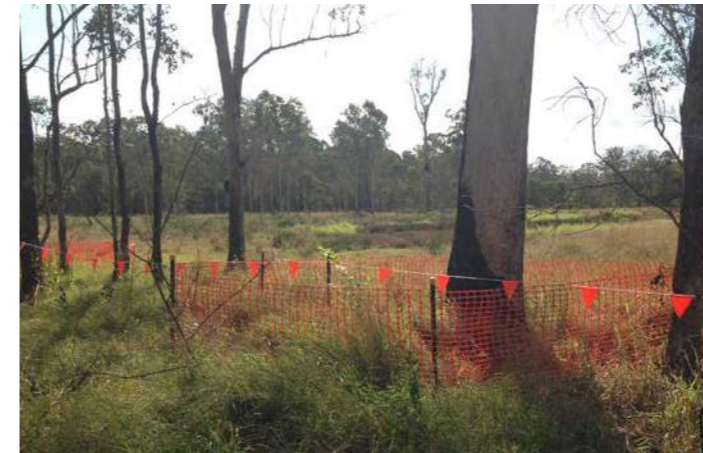
Significant Tree Protection Fencing

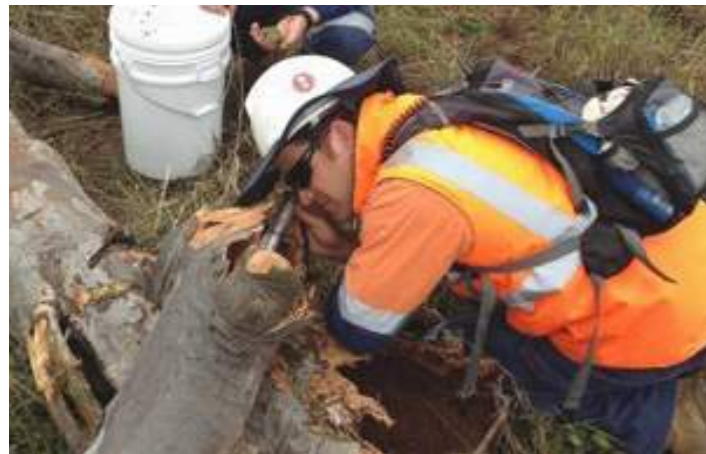
Fauna Spotter During Tree Clearing
