# Annual Compliance Report

17 October 2023 to 16 October 2024 EPBC 2013/7057  
Spring Mountain Mixed Use Master Planned Community  
Development, Spring Mountain, Queensland

Prepared for Lendlease Communities (Springfield) Pty Limited  
14 January 2025

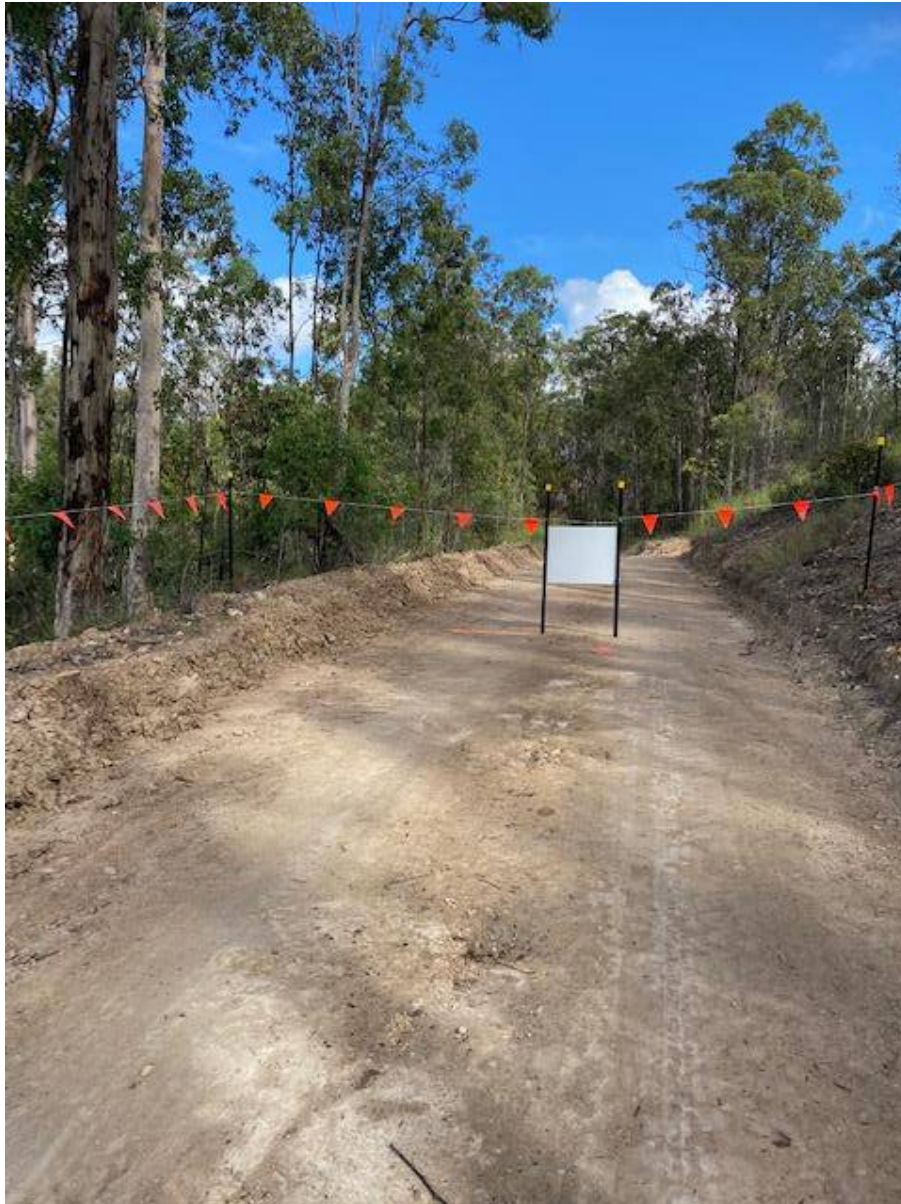
Categorical surveyed demarcation vegetation clearance perimeter fauna friendly fencing was witnessed offering onsite fauna management compliance.
