# Annual Compliance Report

17 October 2023 to 16 October 2024 EPBC 2013/7057  
Spring Mountain Mixed Use Master Planned Community  
Development, Spring Mountain, Queensland

Prepared for Lendlease Communities (Springfield) Pty Limited  
14 January 2025

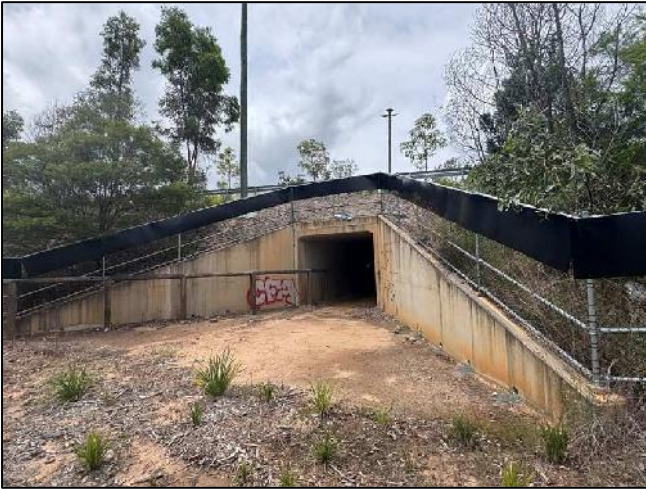
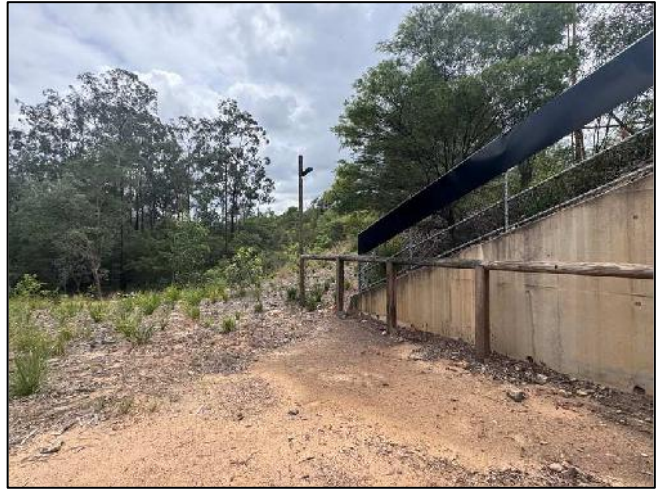
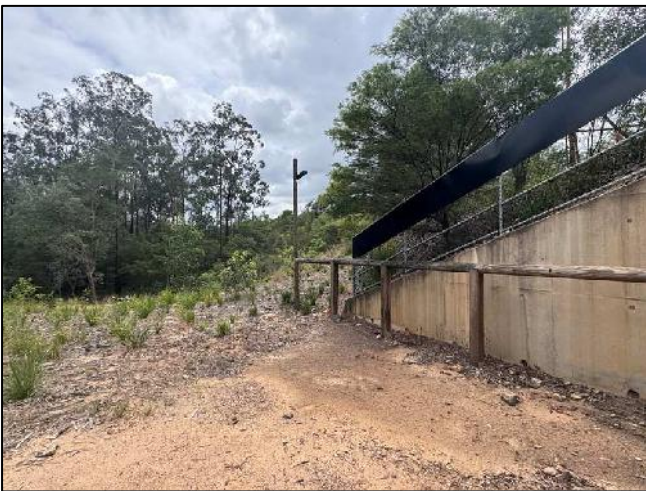
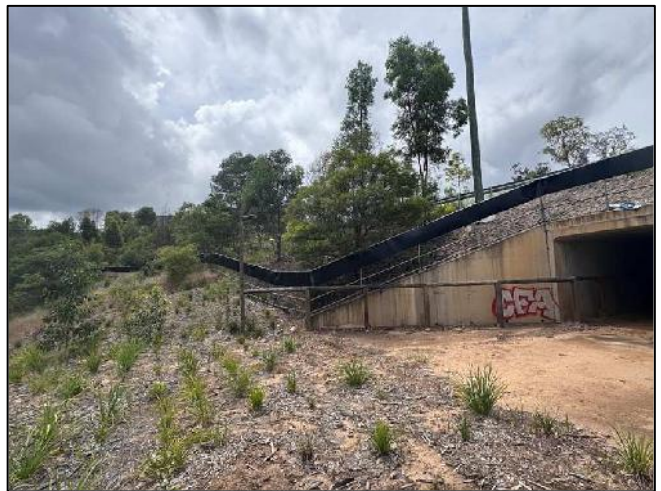
Village 17 –London Avenue – Northern End POV

## Non-Functional Dry Passage Culverts

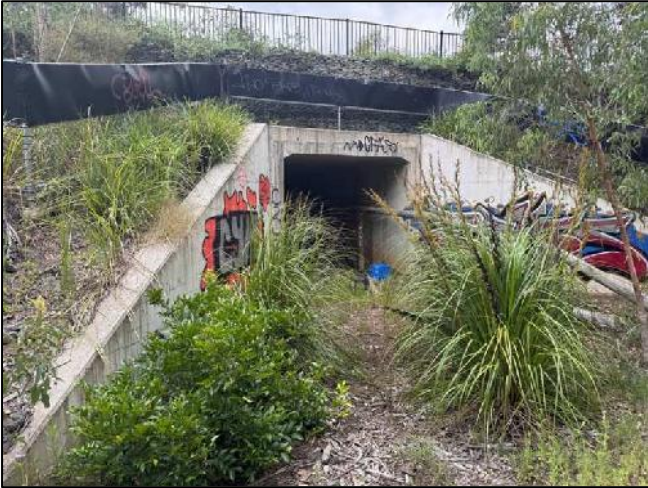
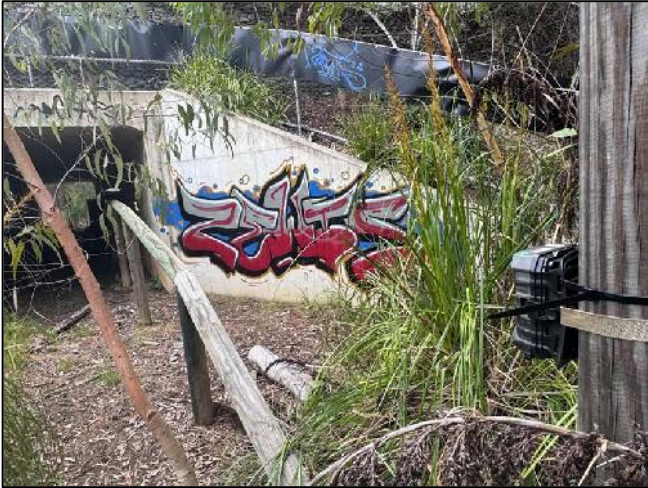
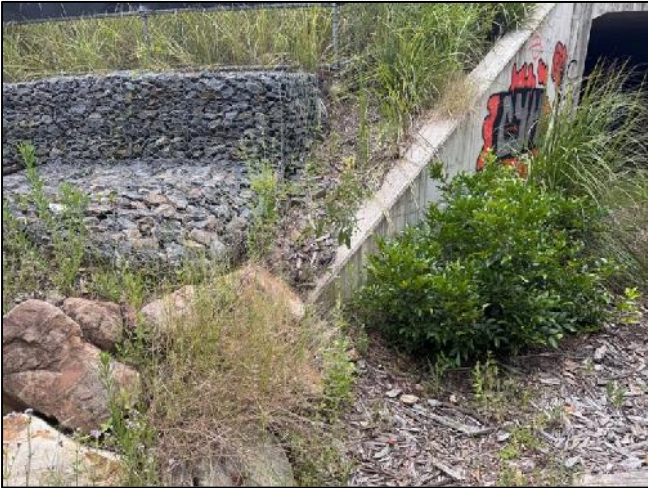
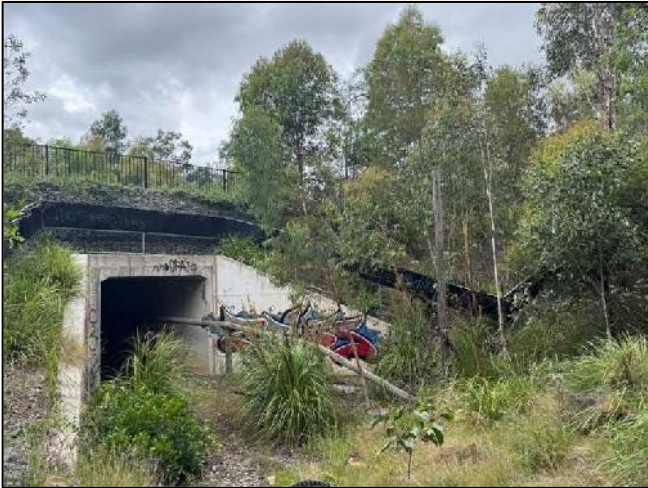
Grande Avenue (Western) – Southern End POV

# Functional Dry Passage Culverts

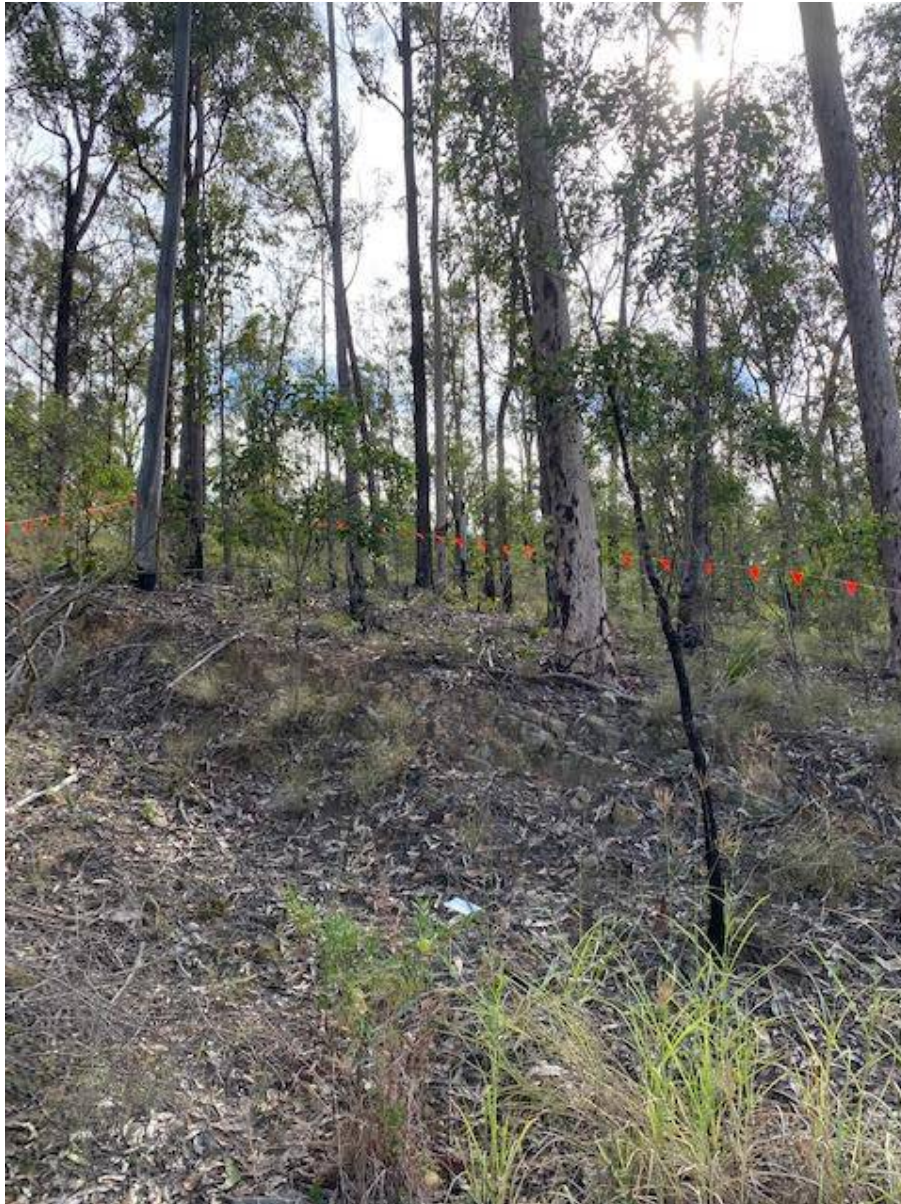
Low numbers of NJKHT's were scheduled for removal during this phase. Open egress areas are evident throughout the site.

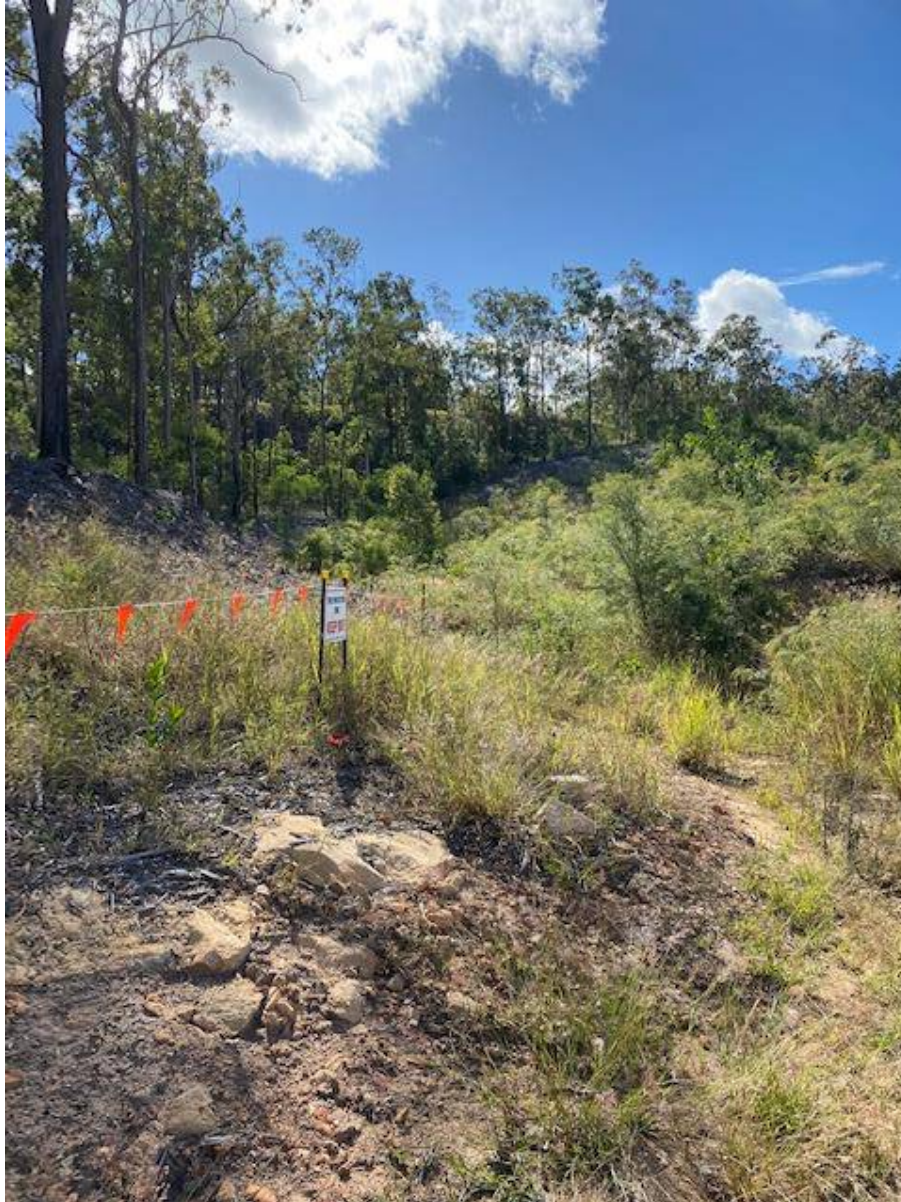
TPZ were established.

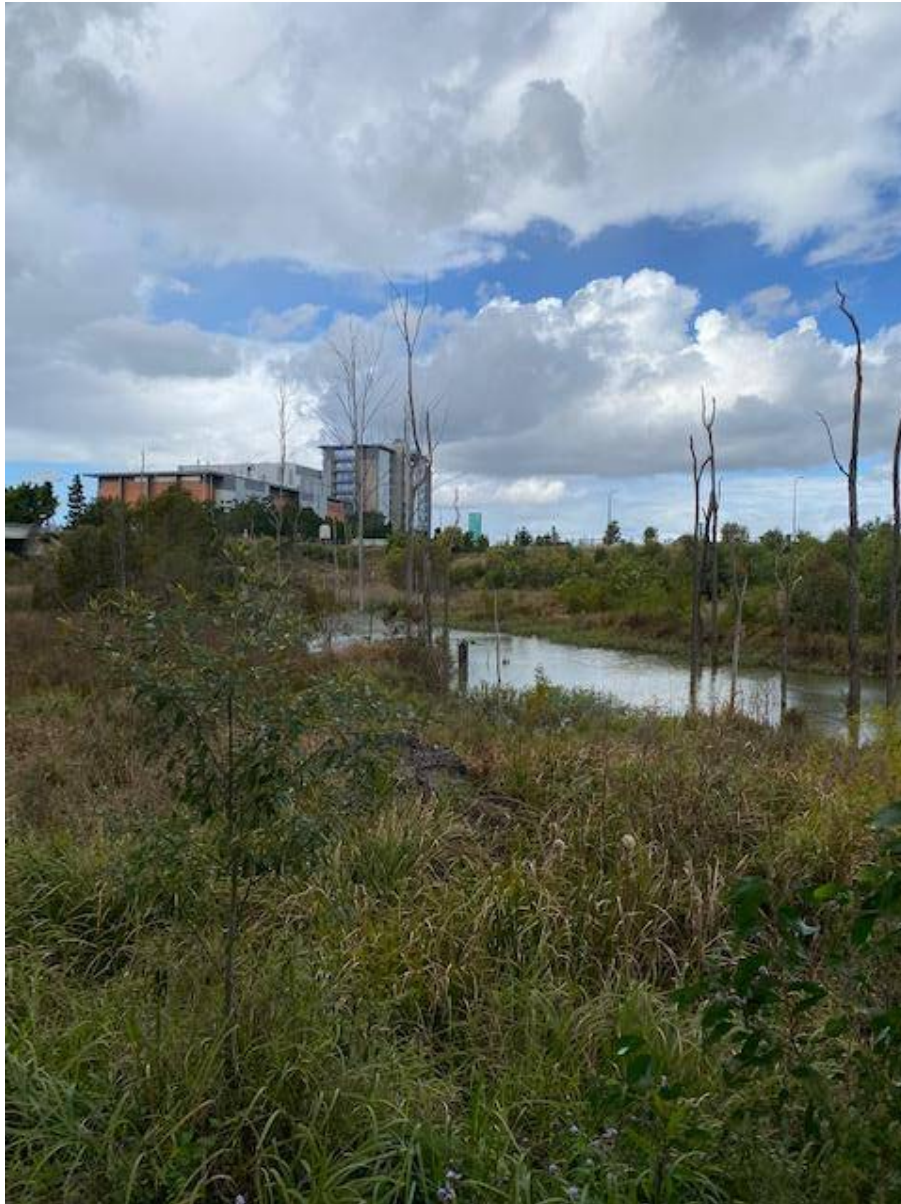
Water bodies were comprehensively checked and cleared.

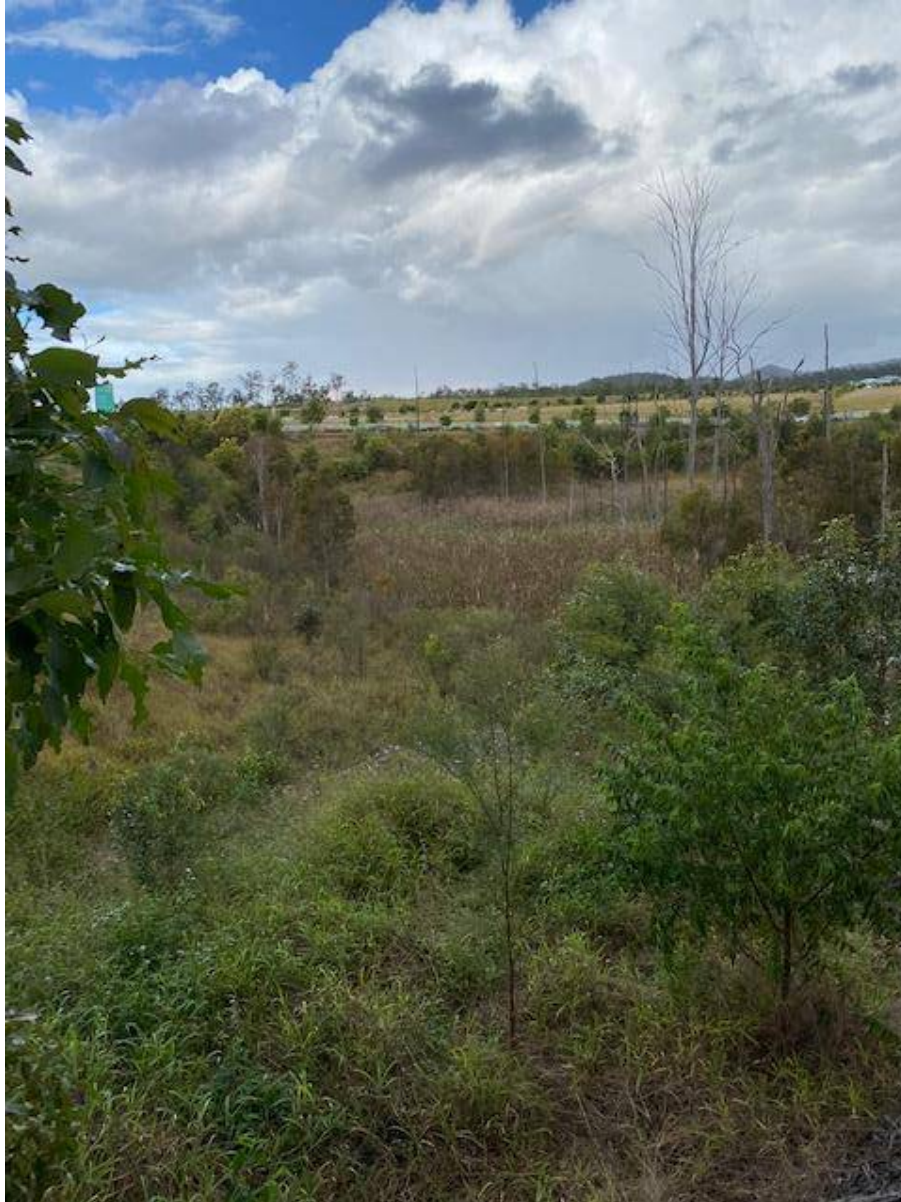
Aquatic vegetation assets will be checked and cleared.

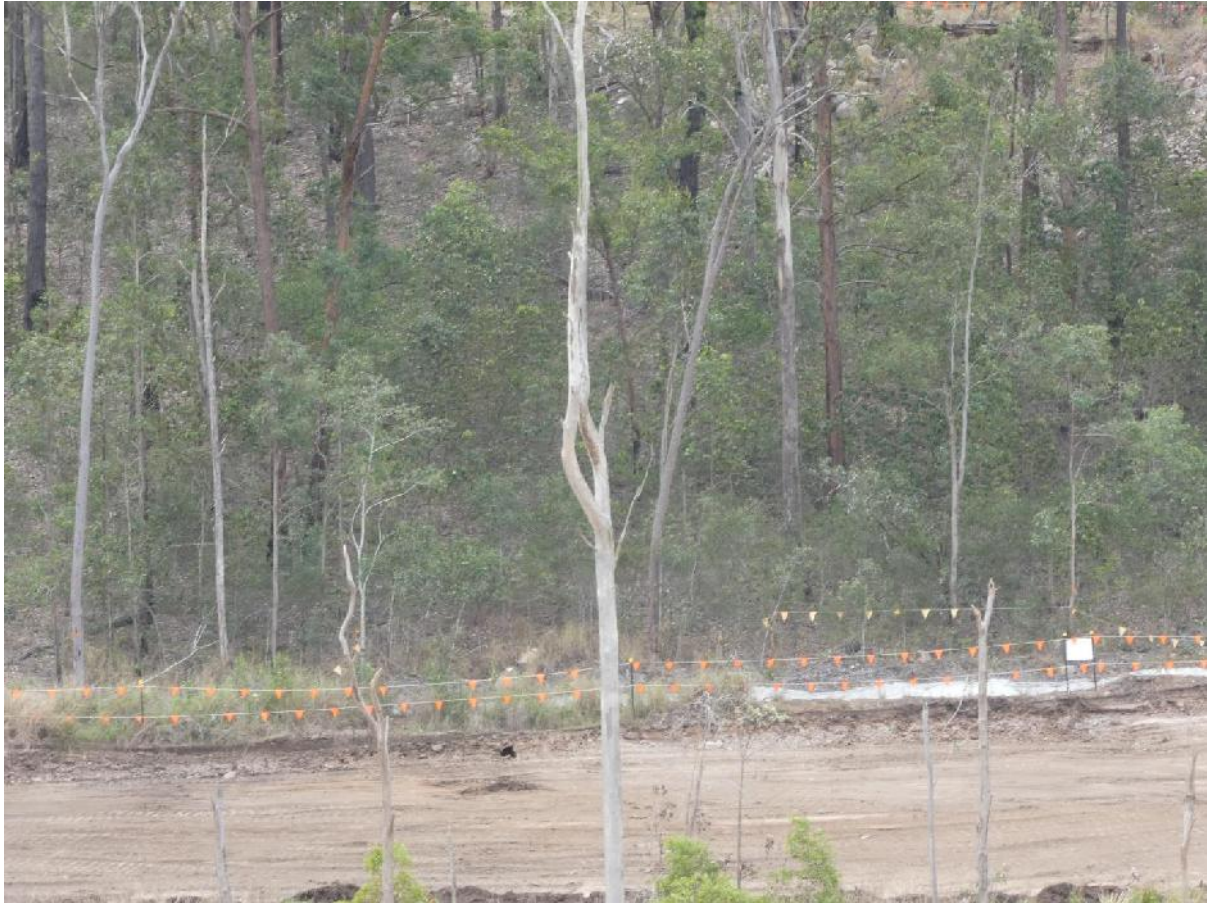
Stags within the water way did not contain hollow bearing natural assets.

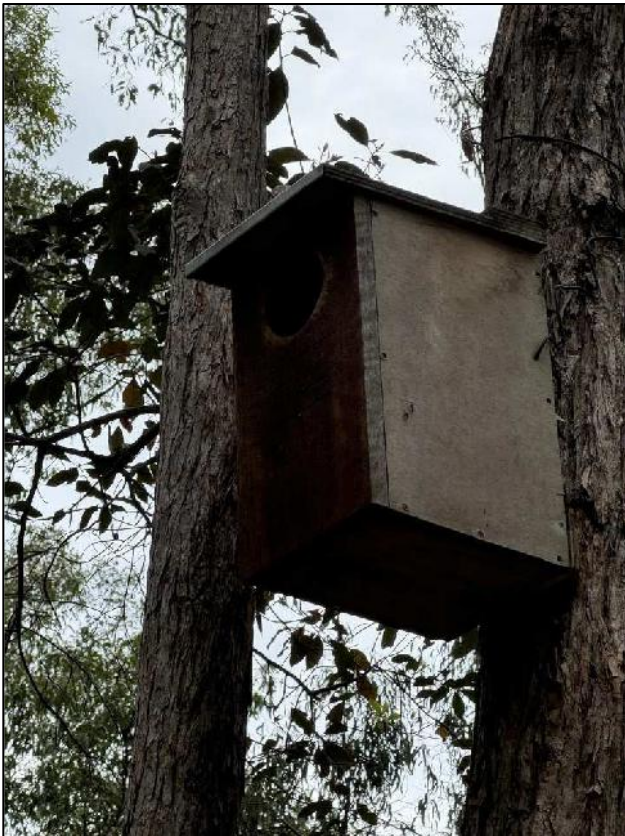
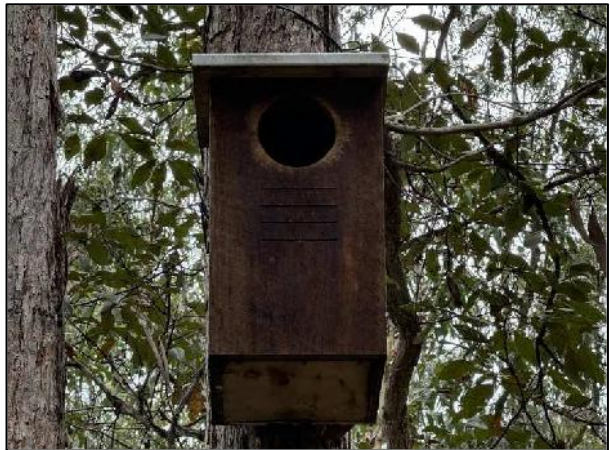
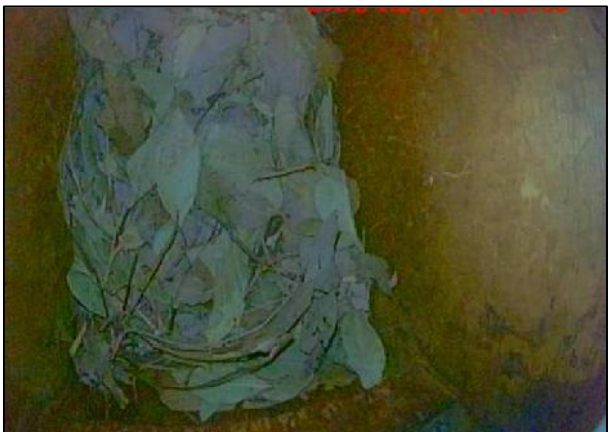
Leaf litter present.

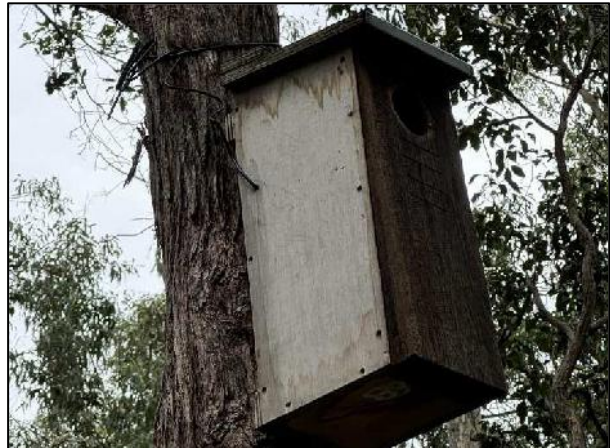
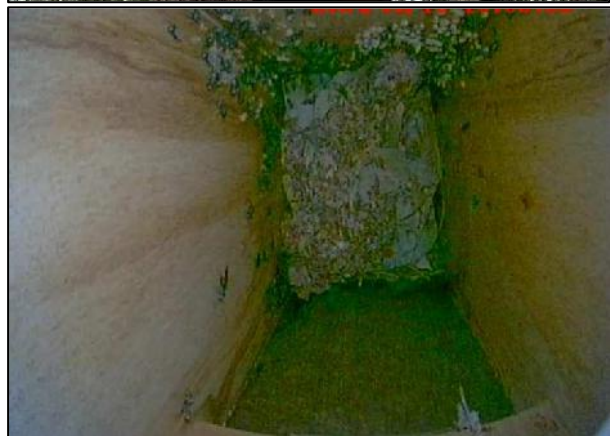
Leaf litter present. Caterpillar nest present on underside of box. Ant nest present inside box

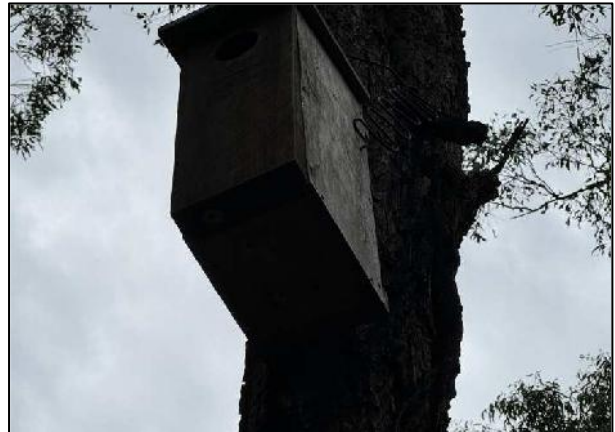
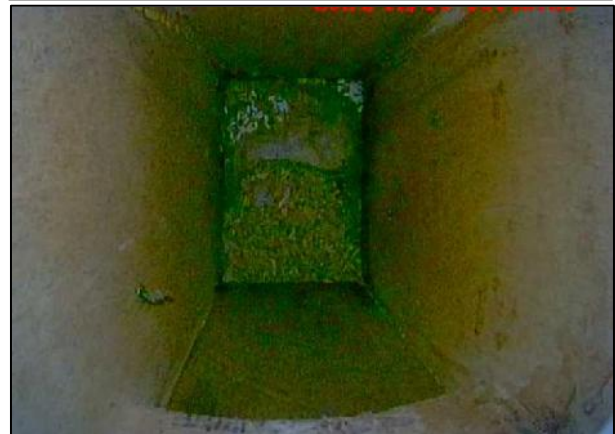
Saw shavings present. Ants also present

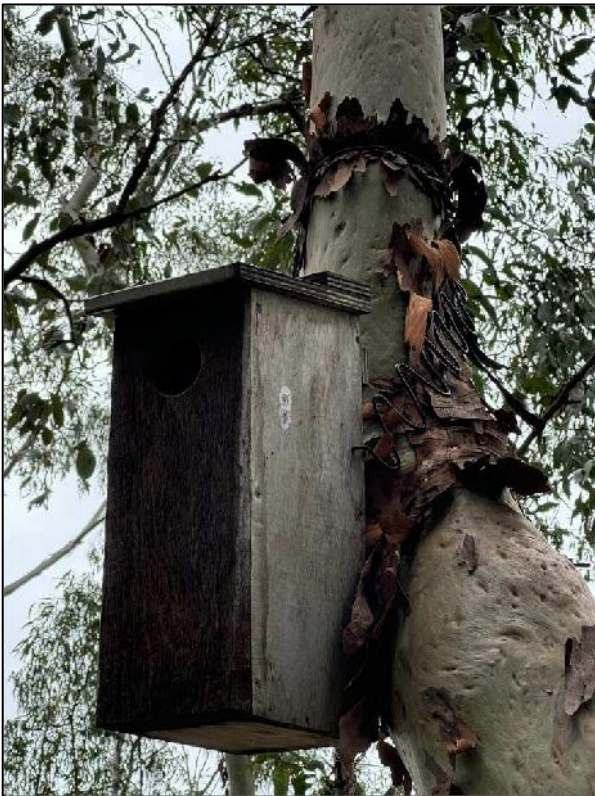
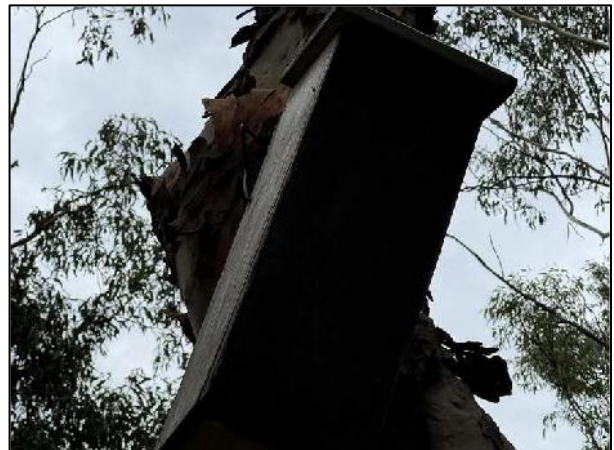
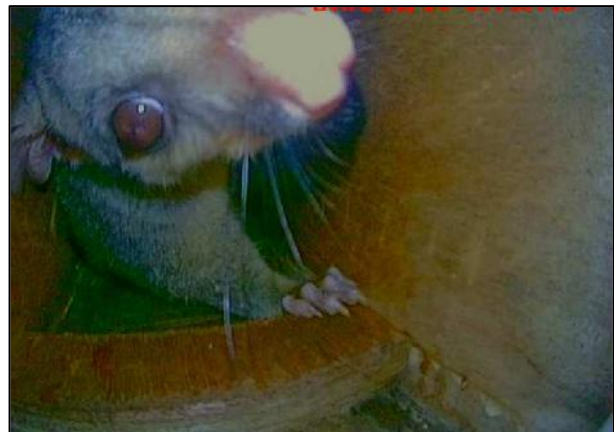
Brushtail Possum (*Trichosurus vulpecula*) Present

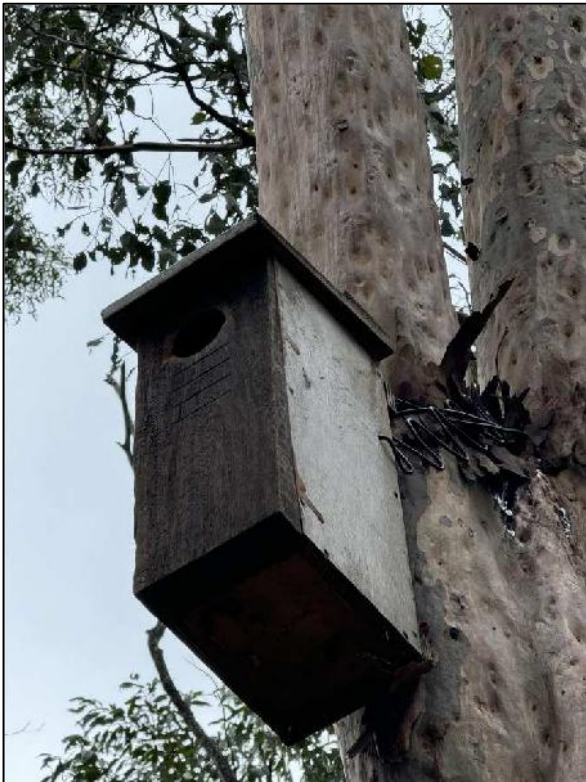
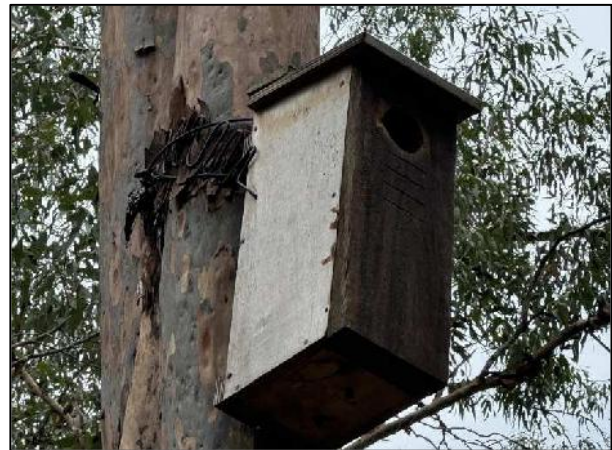
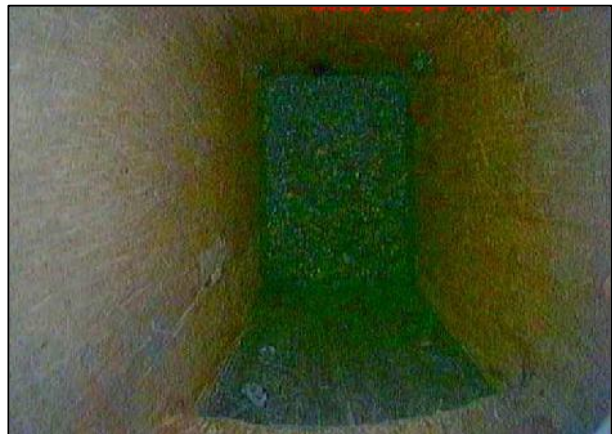
Saw shavings present.

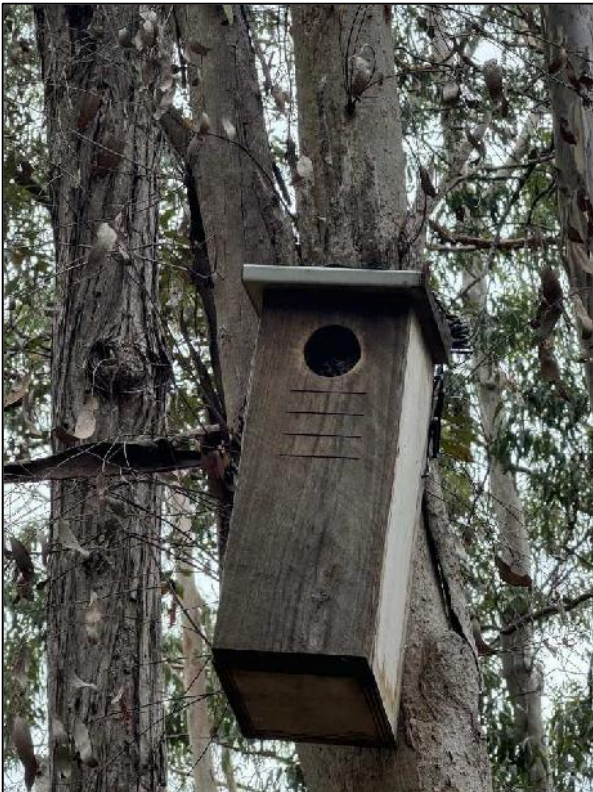
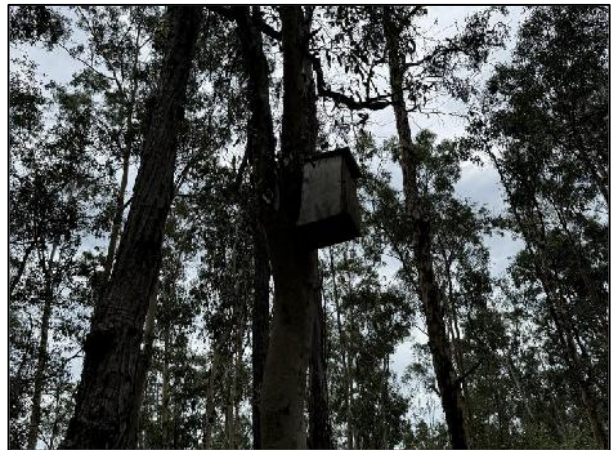
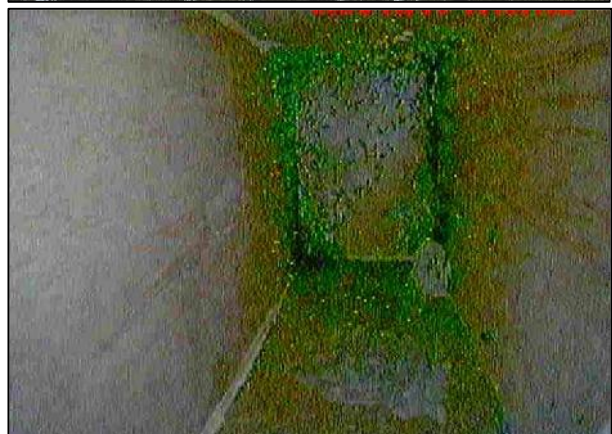
No nesting material. Rattle Ant nest inside box.

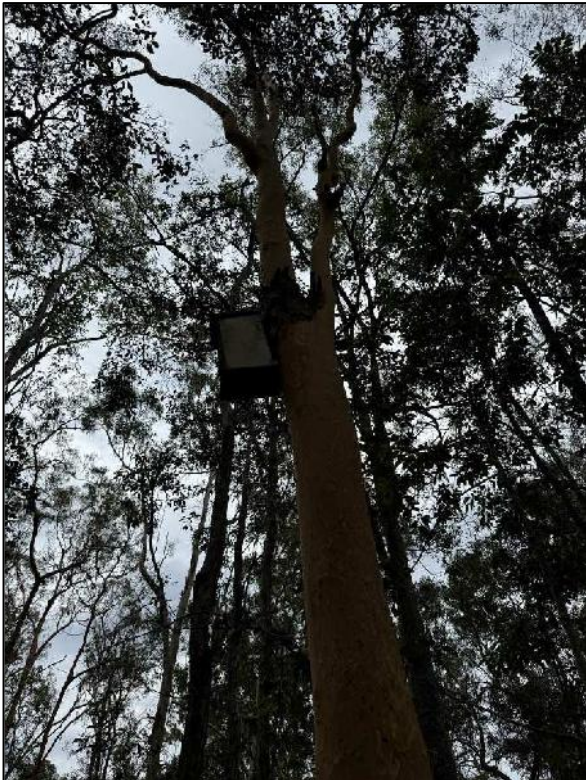
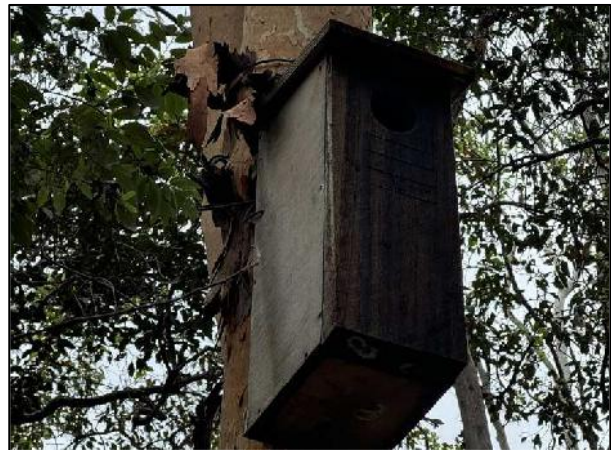
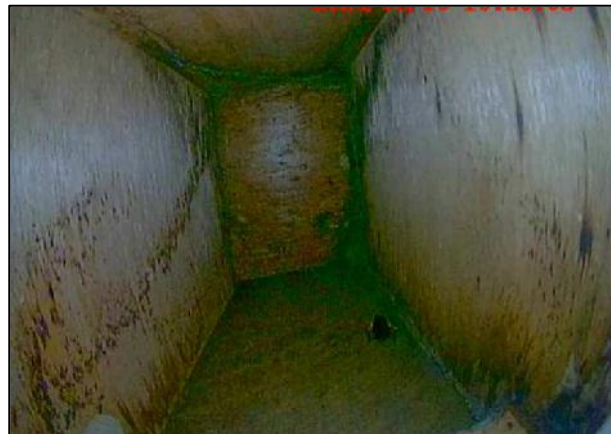
No nesting material present covering the floor of the box.

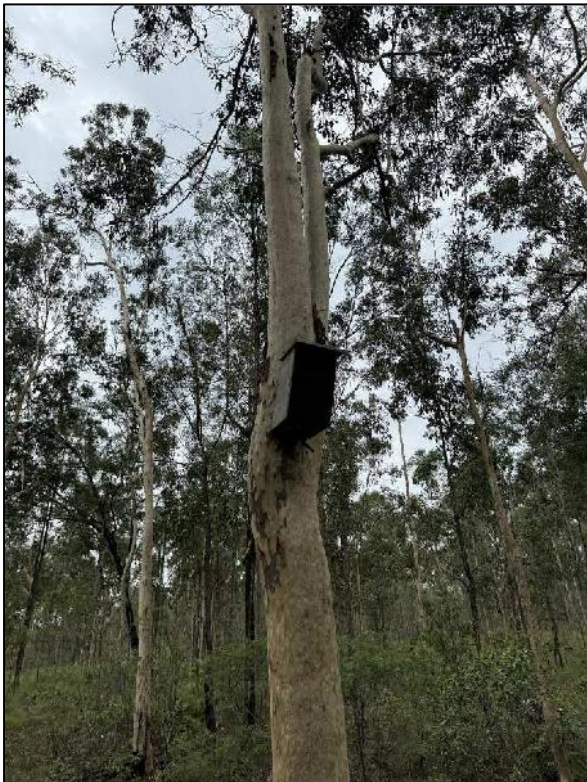
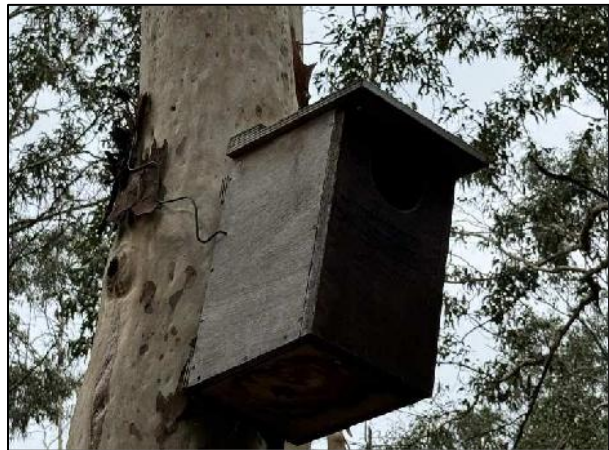
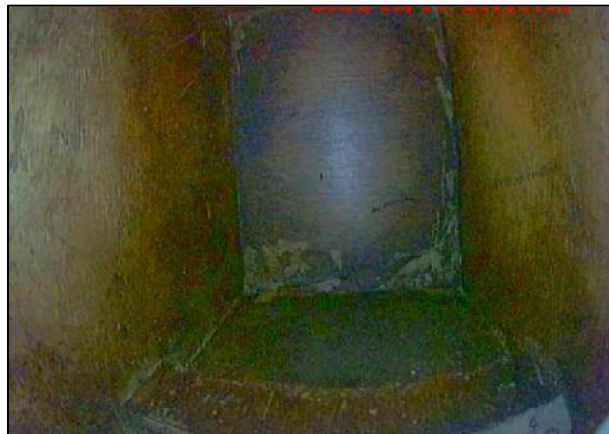
Minor leaf litter present in corners

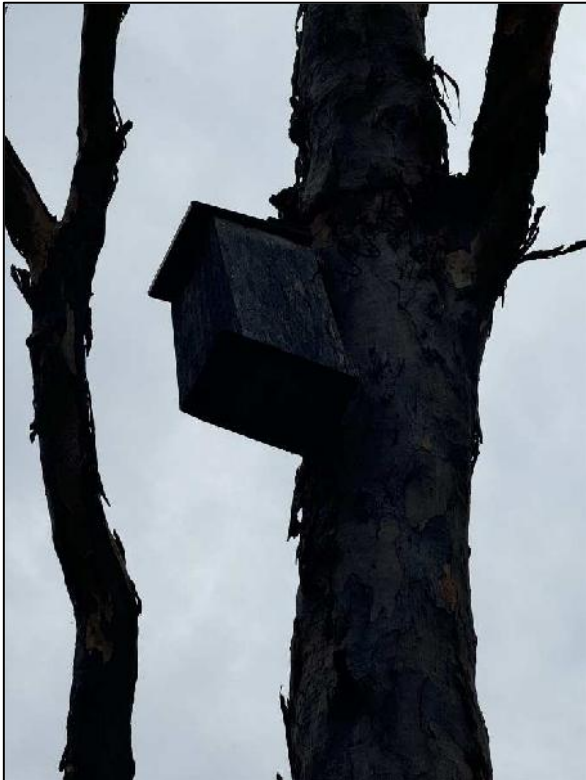
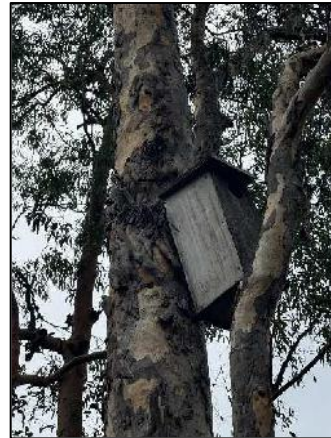
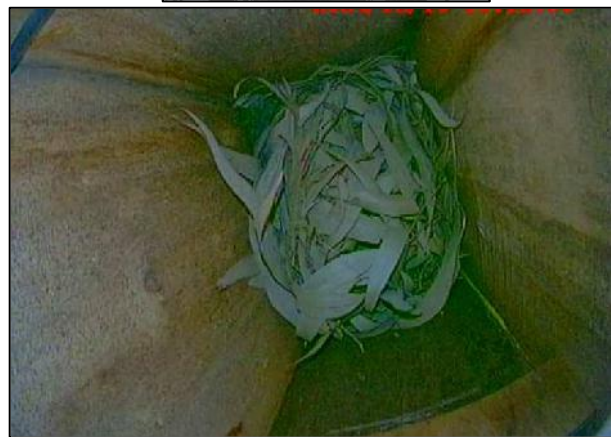
Nesting material present.

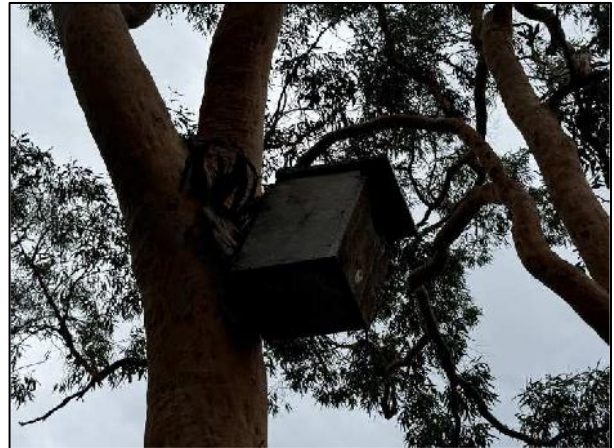
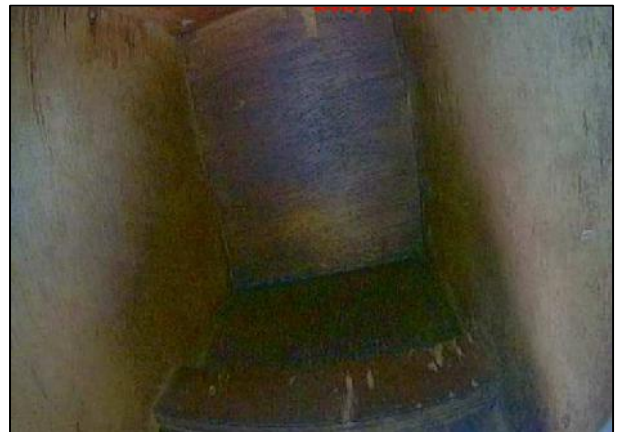
No nesting material present.

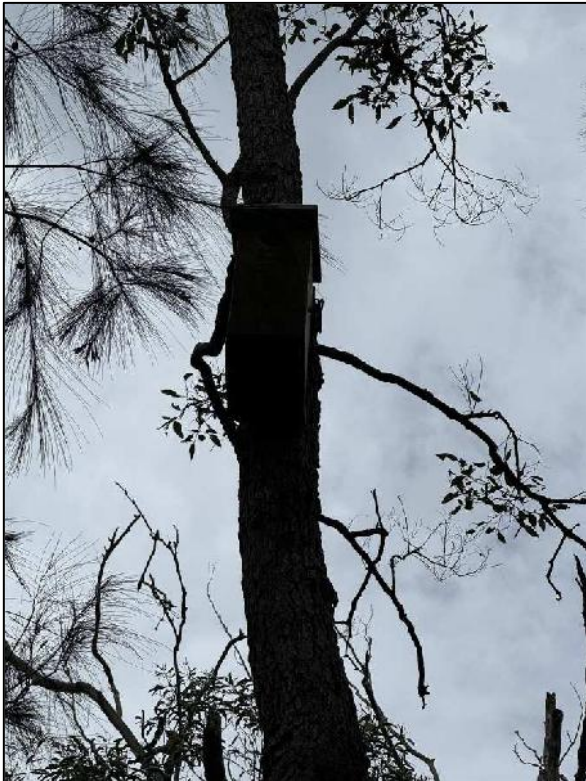
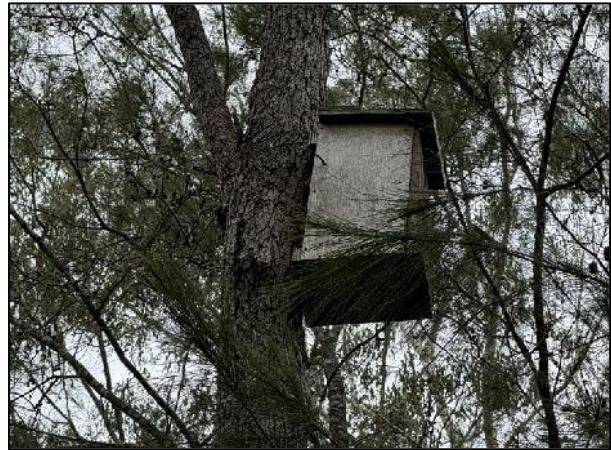
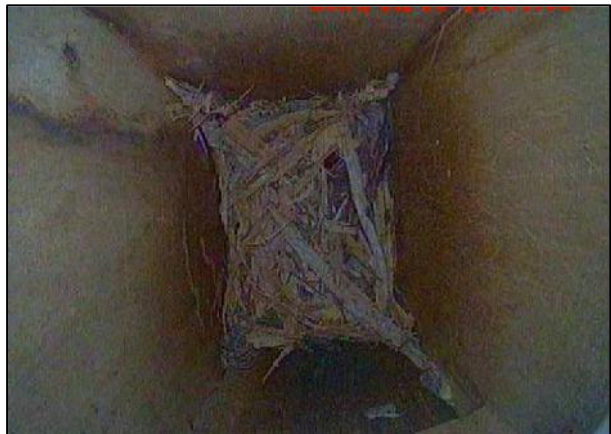
Leaf litter present.

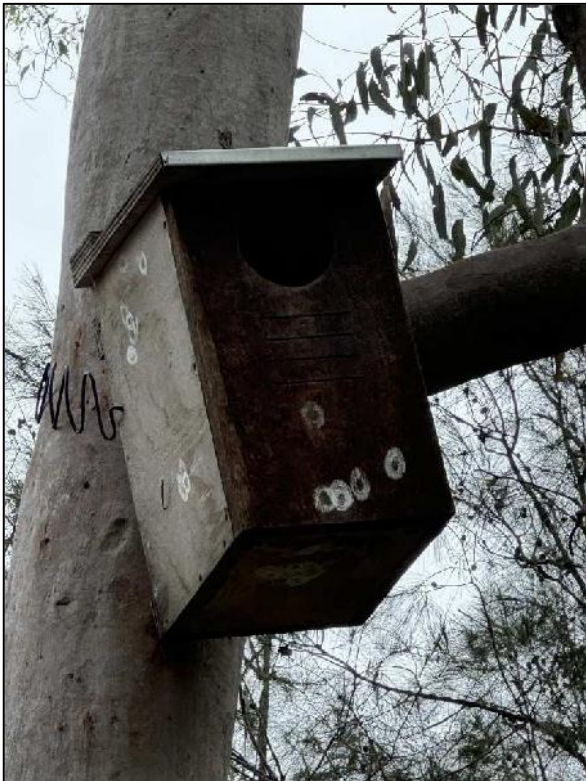
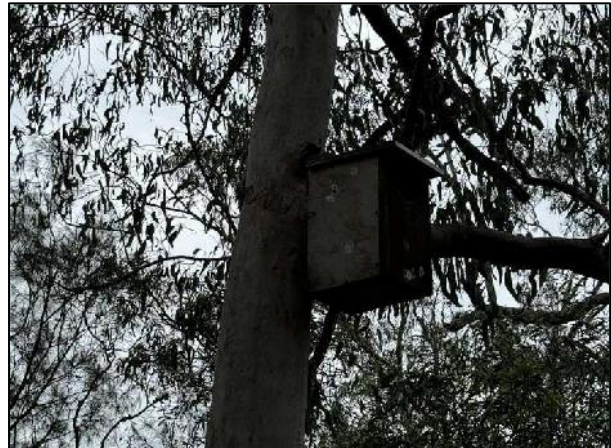
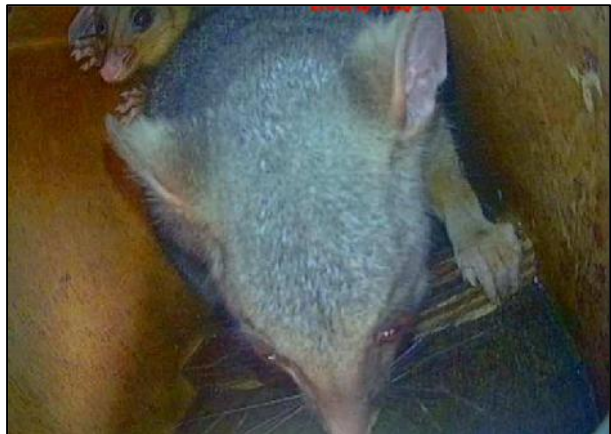
Brushtail Possums

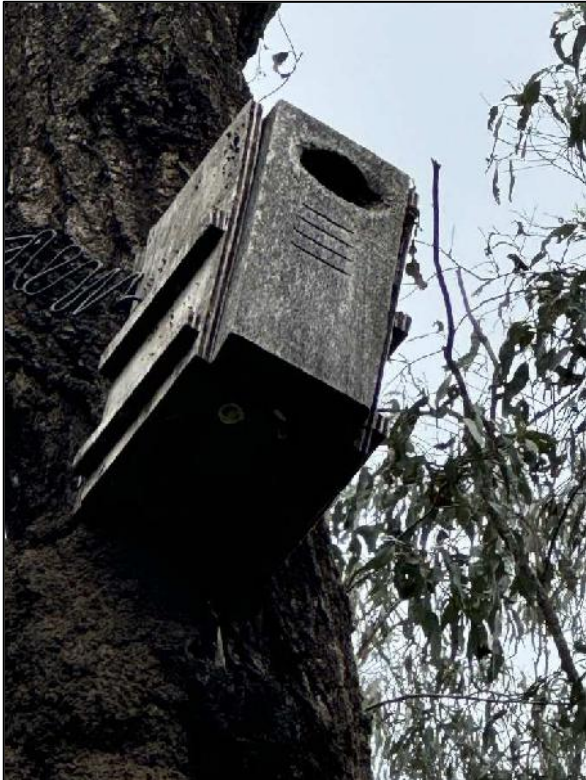
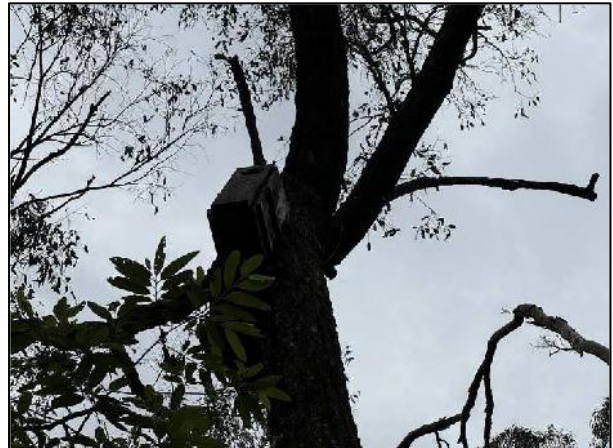
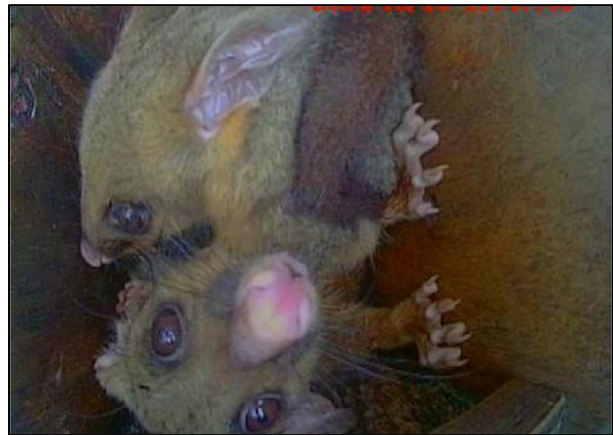
Brushtail Possums.

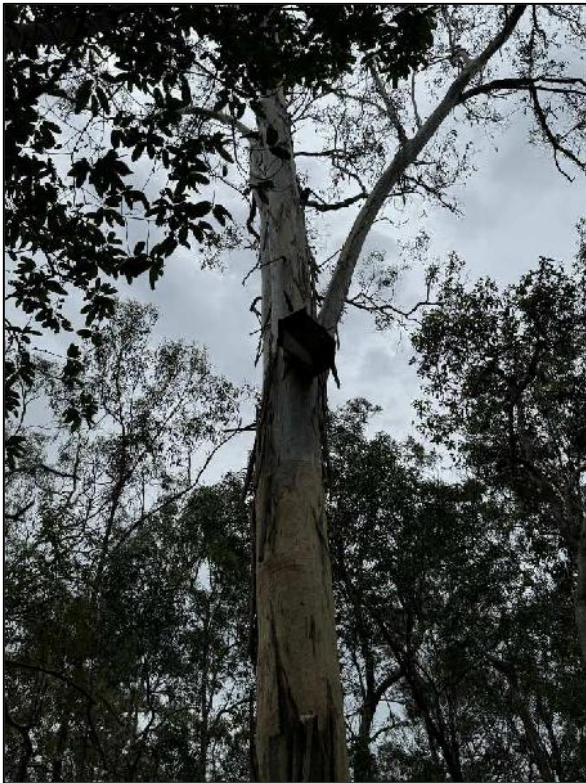
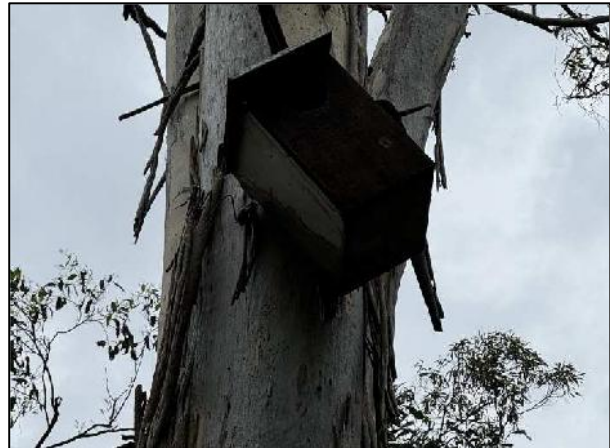
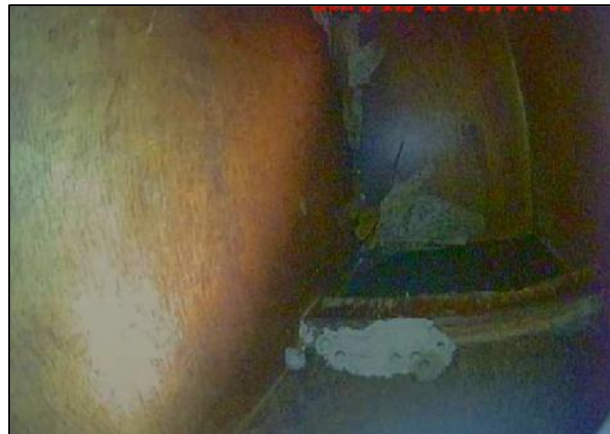
No indication of nesting. Mud wasp Nests

As discussed above, five (5) nest boxes require corrective actions, where four (4) require potential repositioning (#14, #16, #26 and #27). One (1) nest box required replacement with the lid/roof missing on the nest box (#13). From this inspection the nest boxes are to be adjusted or secured, to restore functionality.

- Four (4) nest boxes (#14, #16, #26 and #27) requiring further attention to reorientate/secure the units; and
- One (1) nest box (#13) requires replacement as there is damage to the lid/roof of the nest box.

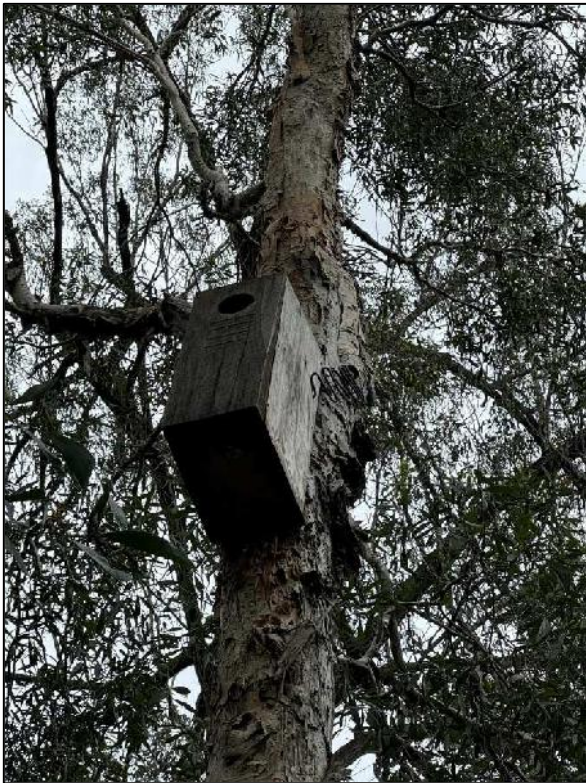
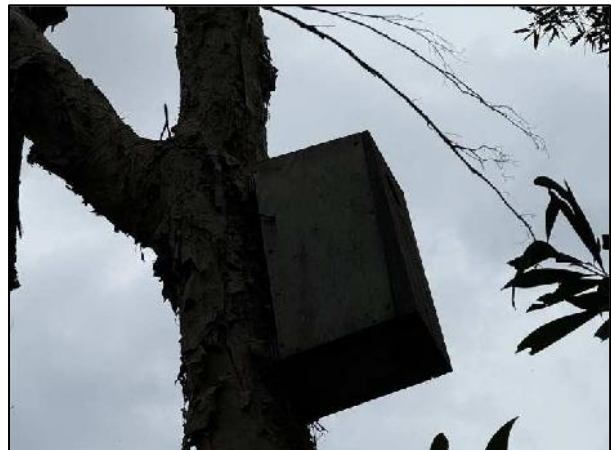
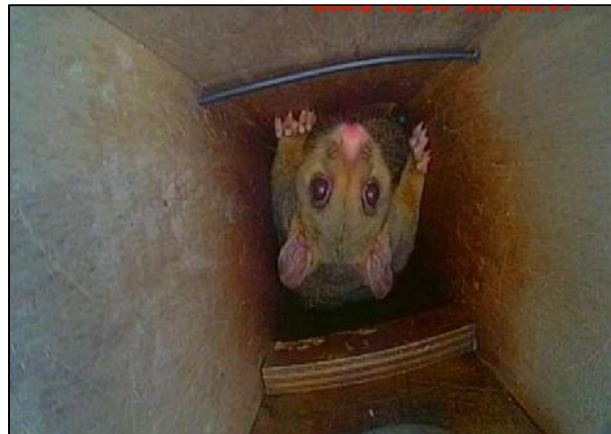
The monitoring event in December 2024 revealed that 57 of 58 nest boxes appear in good structural condition. Nest box fifteen (15) was in poor condition with no lid on the nest box. Fifteen (15) nest boxes were occupied by ants, five (5) with spiders, four (4) with insect mud nests and one (1) with an external caterpillar nest. Four (4) nest boxes were recorded on angles, one (1) nest box was identified to have Australian native stingless bees nest present, one (1) looked to have an internal screw exposed and one (1) nest box the tree has died.

Brushtail Possum. Box missing its lid.
