# Annual Compliance Report

17 October 2023 to 16 October 2024 EPBC 2013/7057  
Spring Mountain Mixed Use Master Planned Community  
Development, Spring Mountain, Queensland

Prepared for Lendlease Communities (Springfield) Pty Limited  
14 January 2025

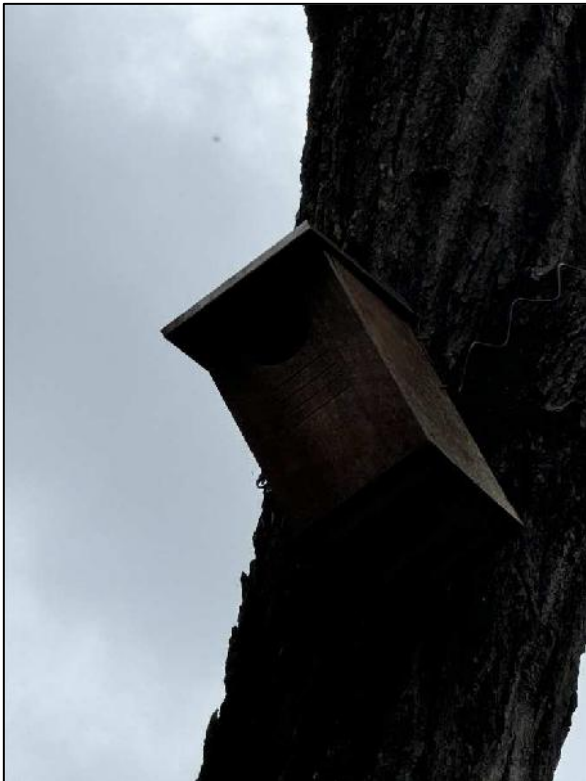
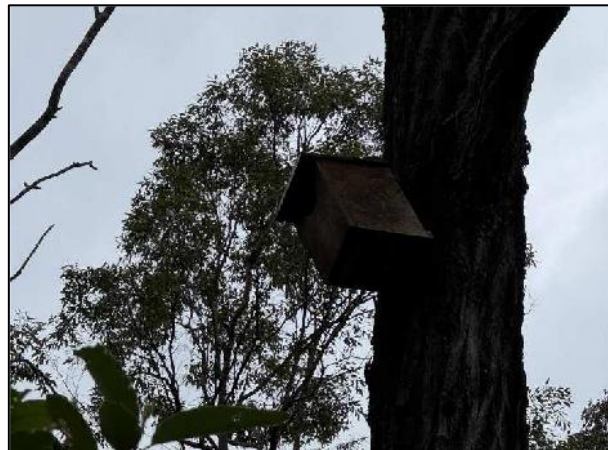
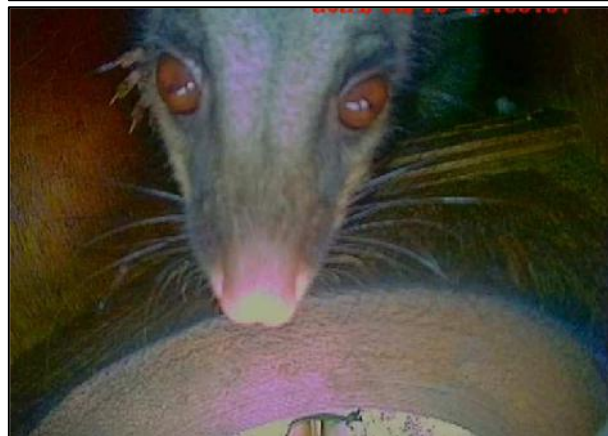
Maintenance Checklist of Nest Box ID: <b>Box 16</b>	Correct	Incorrect	Other
1. Box is not occupied by pest species	✓		
2. Box is not vandalised or missing	✓		
3. Box is securely attached with slight lean forward		✓	Reposition
4. Box is located at optimal height	✓		
5. Box is not damaged or rotten	✓		
6. The foot holds/ladder in interior of box for young is intact	✓		
7. There are no blockages in drainage holes	✓		
8. Entrance hole is free from obstruction and not damaged or worn	✓		
9. Nesting materials have been replaced to cover floor of box	✓		
10. All soiled materials like old shavings, membrane, egg shells have been removed	✓		
11. Box is aligned away from prevailing winds, rain and excessive heat	✓

Brushtail Possum.

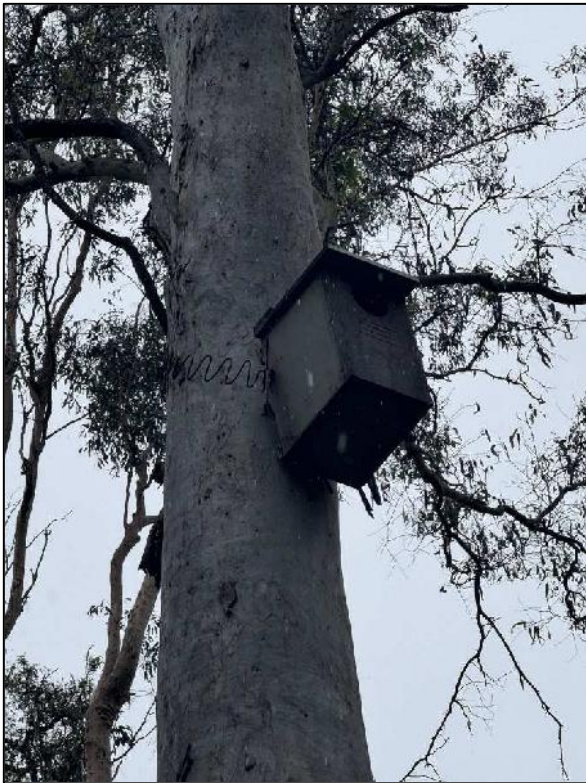
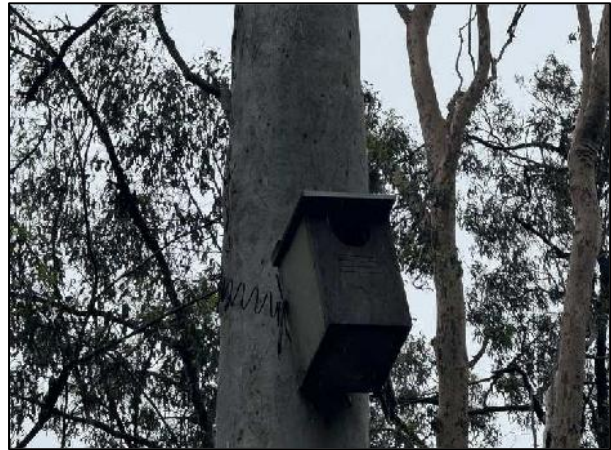
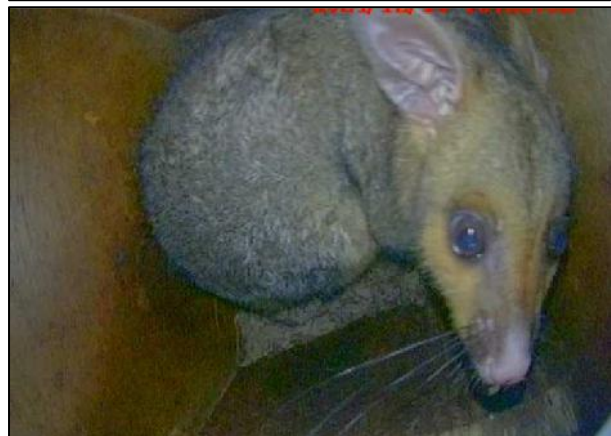
Maintenance Checklist of Nest Box ID: <b>Box 17</b>	Correct	Incorrect	Other
1. Box is not occupied by pest species	✓		
2. Box is not vandalised or missing	✓		
3. Box is securely attached with slight lean forward	✓		
4. Box is located at optimal height	✓		
5. Box is not damaged or rotten	✓		
6. The foot holds/ladder in interior of box for young is intact	✓		
7. There are no blockages in drainage holes	✓		
8. Entrance hole is free from obstruction and not damaged or worn	✓		
9. Nesting materials have been replaced to cover floor of box	✓		
10. All soiled materials like old shavings, membrane, egg shells have been removed	✓		
11. Box is aligned away from prevailing winds, rain and excessive heat	✓

Brushtail Possum

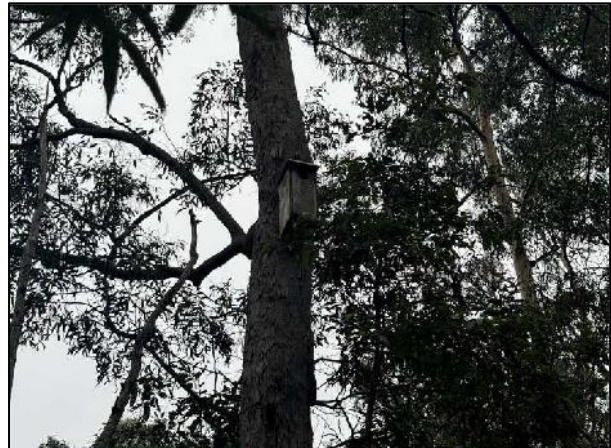
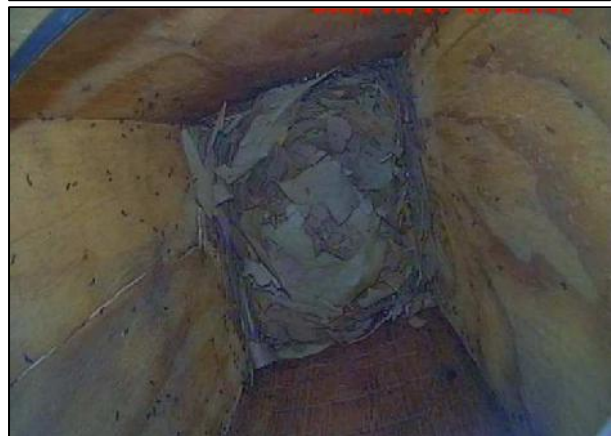
Maintenance Checklist of Nest Box ID: <b>Box 18</b>	Correct	Incorrect	Other
1. Box is not occupied by pest species	✓		
2. Box is not vandalised or missing	✓		
3. Box is securely attached with slight lean forward	✓		
4. Box is located at optimal height	✓		
5. Box is not damaged or rotten	✓		
6. The foot holds/ladder in interior of box for young is intact	✓		
7. There are no blockages in drainage holes	✓		
8. Entrance hole is free from obstruction and not damaged or worn	✓		
9. Nesting materials have been replaced to cover floor of box	✓		
10. All soiled materials like old shavings, membrane, egg shells have been removed	✓		
11. Box is aligned away from prevailing winds, rain and excessive heat	✓

Leaf litter present.

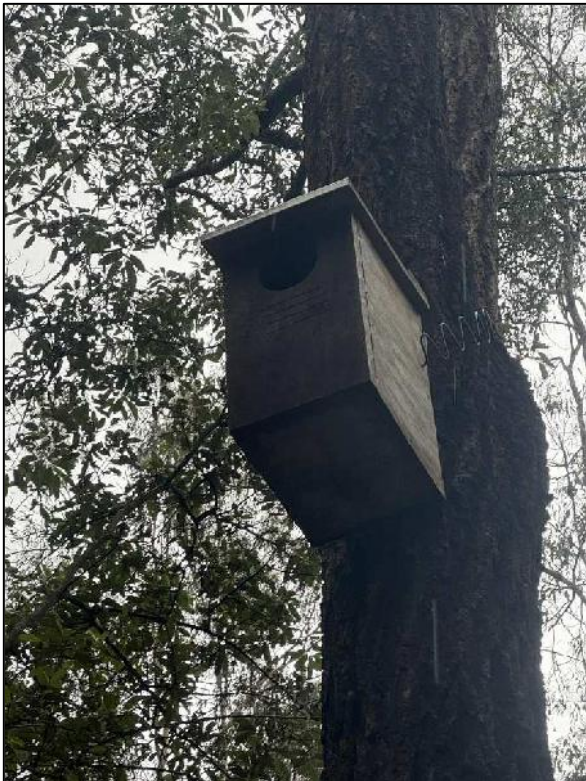
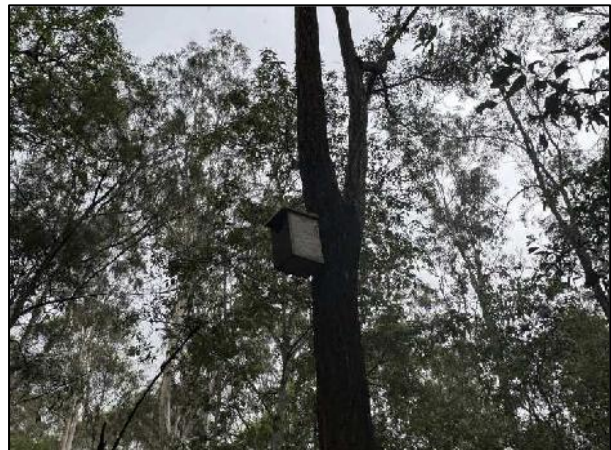
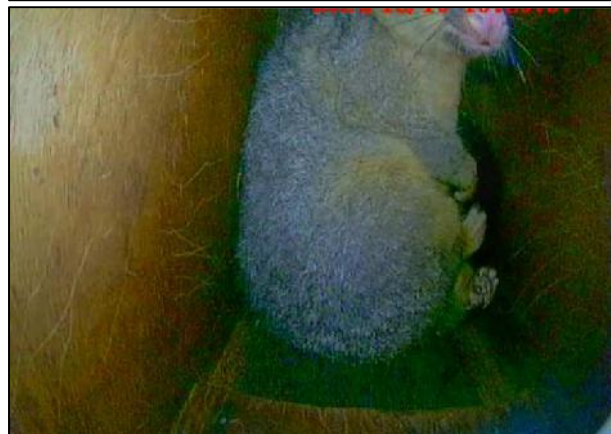
Maintenance Checklist of Nest Box ID: <b>Box 19</b>	Correct	Incorrect	Other
1. Box is not occupied by pest species	✓		
2. Box is not vandalised or missing	✓		
3. Box is securely attached with slight lean forward	✓		
4. Box is located at optimal height	✓		
5. Box is not damaged or rotten	✓		
6. The foot holds/ladder in interior of box for young is intact	✓		
7. There are no blockages in drainage holes	✓		
8. Entrance hole is free from obstruction and not damaged or worn	✓		
9. Nesting materials have been replaced to cover floor of box	✓		
10. All soiled materials like old shavings, membrane, egg shells have been removed	✓		
11. Box is aligned away from prevailing winds, rain and excessive heat	✓

Brushtail Possum.

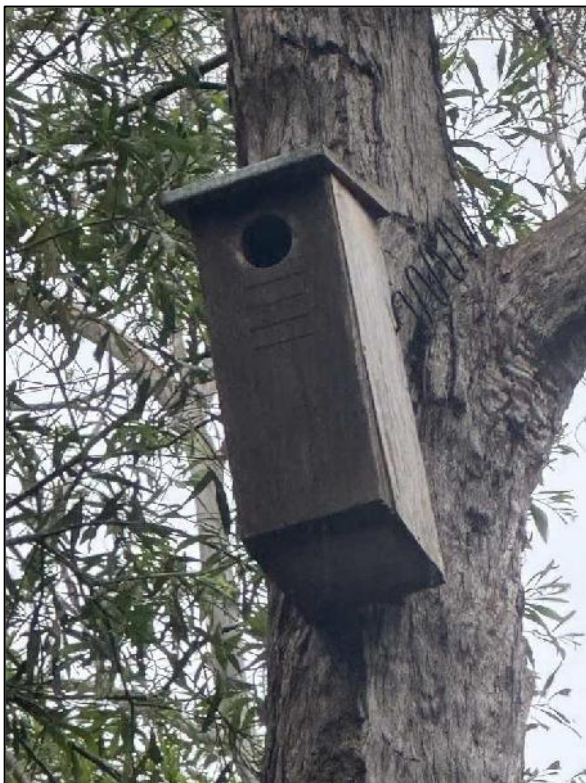
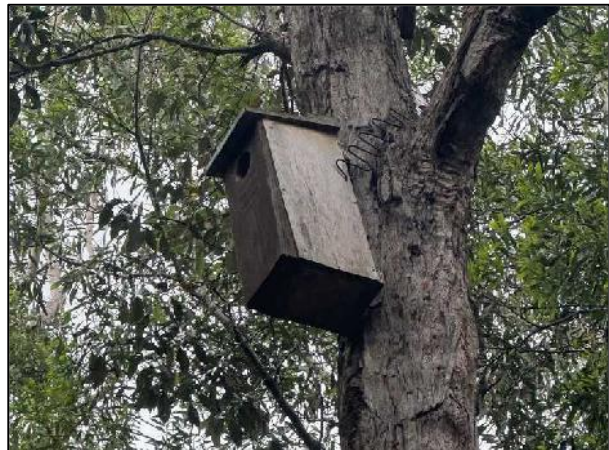
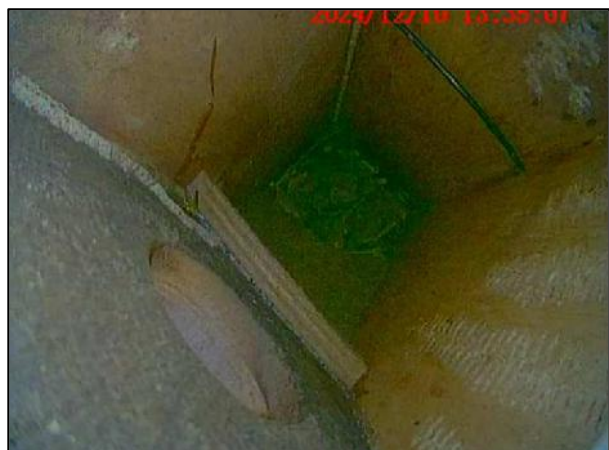
Maintenance Checklist of Nest Box ID: <b>Box 20</b>	Correct	Incorrect	Other
1. Box is not occupied by pest species	✓		
2. Box is not vandalised or missing	✓		
3. Box is securely attached with slight lean forward	✓		
4. Box is located at optimal height	✓		
5. Box is not damaged or rotten	✓		
6. The foot holds/ladder in interior of box for young is intact	✓		
7. There are no blockages in drainage holes	✓		
8. Entrance hole is free from obstruction and not damaged or worn	✓		
9. Nesting materials have been replaced to cover floor of box	✓		
10. All soiled materials like old shavings, membrane, egg shells have been removed	✓		
11. Box is aligned away from prevailing winds, rain and excessive heat	✓

Leaf litter present

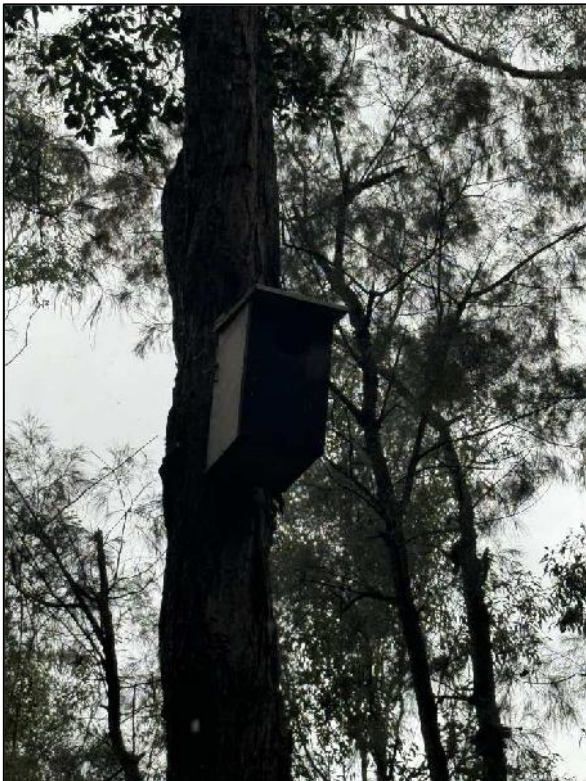
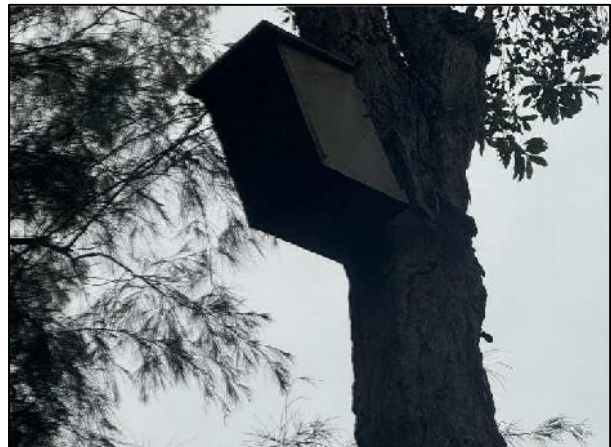
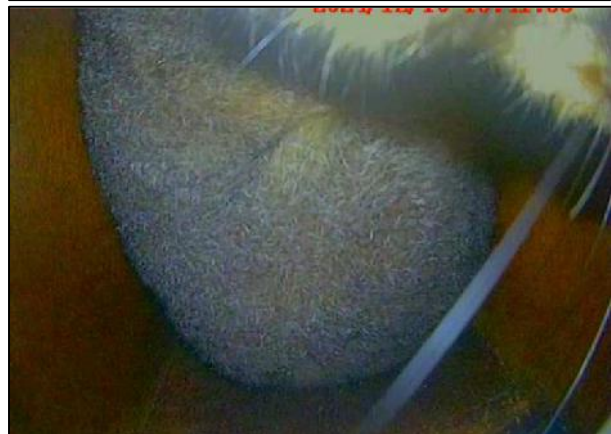
Maintenance Checklist of Nest Box ID: <b>Box 21</b>	Correct	Incorrect	Other
1. Box is not occupied by pest species	✓		
2. Box is not vandalised or missing	✓		
3. Box is securely attached with slight lean forward	✓		
4. Box is located at optimal height	✓		
5. Box is not damaged or rotten	✓		
6. The foot holds/ladder in interior of box for young is intact	✓		
7. There are no blockages in drainage holes	✓		
8. Entrance hole is free from obstruction and not damaged or worn	✓		
9. Nesting materials have been replaced to cover floor of box	✓		
10. All soiled materials like old shavings, membrane, egg shells have been removed	✓		
11. Box is aligned away from prevailing winds, rain and excessive heat	✓

Brushtail Possum.

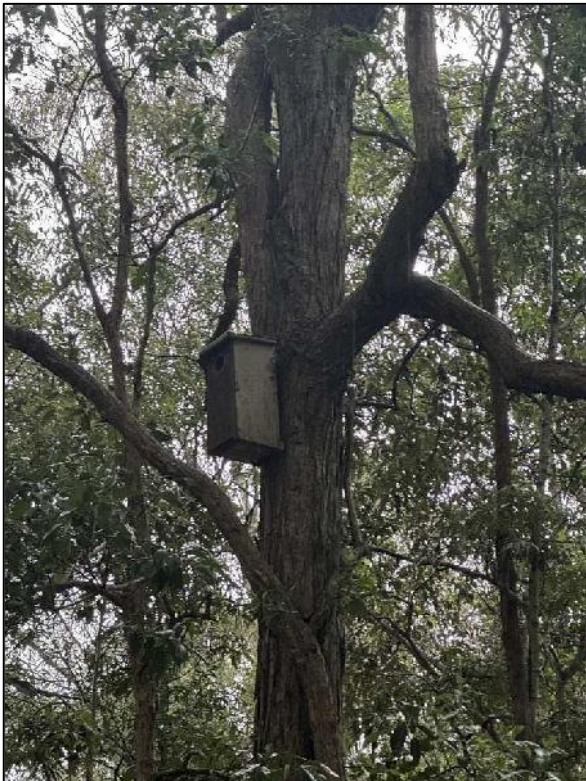
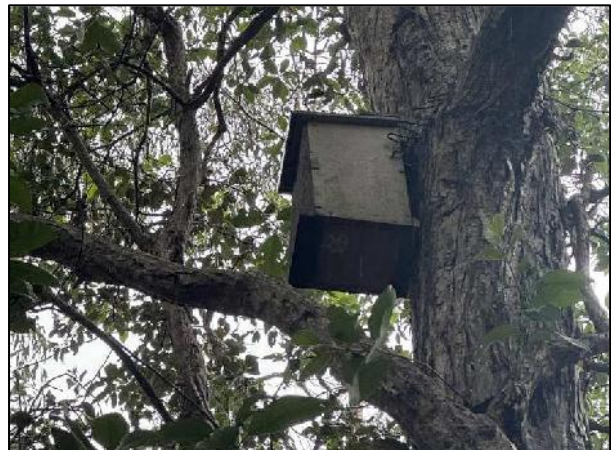
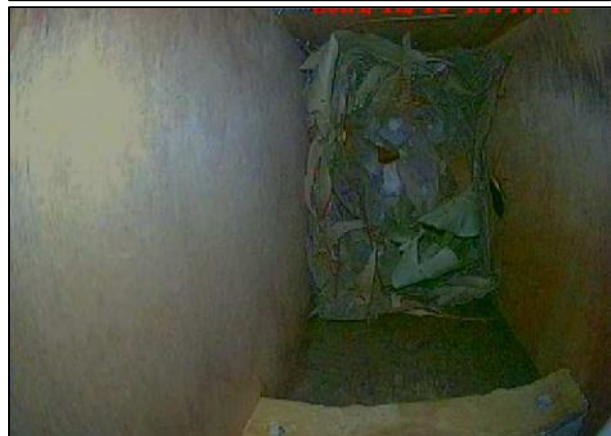
Maintenance Checklist of Nest Box ID: <b>Box 22</b>	Correct	Incorrect	Other
1. Box is not occupied by pest species	✓		
2. Box is not vandalised or missing	✓		
3. Box is securely attached with slight lean forward	✓		
4. Box is located at optimal height	✓		
5. Box is not damaged or rotten	✓		
6. The foot holds/ladder in interior of box for young is intact	✓		
7. There are no blockages in drainage holes	✓		
8. Entrance hole is free from obstruction and not damaged or worn	✓		
9. Nesting materials have been replaced to cover floor of box	✓		
10. All soiled materials like old shavings, membrane, egg shells have been removed	✓		
11. Box is aligned away from prevailing winds, rain and excessive heat	✓

Leaf litter present. Internally exposed screw.

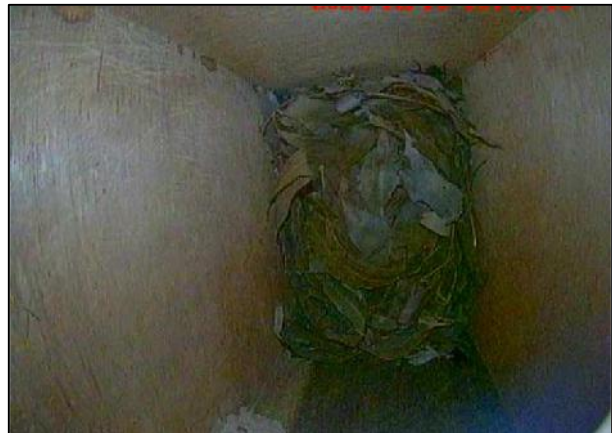
Maintenance Checklist of Nest Box ID: <b>Box 23</b>	Correct	Incorrect	Other
1. Box is not occupied by pest species	✓		
2. Box is not vandalised or missing	✓		
3. Box is securely attached with slight lean forward	✓		
4. Box is located at optimal height	✓		
5. Box is not damaged or rotten	✓		
6. The foot holds/ladder in interior of box for young is intact	✓		
7. There are no blockages in drainage holes	✓		
8. Entrance hole is free from obstruction and not damaged or worn	✓		
9. Nesting materials have been replaced to cover floor of box	✓		
10. All soiled materials like old shavings, membrane, egg shells have been removed	✓		
11. Box is aligned away from prevailing winds, rain and excessive heat	✓

Leaf litter present.

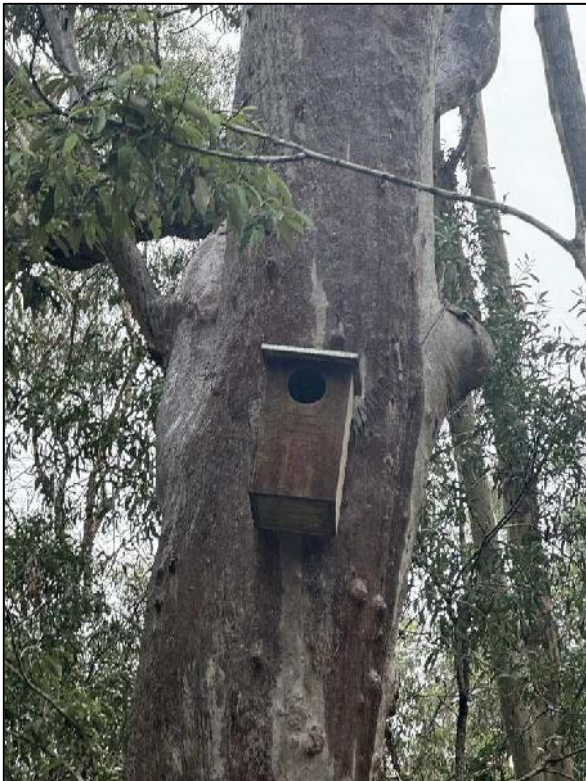
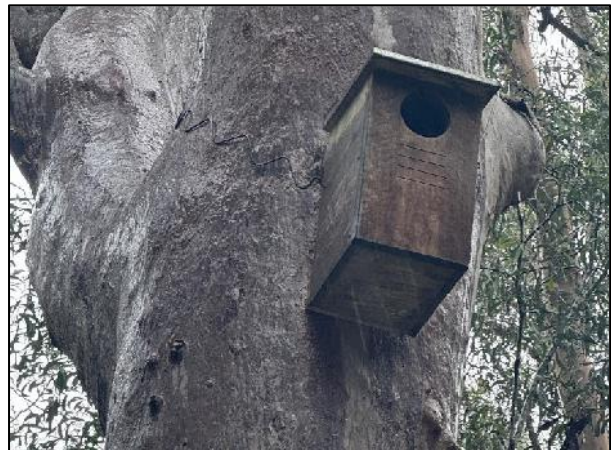
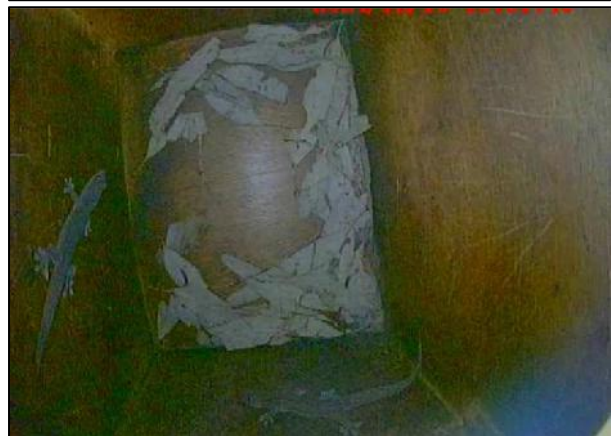
Maintenance Checklist of Nest Box ID: <b>Box 24</b>	Correct	Incorrect	Other
1. Box is not occupied by pest species	✓		
2. Box is not vandalised or missing	✓		
3. Box is securely attached with slight lean forward	✓		
4. Box is located at optimal height	✓		
5. Box is not damaged or rotten	✓		
6. The foot holds/ladder in interior of box for young is intact	✓		
7. There are no blockages in drainage holes	✓		
8. Entrance hole is free from obstruction and not damaged or worn	✓		
9. Nesting materials have been replaced to cover floor of box	✓		
10. All soiled materials like old shavings, membrane, egg shells have been removed	✓		
11. Box is aligned away from prevailing winds, rain and excessive heat	✓

Leaf litter and geckos.

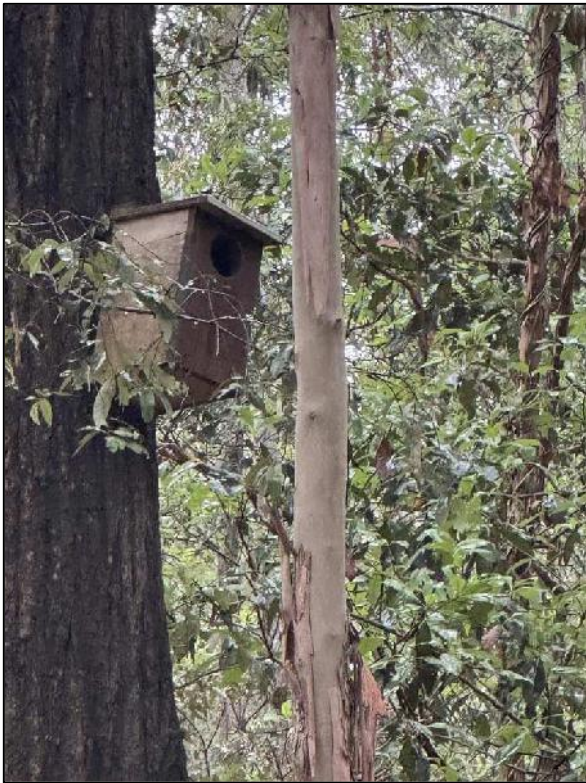
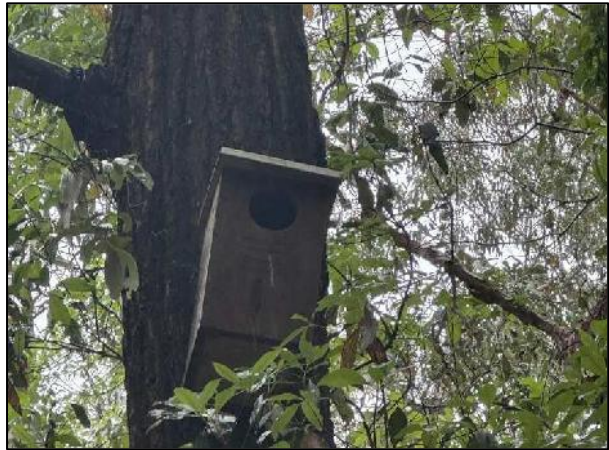
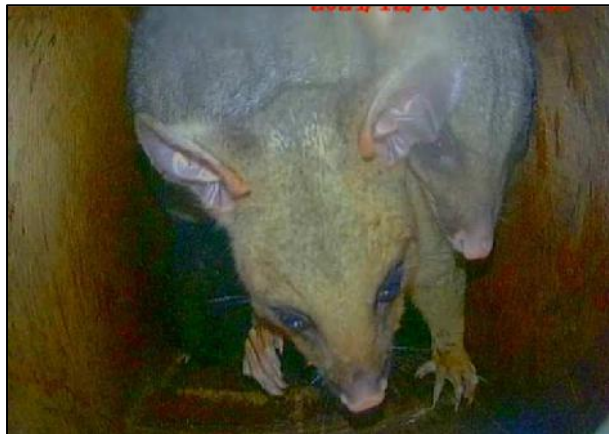
Maintenance Checklist of Nest Box ID: <b>Box 25</b>	Correct	Incorrect	Other
1. Box is not occupied by pest species	✓		
2. Box is not vandalised or missing	✓		
3. Box is securely attached with slight lean forward	✓		
4. Box is located at optimal height	✓		
5. Box is not damaged or rotten	✓		
6. The foot holds/ladder in interior of box for young is intact	✓		
7. There are no blockages in drainage holes	✓		
8. Entrance hole is free from obstruction and not damaged or worn	✓		
9. Nesting materials have been replaced to cover floor of box	✓		
10. All soiled materials like old shavings, membrane, egg shells have been removed	✓		
11. Box is aligned away from prevailing winds, rain and excessive heat	✓

Brushtail Possums.

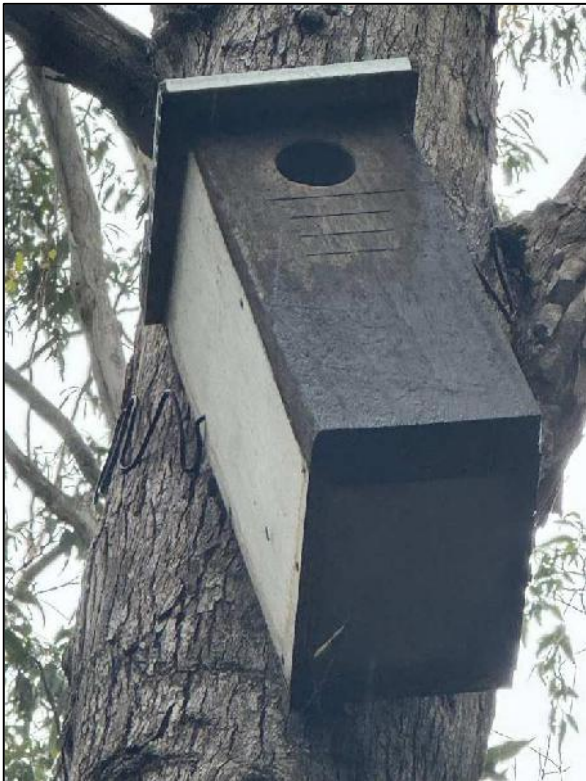
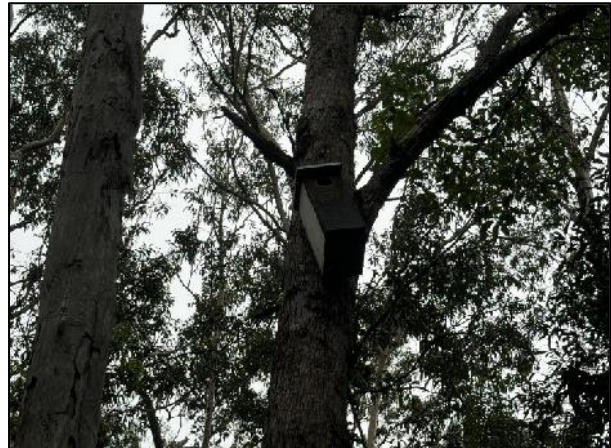
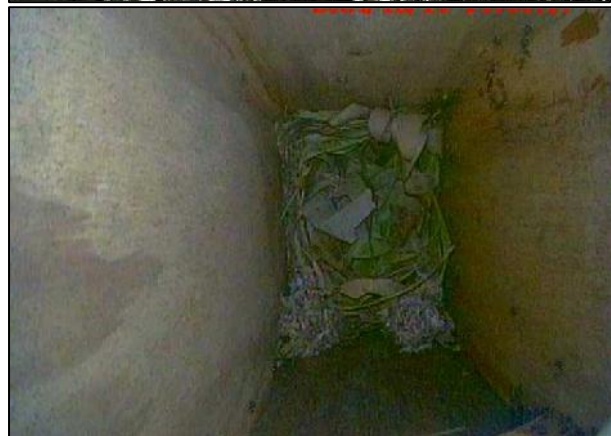
Maintenance Checklist of Nest Box ID: <b>Box 26</b>	Correct	Incorrect	Other
1. Box is not occupied by pest species	✓		
2. Box is not vandalised or missing	✓		
3. Box is securely attached with slight lean forward		✓	Reposition
4. Box is located at optimal height	✓		
5. Box is not damaged or rotten	✓		
6. The foot holds/ladder in interior of box for young is intact	✓		
7. There are no blockages in drainage holes	✓		
8. Entrance hole is free from obstruction and not damaged or worn	✓		
9. Nesting materials have been replaced to cover floor of box	✓		
10. All soiled materials like old shavings, membrane, egg shells have been removed	✓		
11. Box is aligned away from prevailing winds, rain and excessive heat	✓

Leaf litter present. Ants present

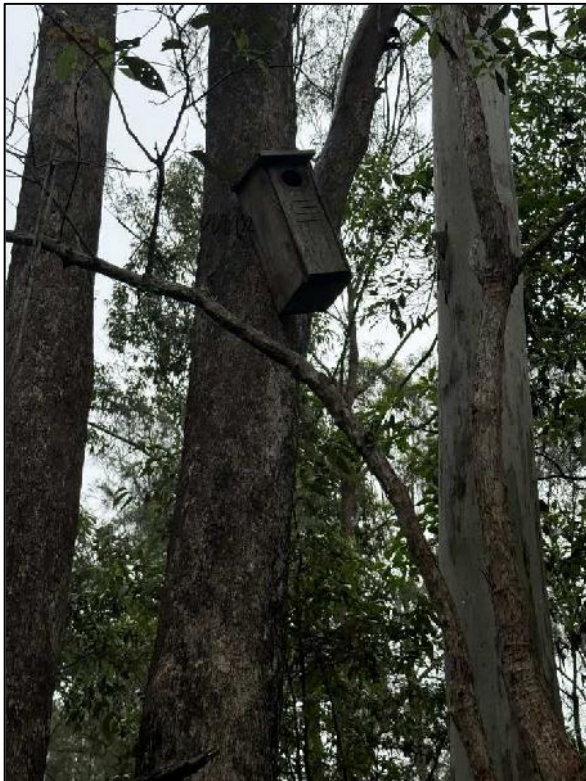
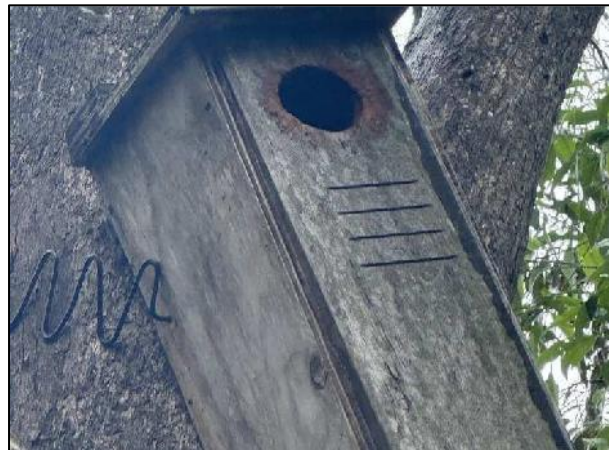
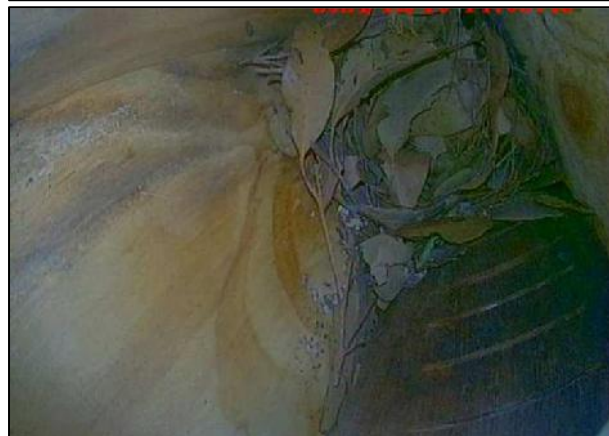
Maintenance Checklist of Nest Box ID: <b>Box 27</b>	Correct	Incorrect	Other
1. Box is not occupied by pest species	✓		
2. Box is not vandalised or missing	✓		
3. Box is securely attached with slight lean forward		✓	Reposition
4. Box is located at optimal height	✓		
5. Box is not damaged or rotten	✓		
6. The foot holds/ladder in interior of box for young is intact	✓		
7. There are no blockages in drainage holes	✓		
8. Entrance hole is free from obstruction and not damaged or worn	✓		
9. Nesting materials have been replaced to cover floor of box	✓		
10. All soiled materials like old shavings, membrane, egg shells have been removed	✓		
11. Box is aligned away from prevailing winds, rain and excessive heat	✓

Leaf litter present.

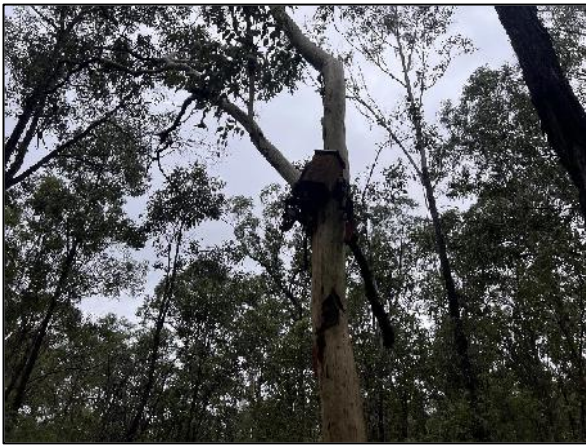
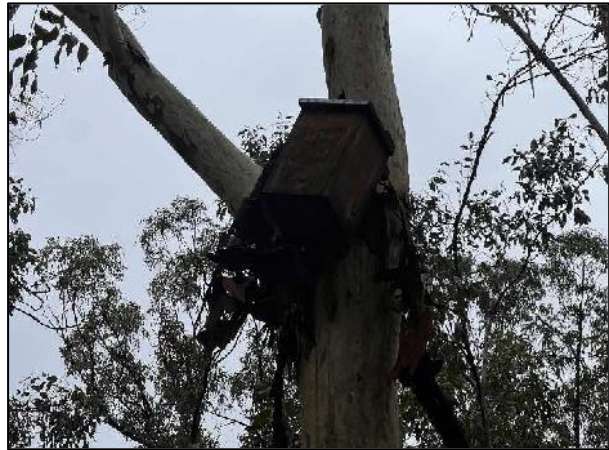
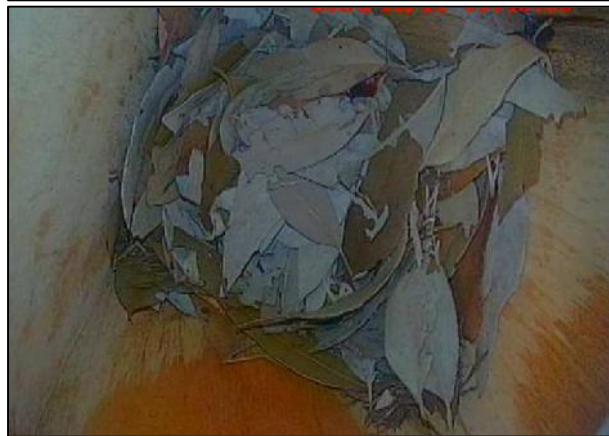
Leaf litter present.

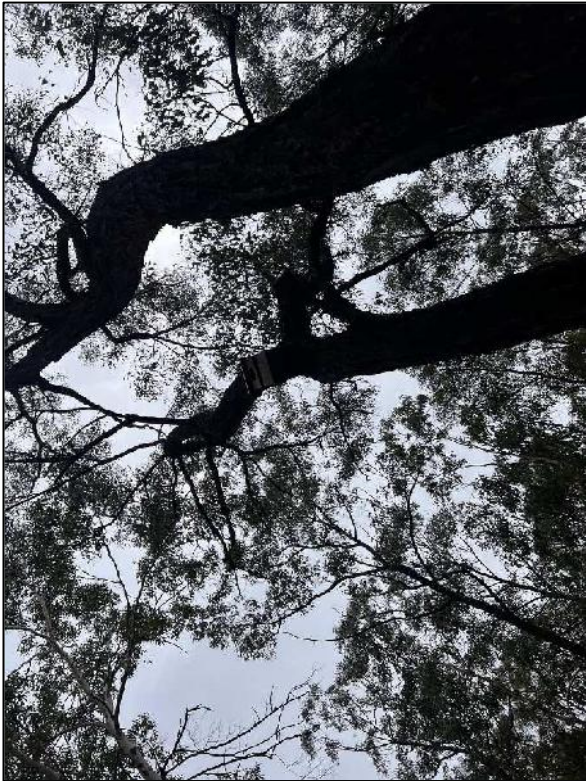
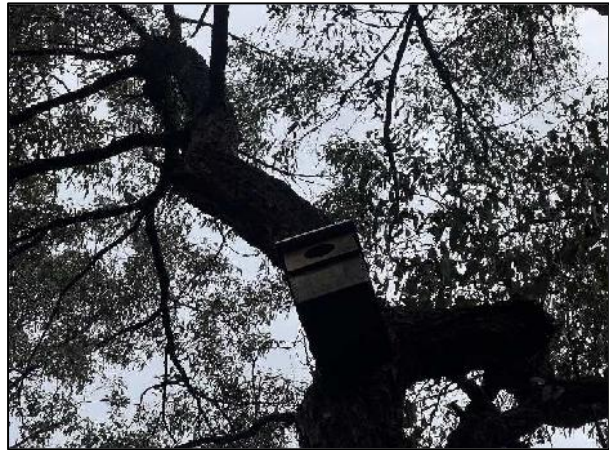
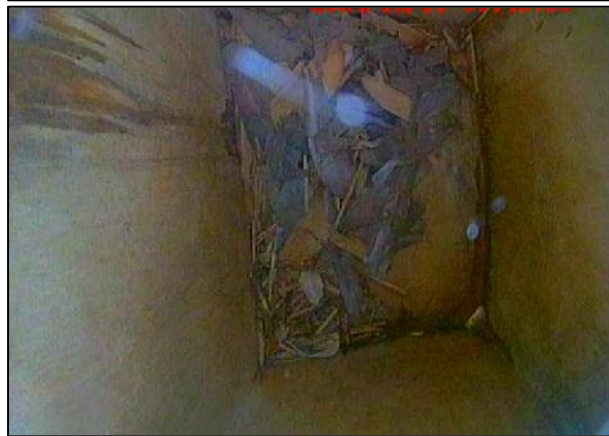
Leaf litter present. Spider-webs on entrance.

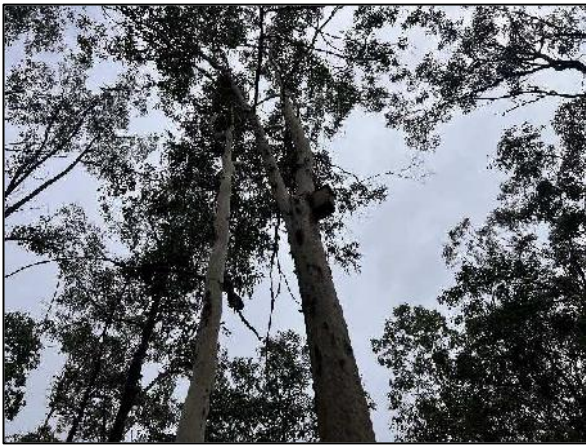
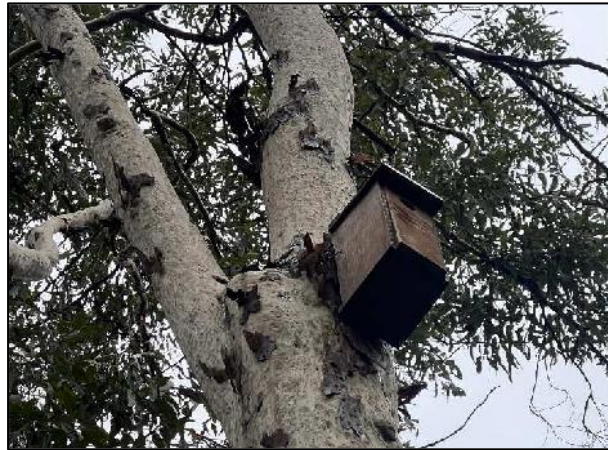
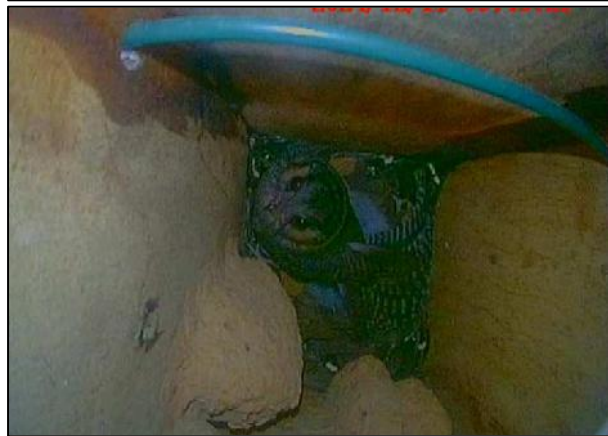
Owlet Nightjar and termite nest.

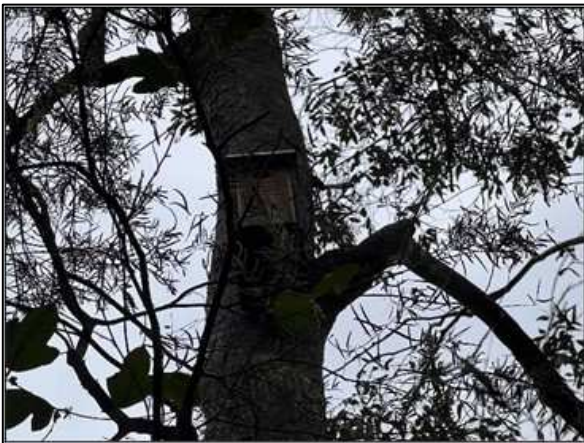
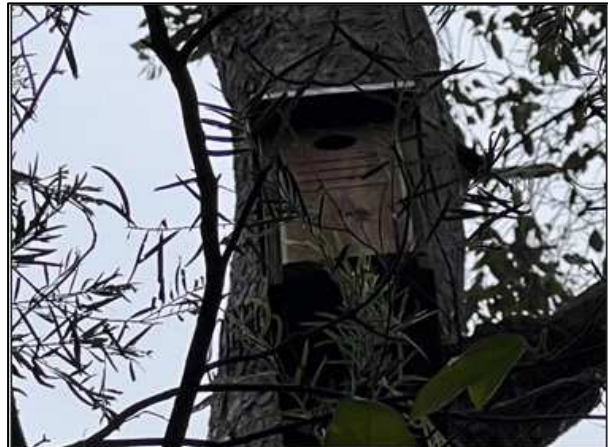
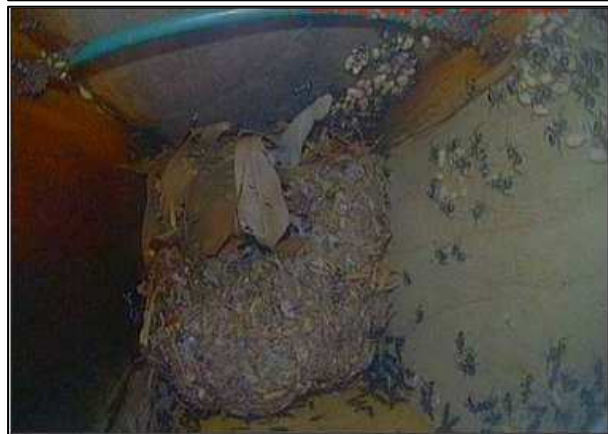
Ant infestation and leaf litter.

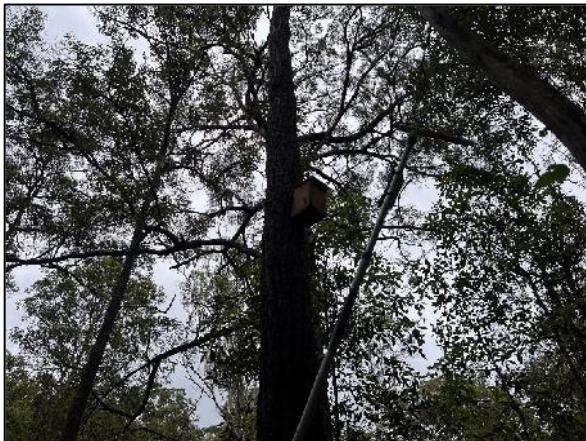
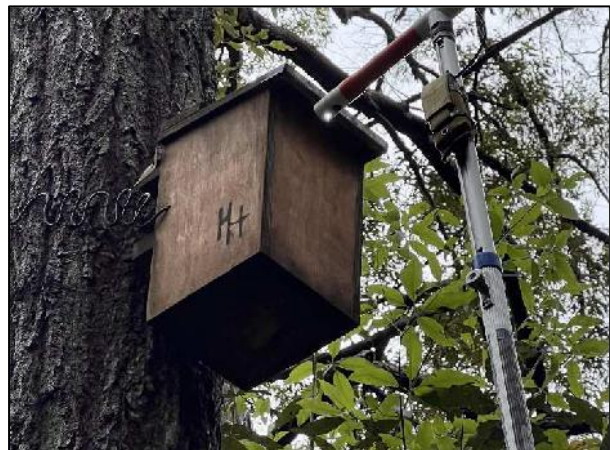
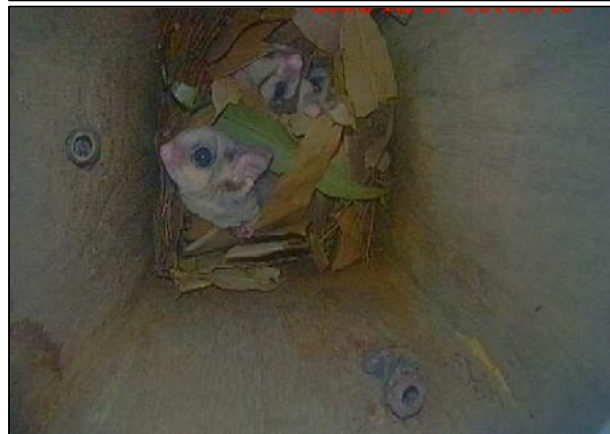
Squirrel gliders.

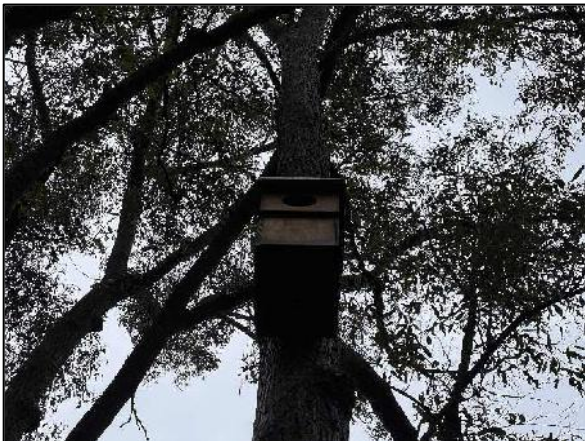
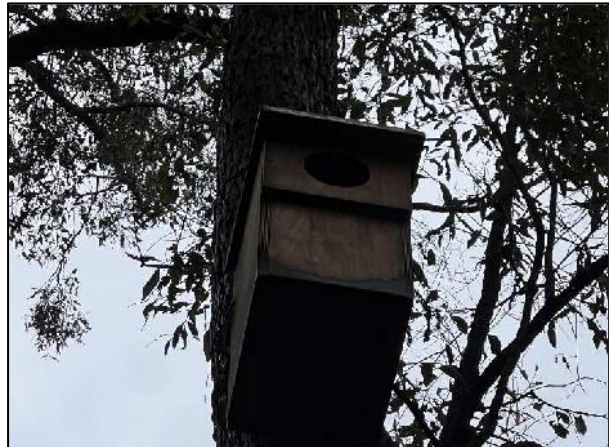
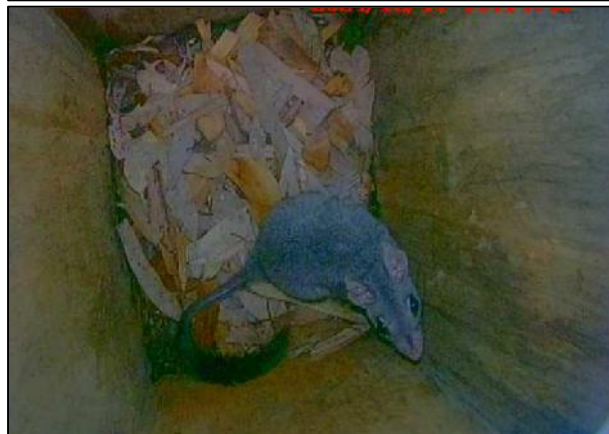
Brushtail phascogale

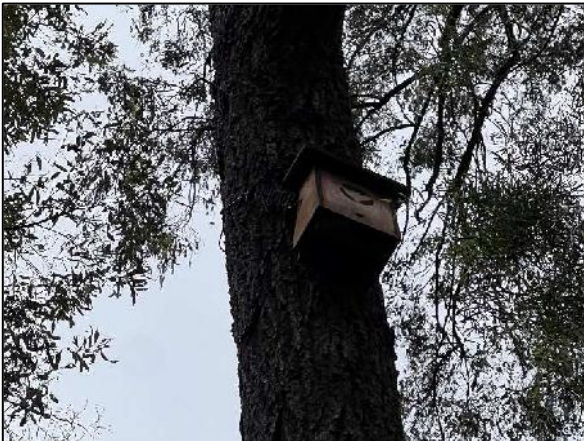
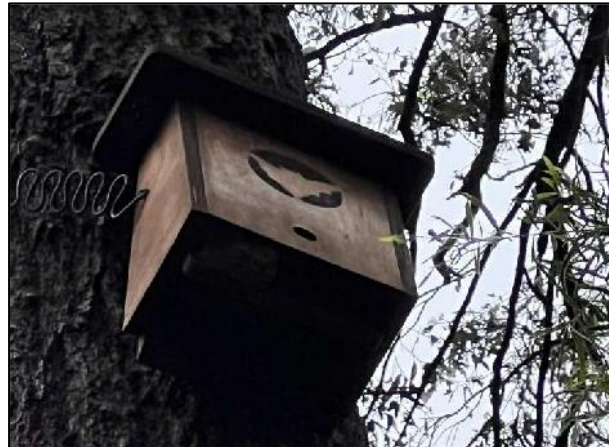
No nesting material present. Spider-webs and insect nests present.

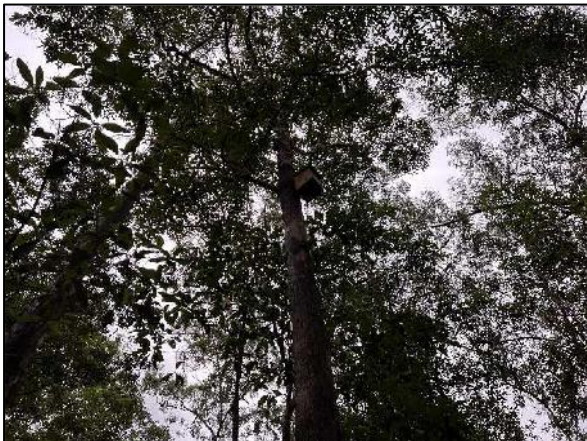
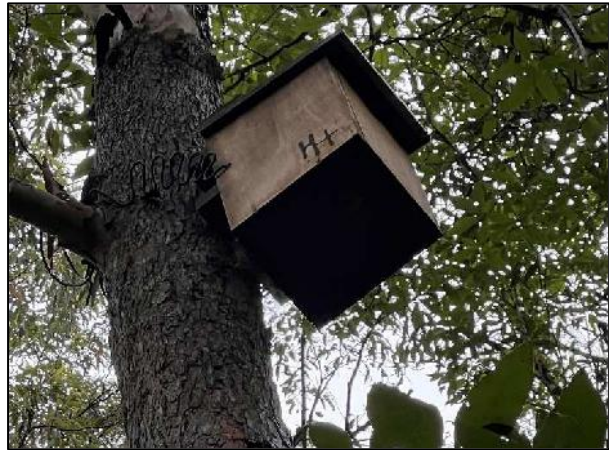
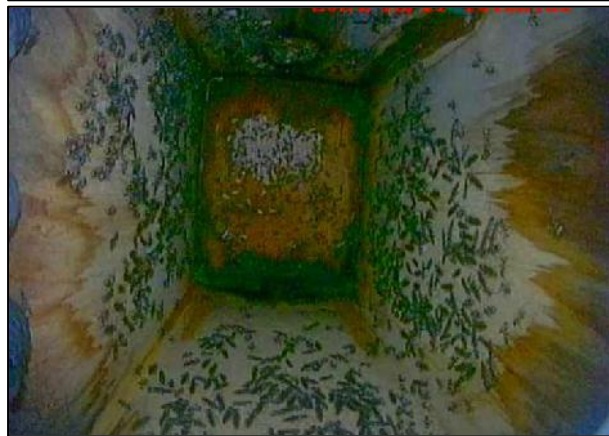
Ant infestation.

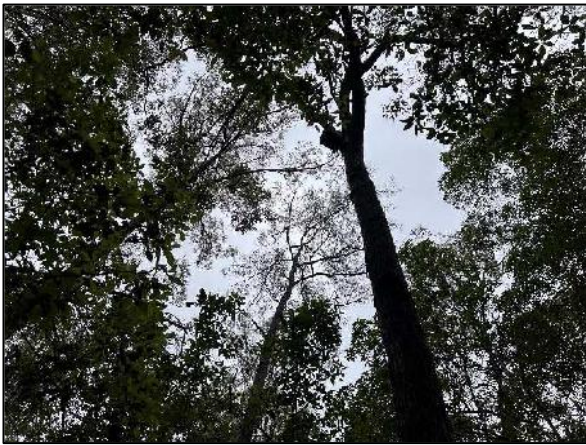
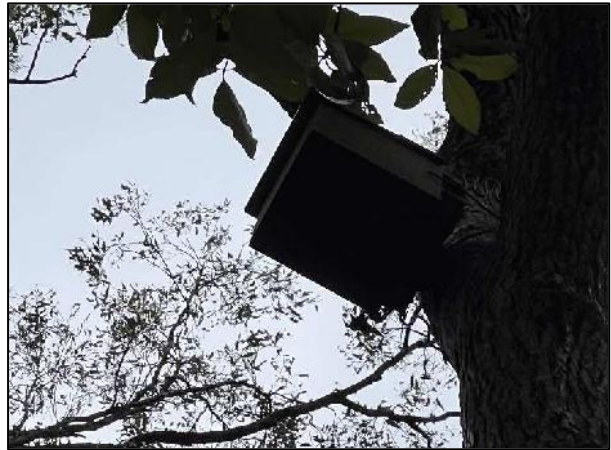
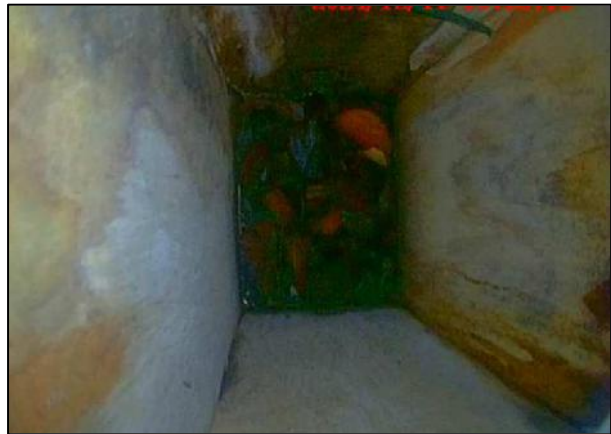
Leaf litter present.

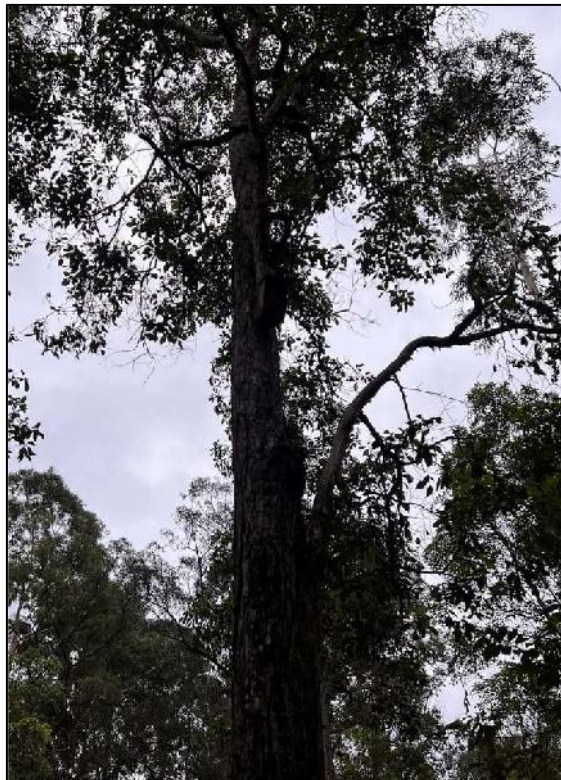
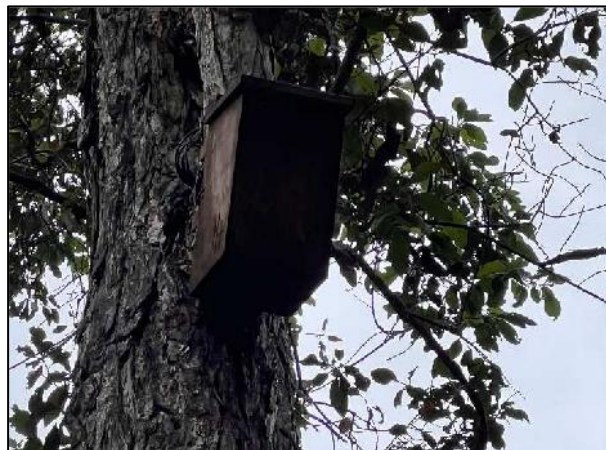
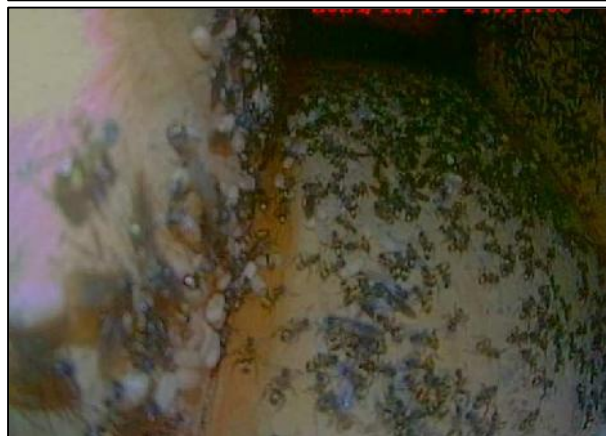
Ant infestation.

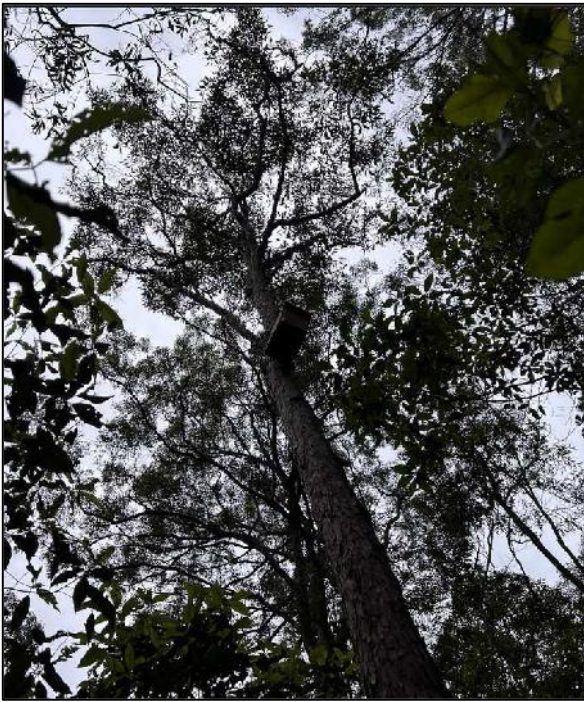
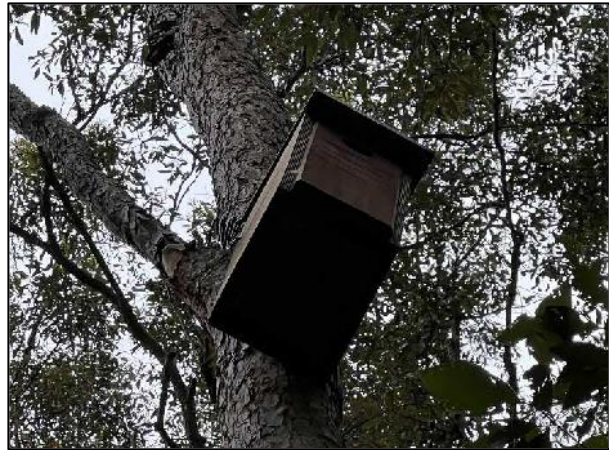
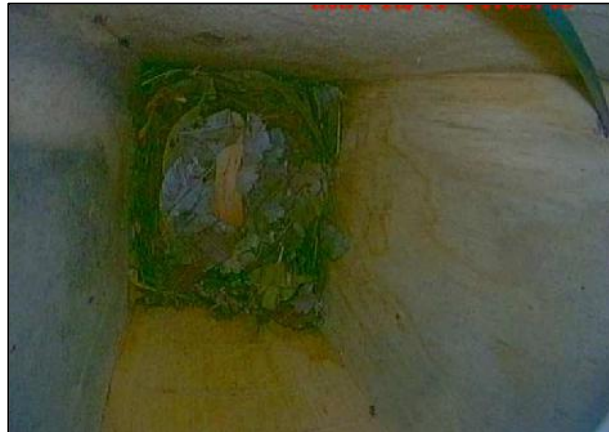
Leaf litter present.
