# Annual Compliance Report

17 October 2023 to 16 October 2024 EPBC 2013/7057  
Spring Mountain Mixed Use Master Planned Community  
Development, Spring Mountain, Queensland

Prepared for Lendlease Communities (Springfield) Pty Limited  
14 January 2025

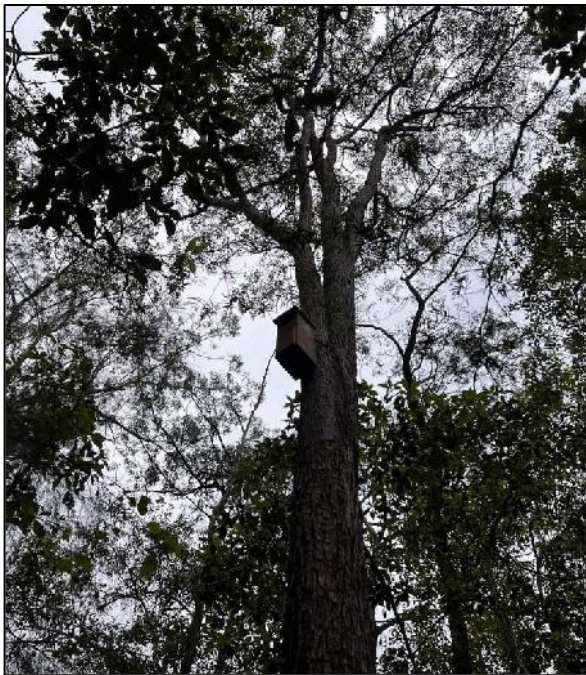
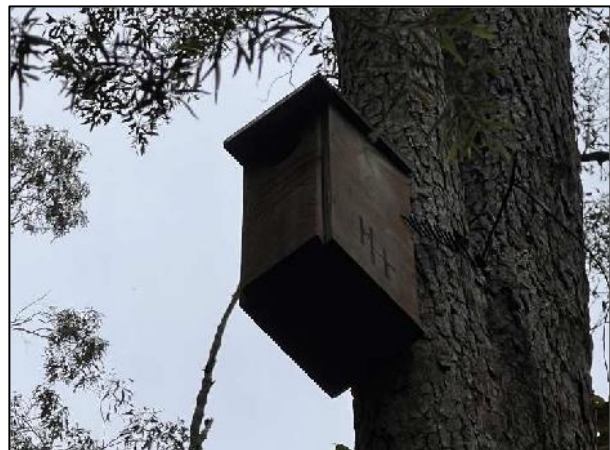
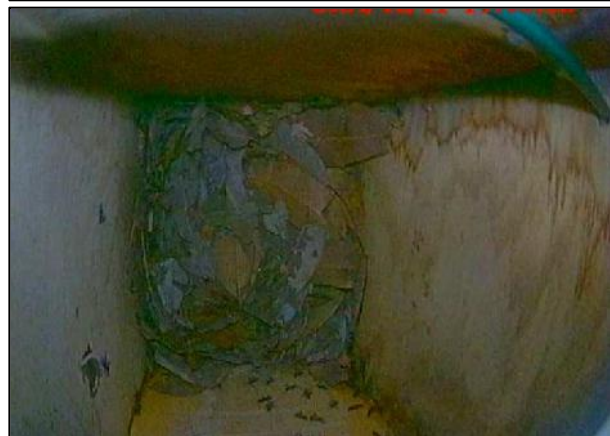
Leaf litter and Ants present

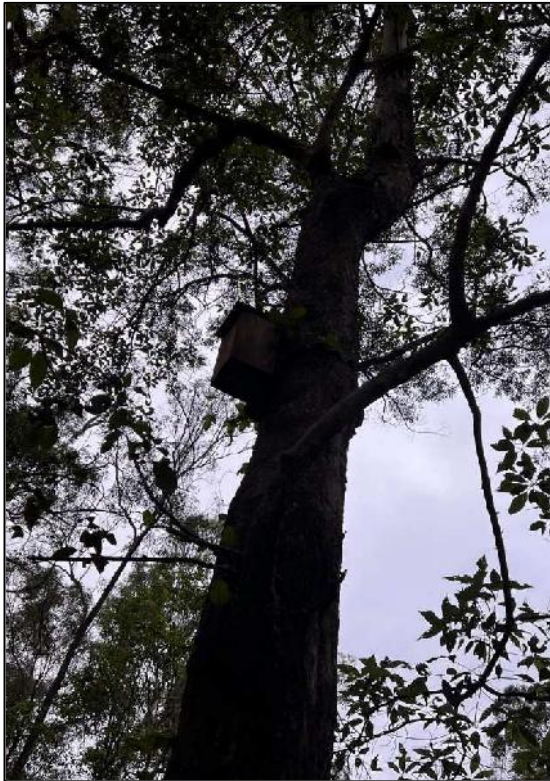
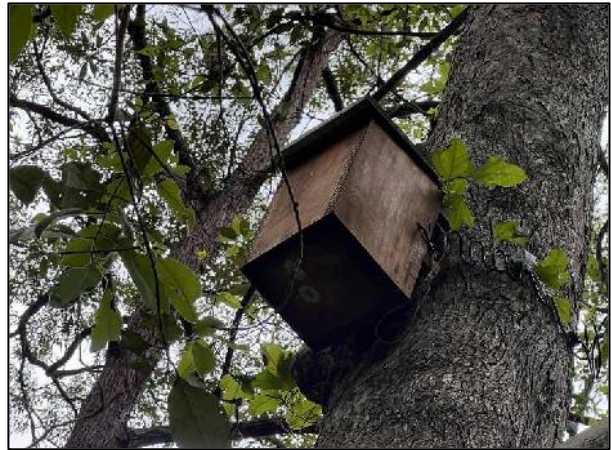
Ant infestation.

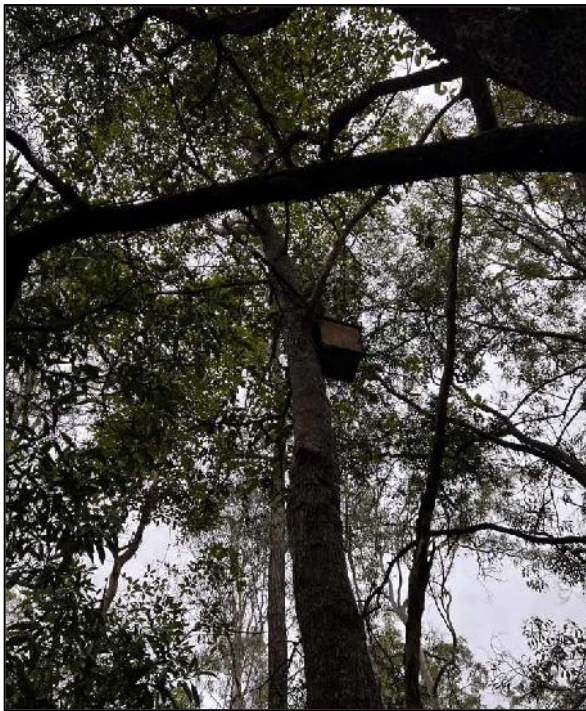
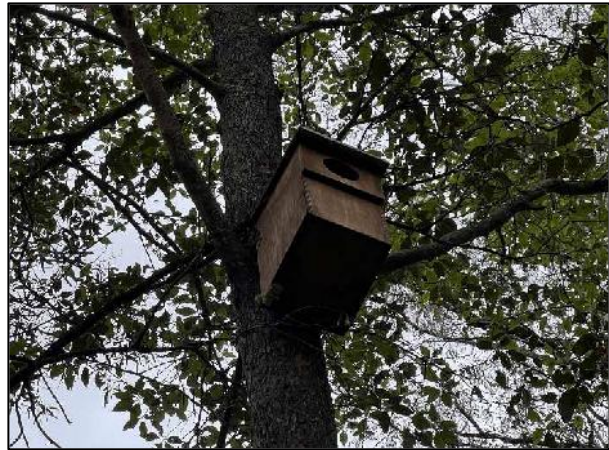
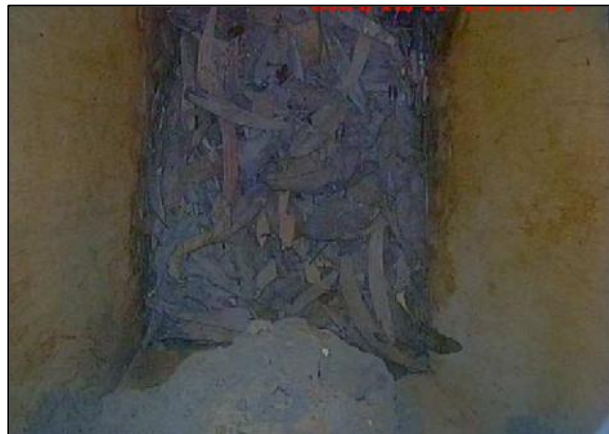
Leaf litter present. Insect mud nest present.

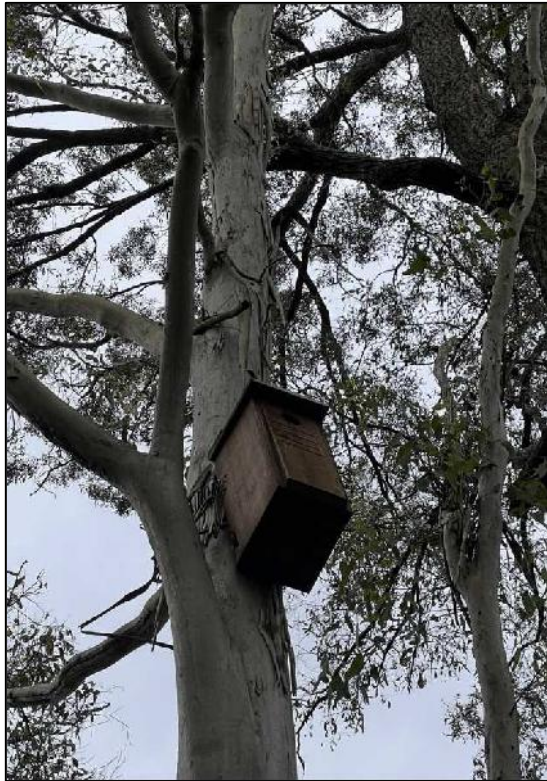
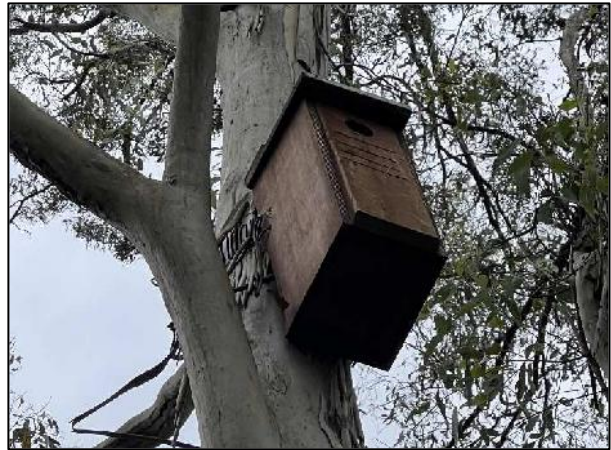
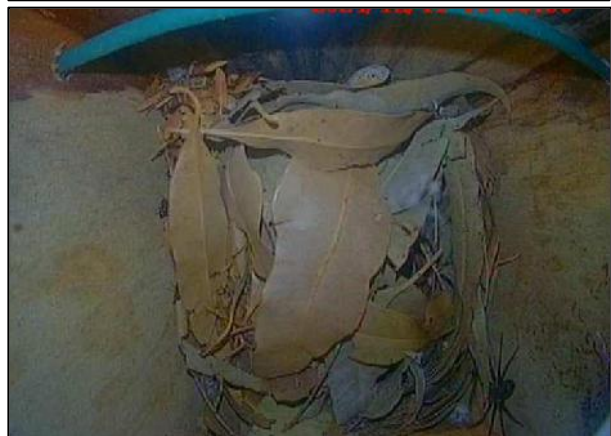
Leaf litter present.

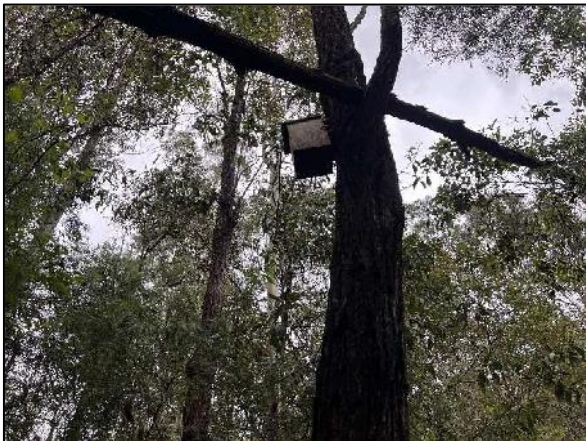
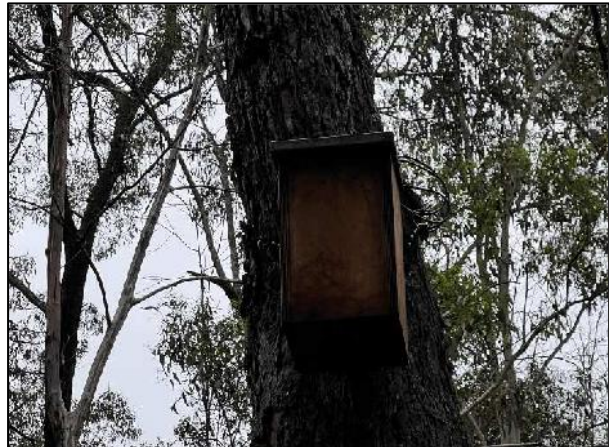
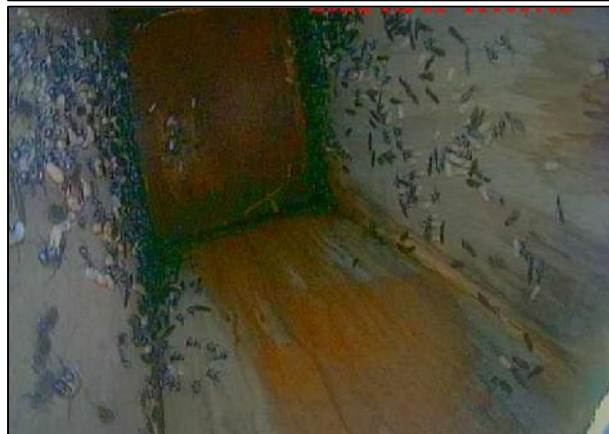
Ant infestation.

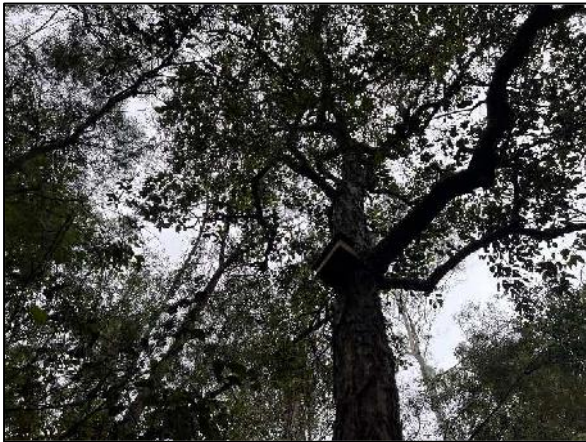
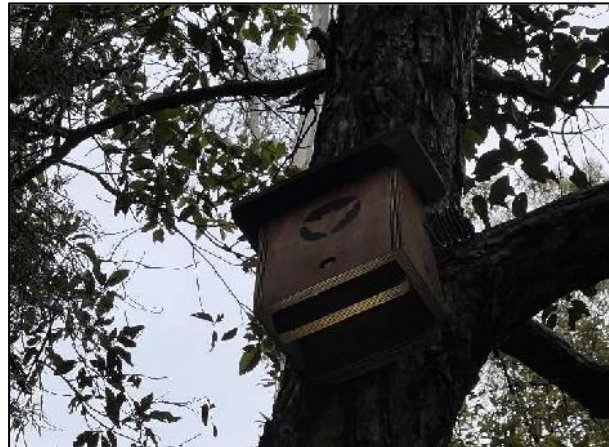
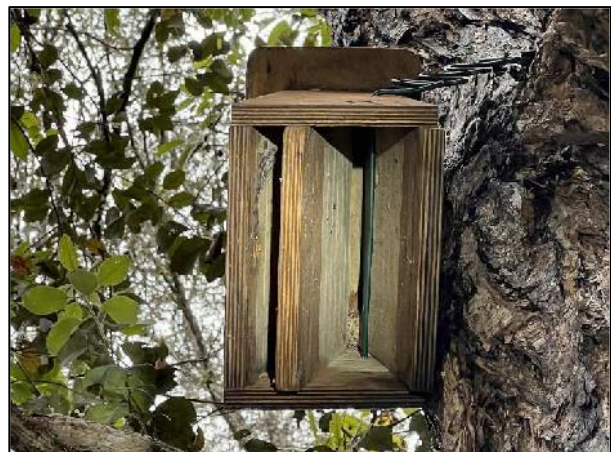
Insects present.

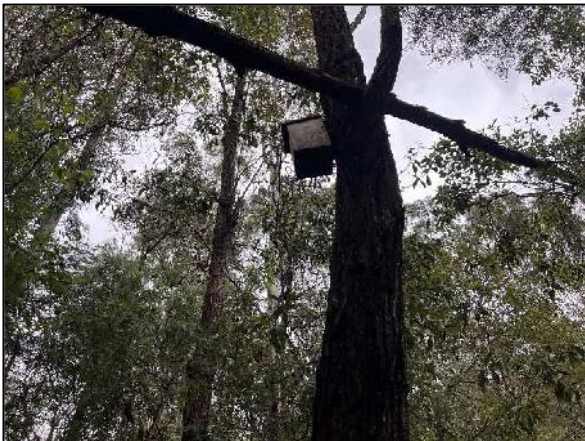
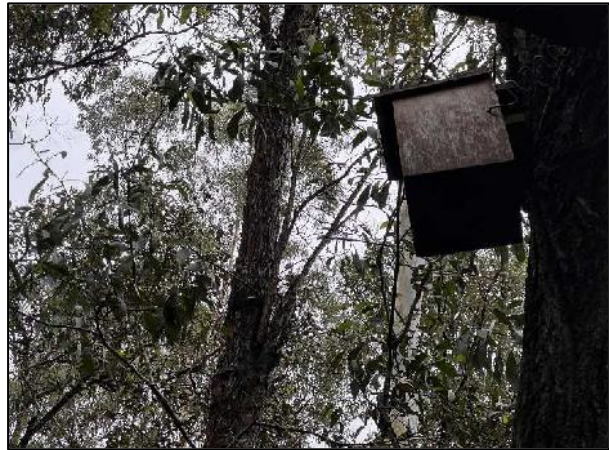
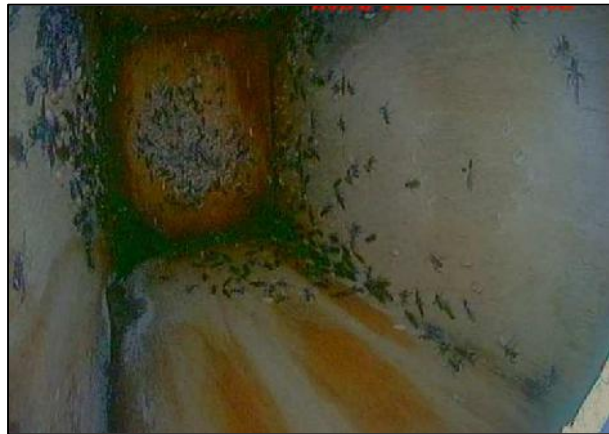
Ant infestation.

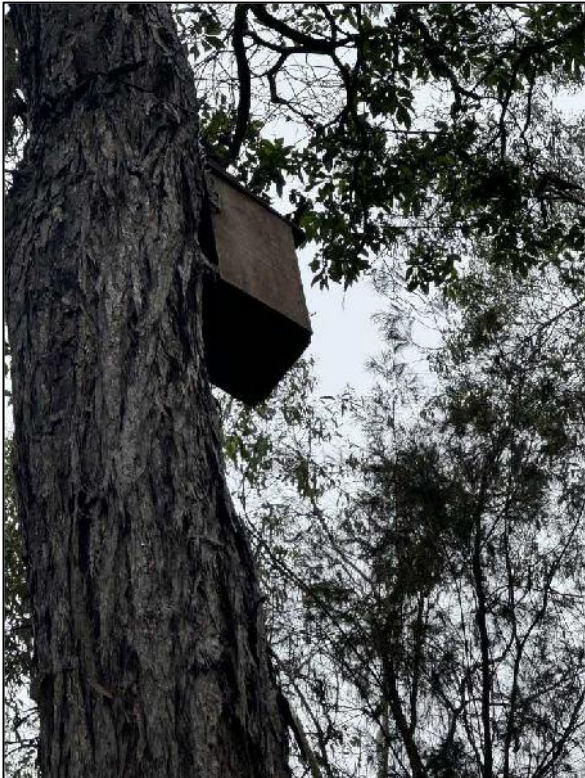
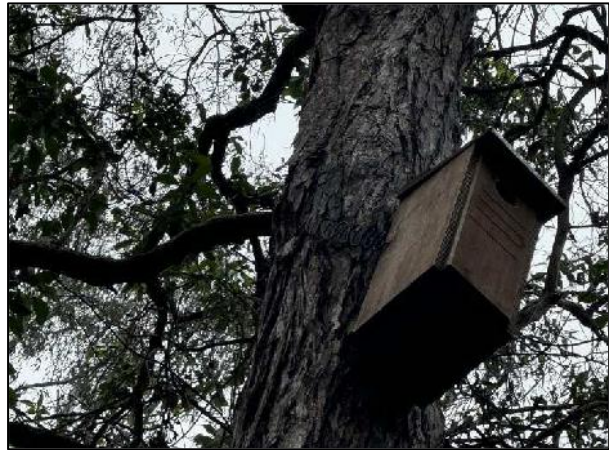
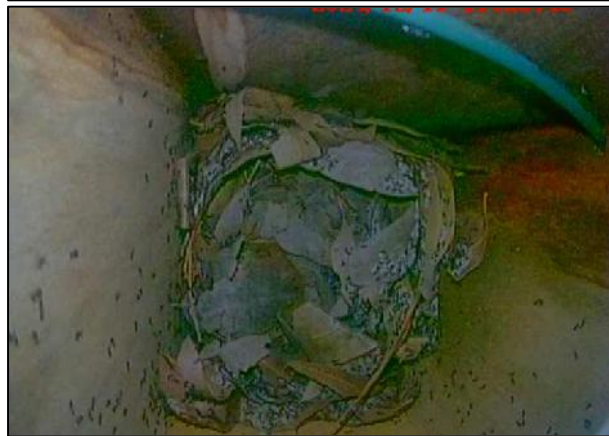
Leaf litter present. Ant infestation.

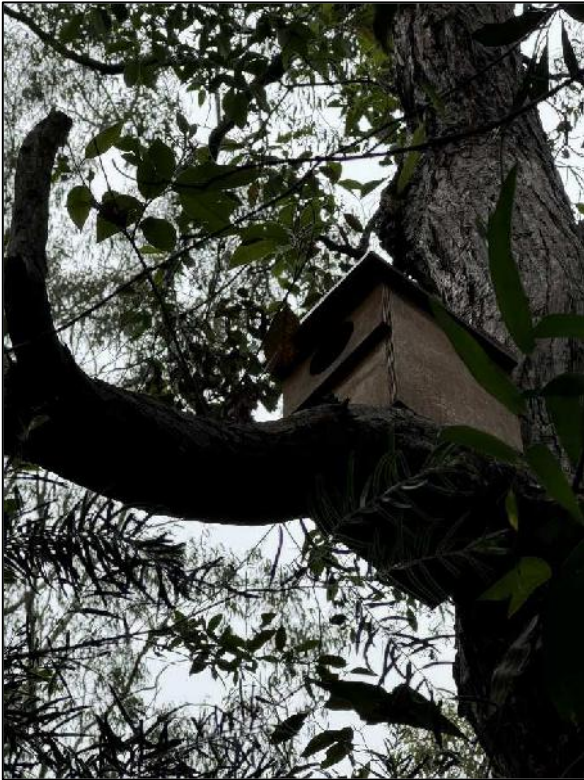
Leaf litter present.

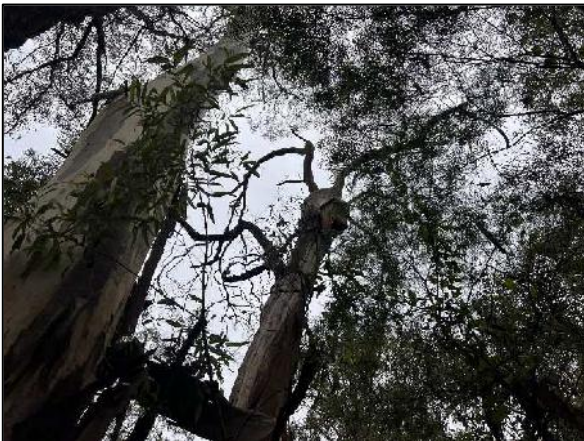
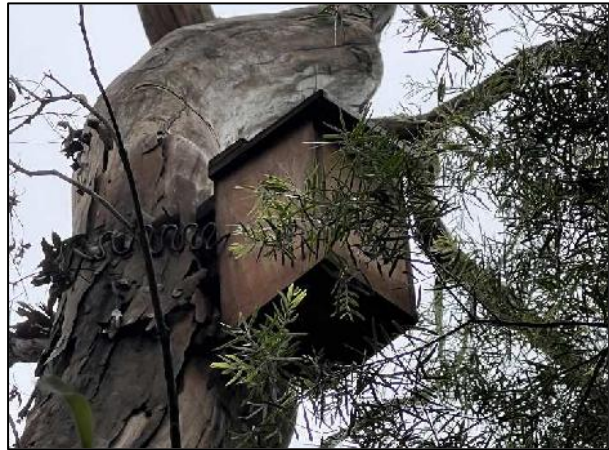
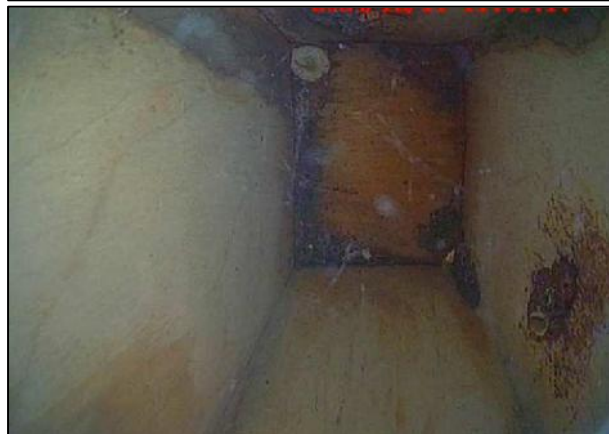
Tree has now died and now considered a stag.

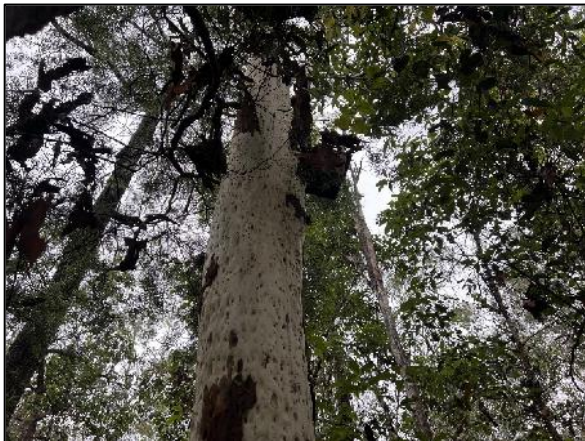
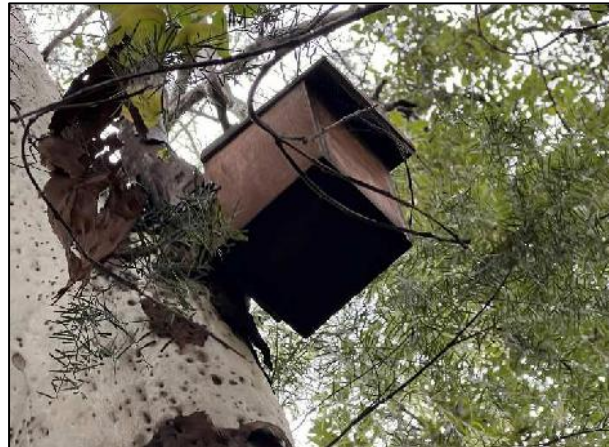
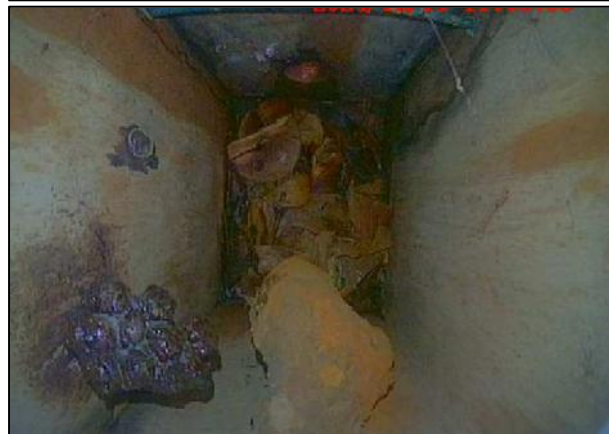
Insect mud nest present. Leaf litter present. Native Bee Hive Present

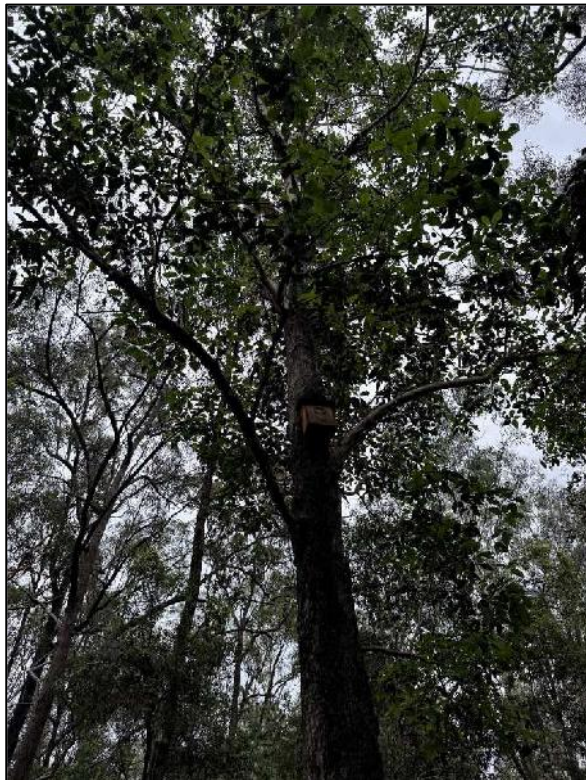
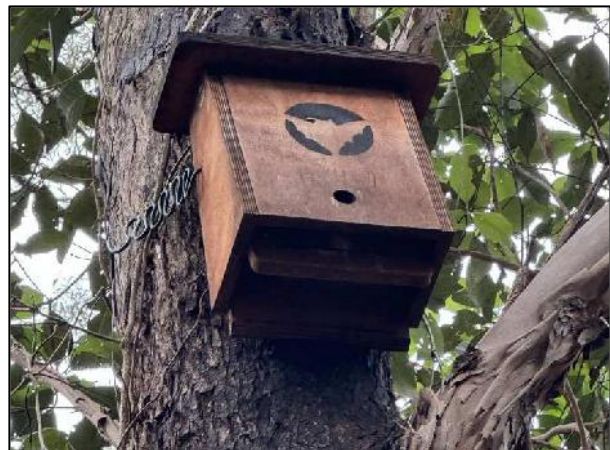
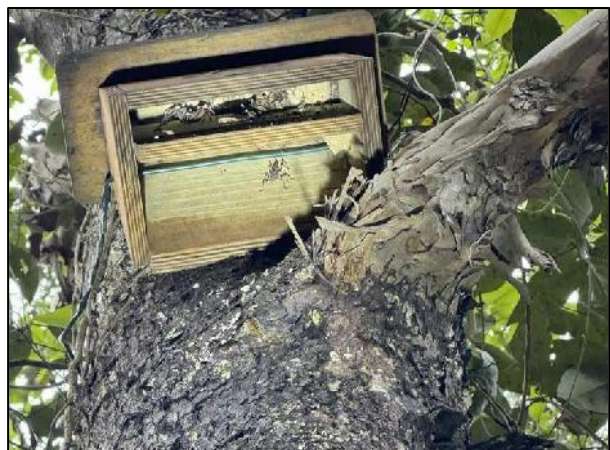
Spiders.

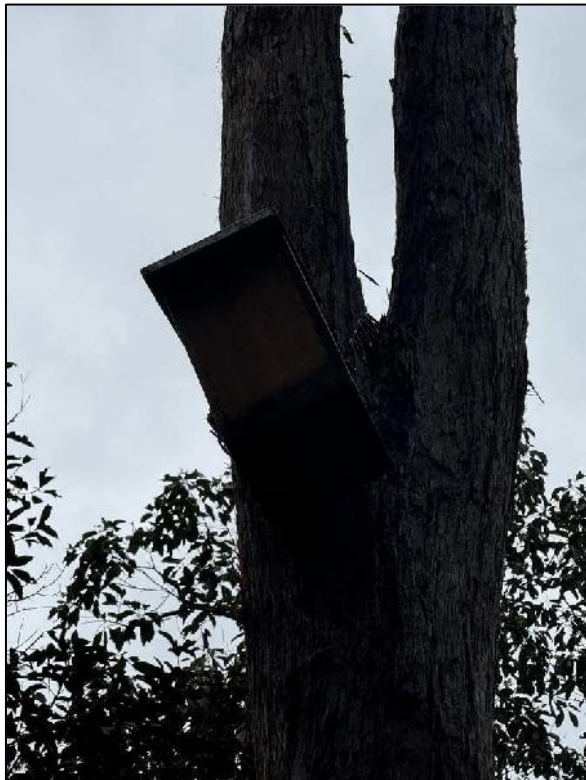
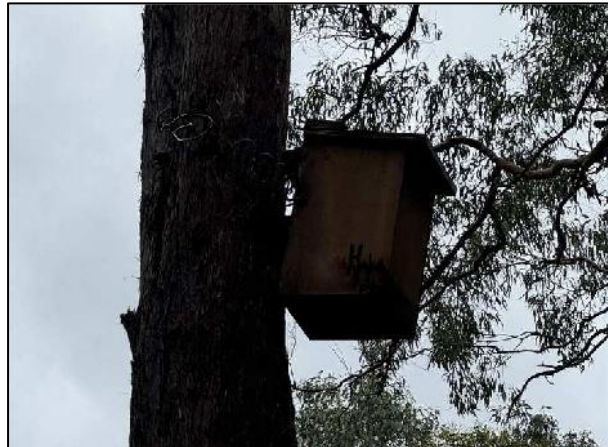
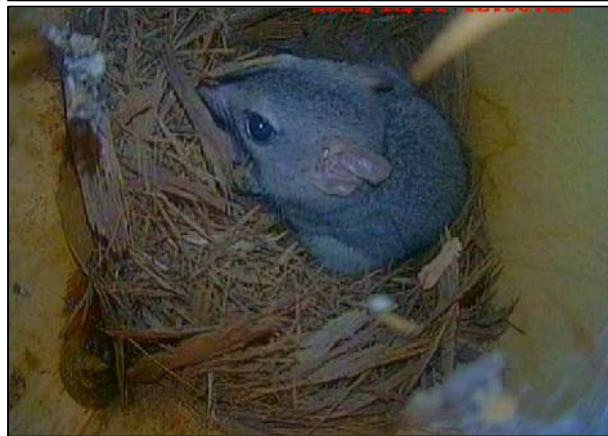
Brushtail phascogale.

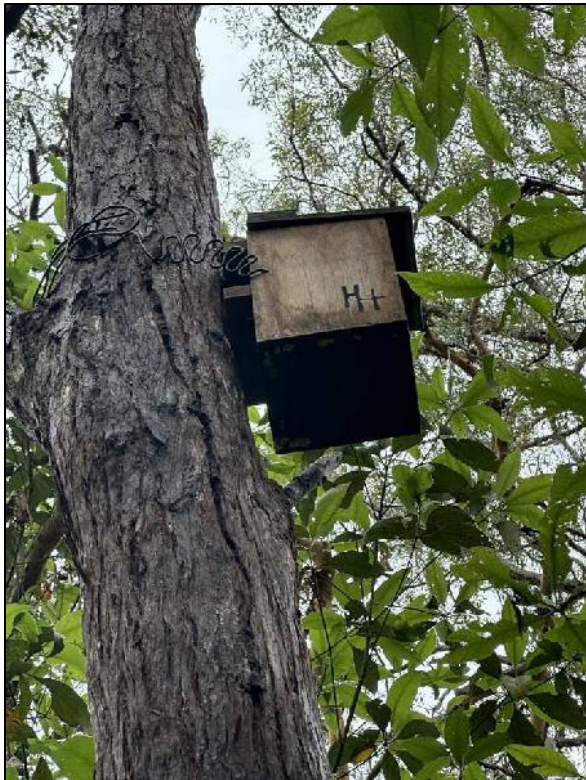
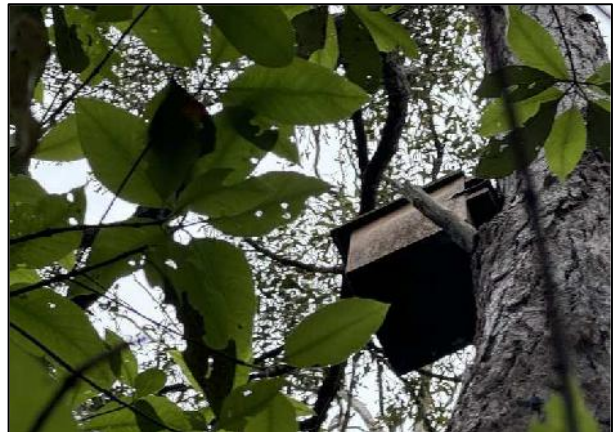
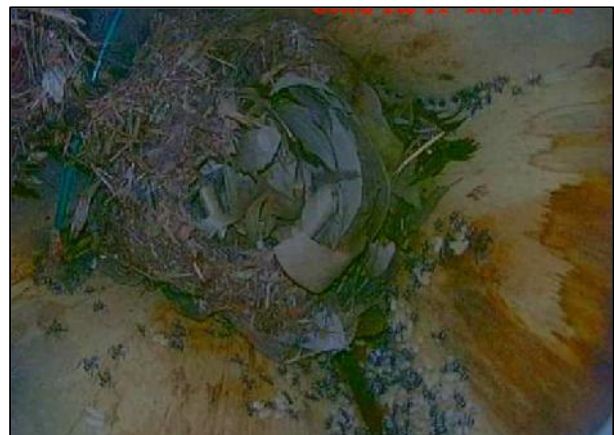
Leaf litter and Ants presence.

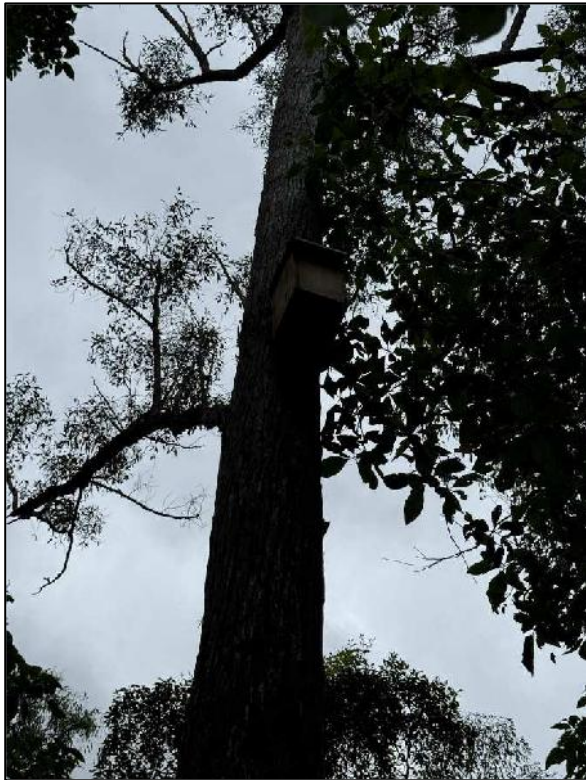
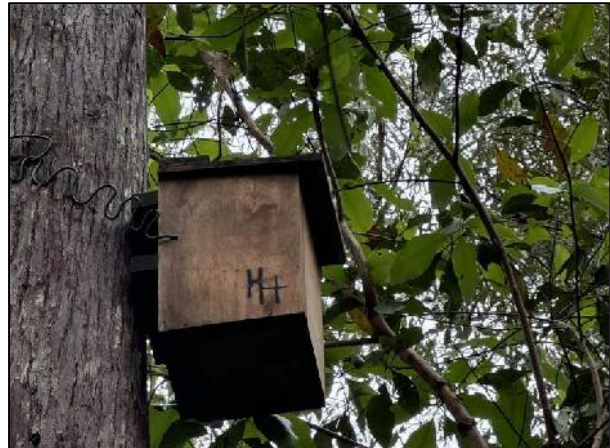
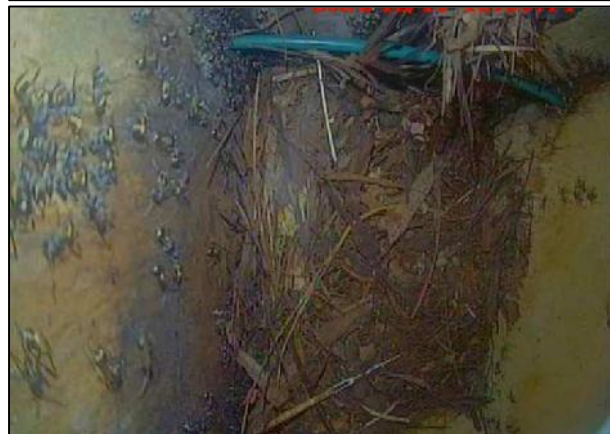
Leaf litter and ants present.

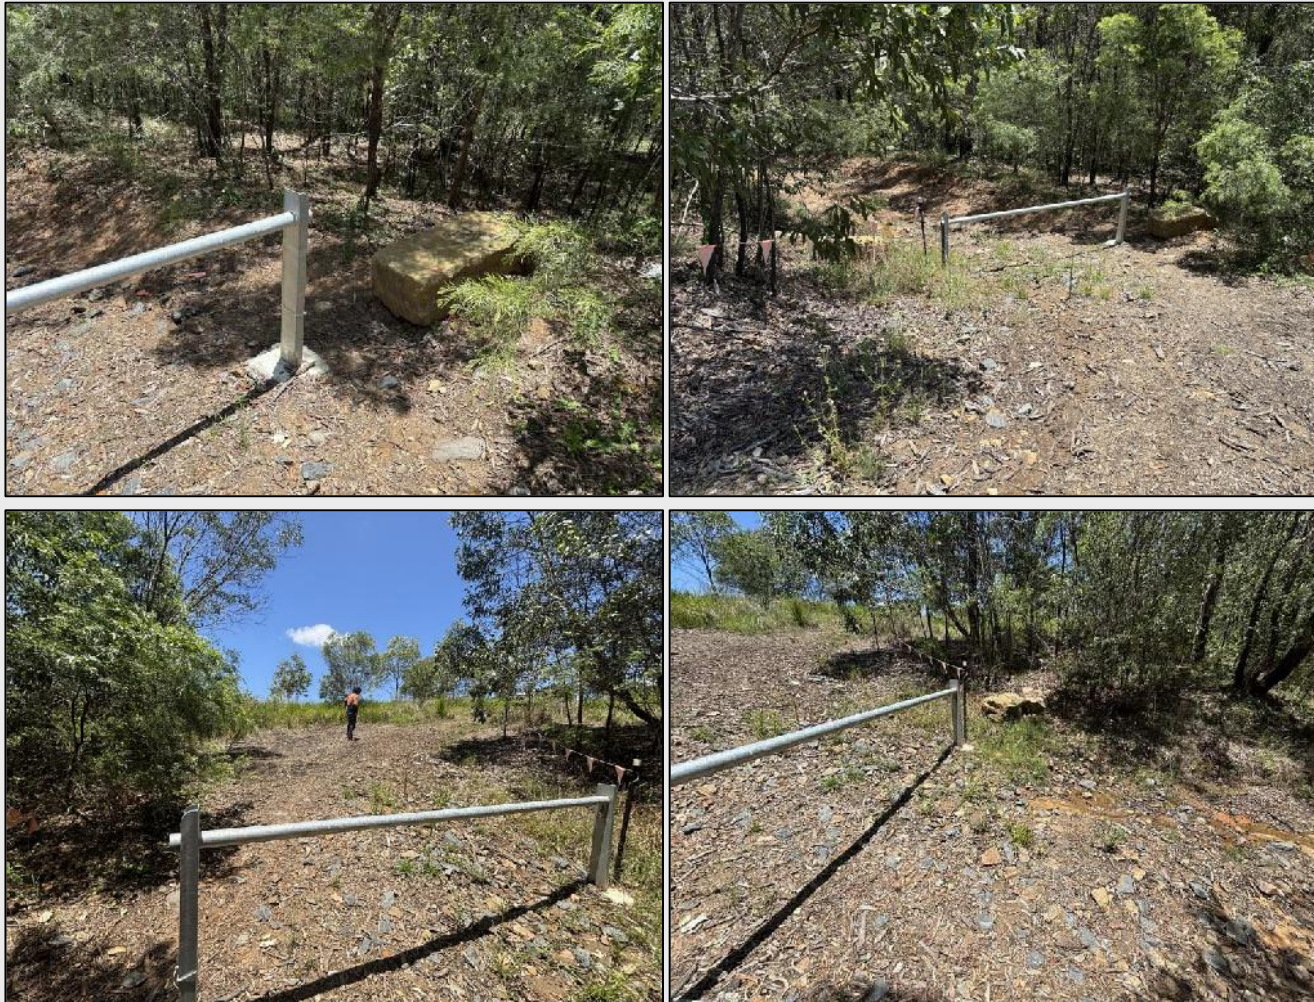
**Securement Point 1**

Sandstone blocks have been replaced with a secure vehicle access bollard.

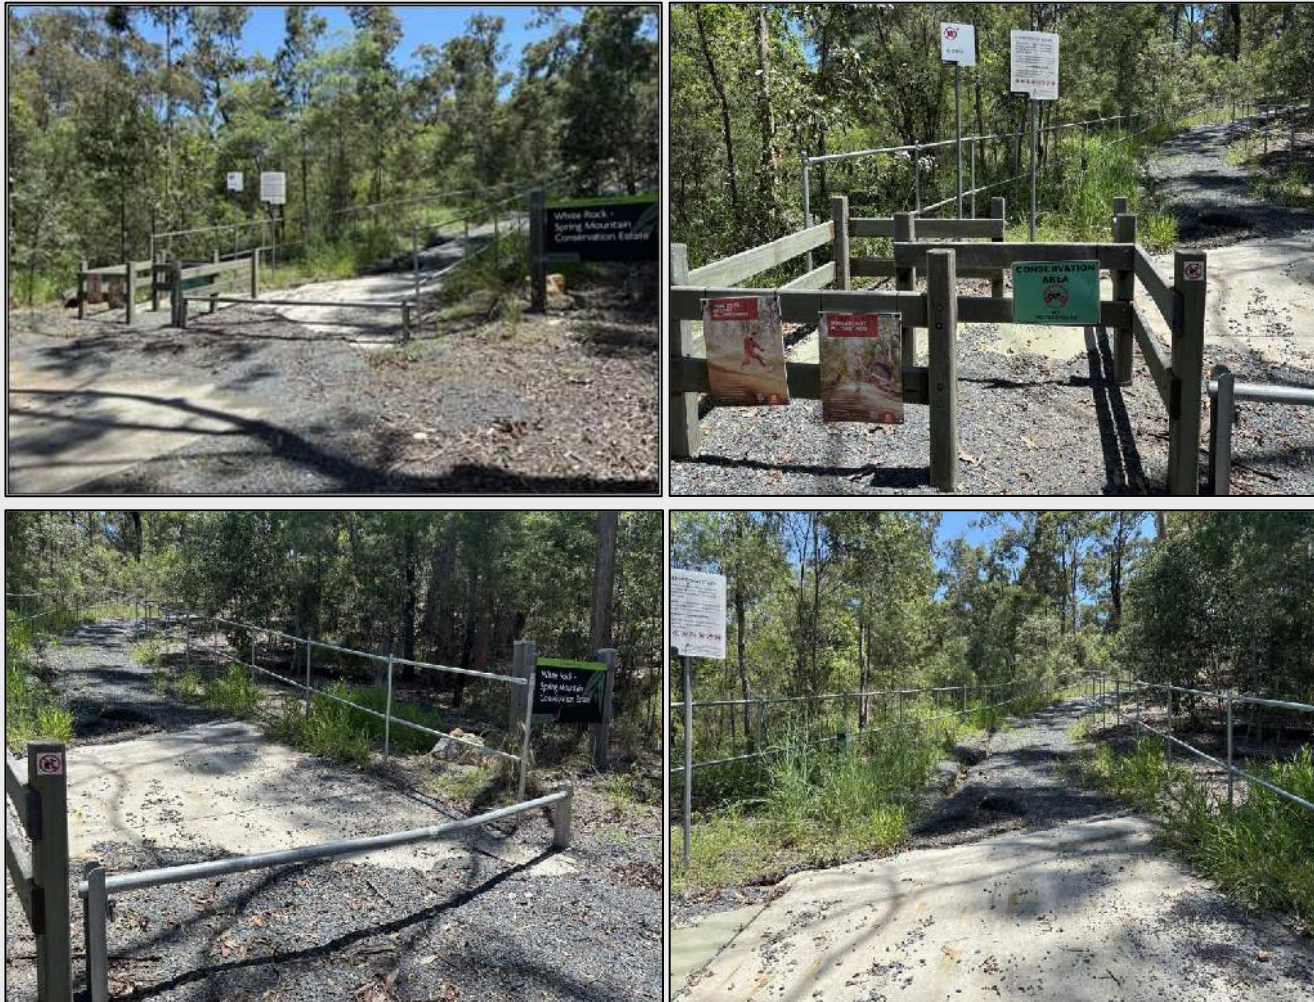
### Securement Point 2

Vehicle access bollard is locked with ICC key, signage and pathway is in okay condition, minor erosion present along gravel track.

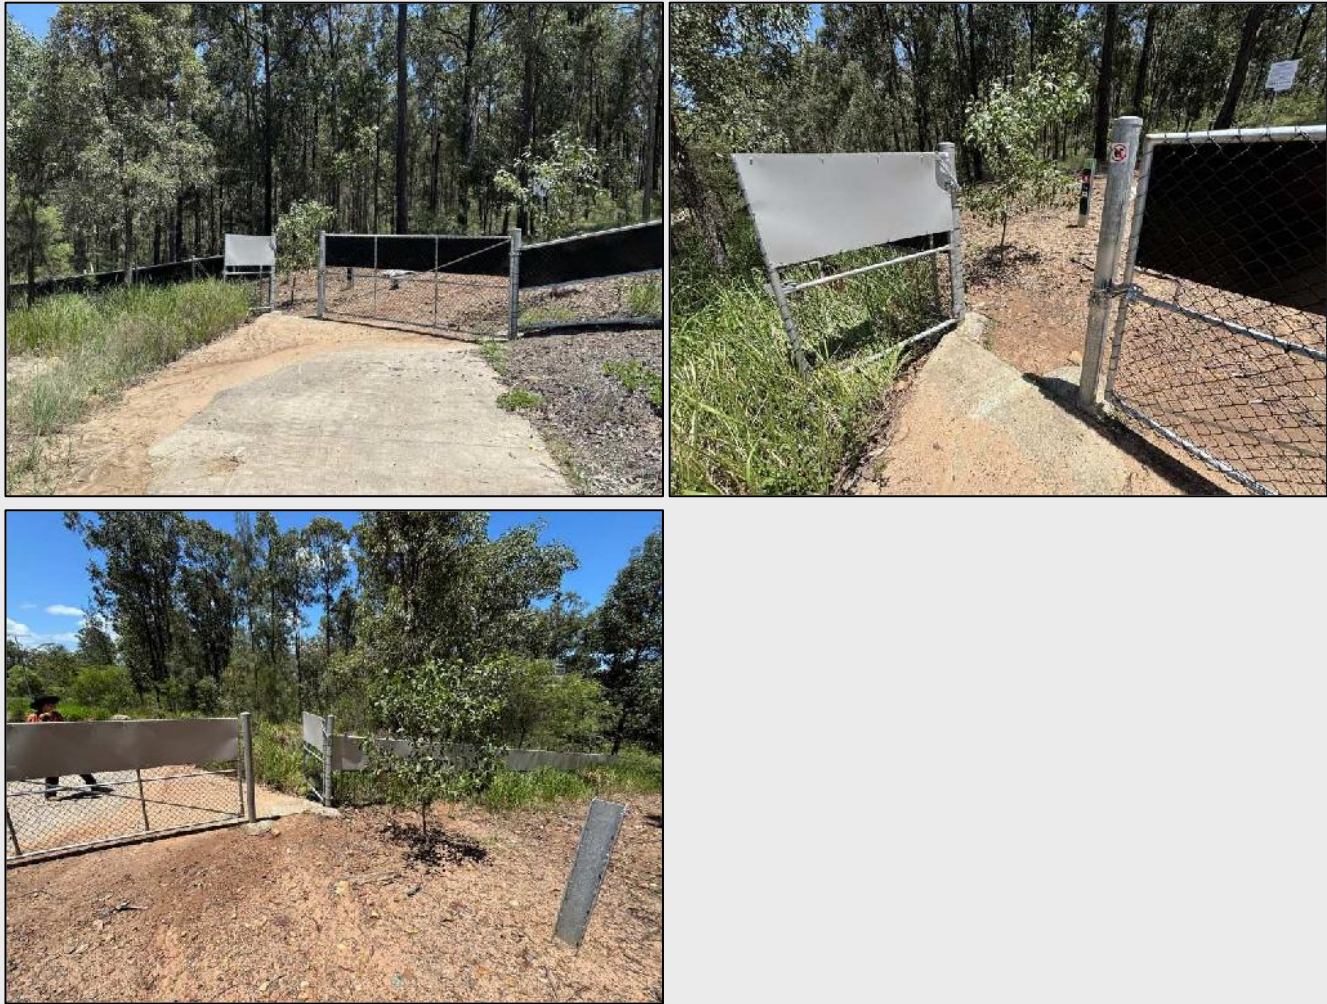
**Securement Point 3**

Vehicle access gate locked with ICC key, pedestrian access unlocked, no signs of forced entry.

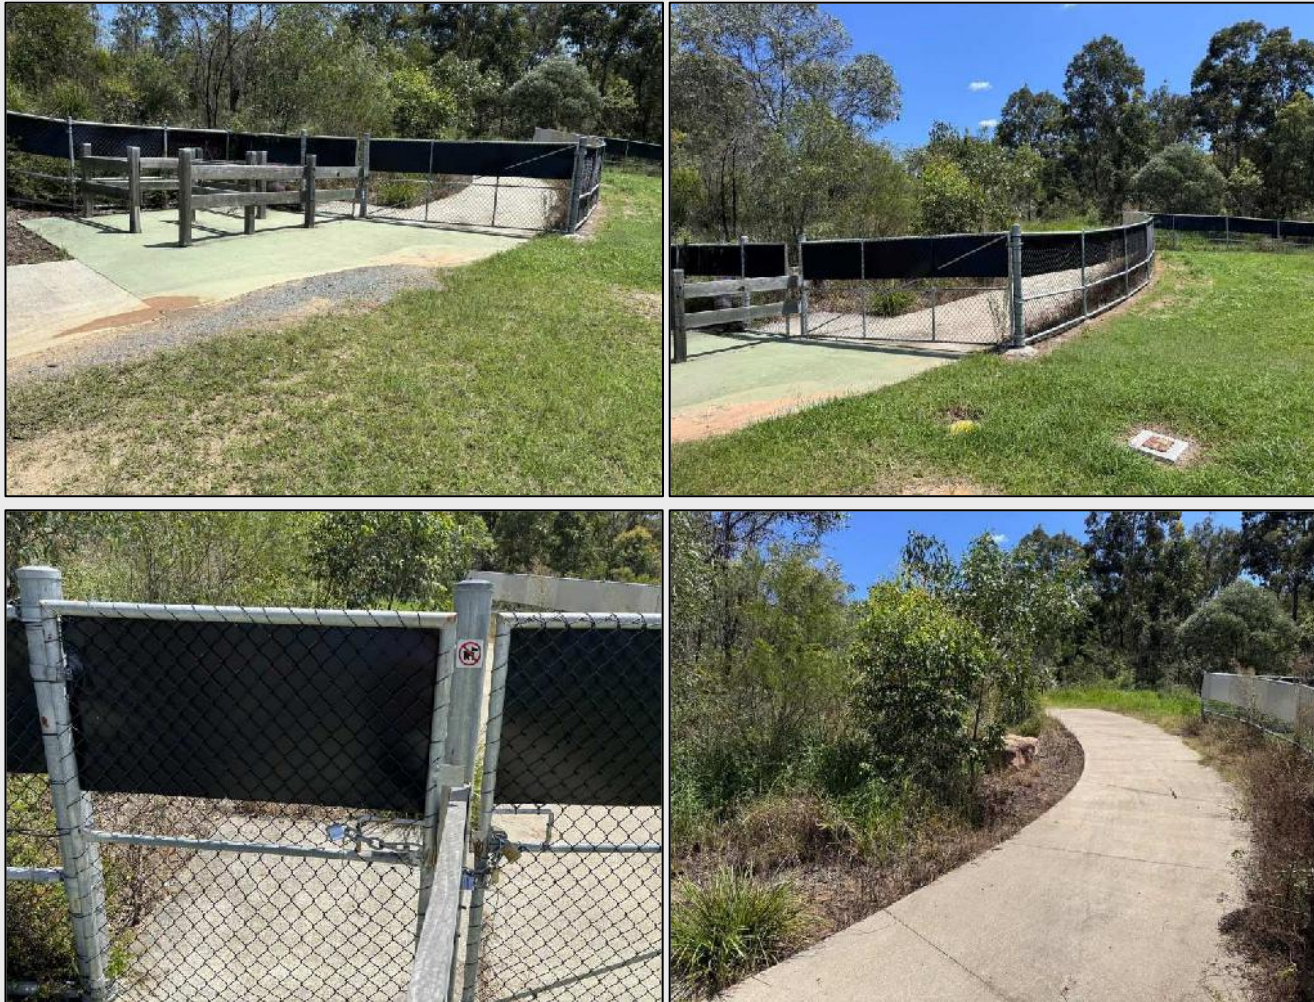
**Securement Point 4**

Vehicle and pedestrian access gate locked with ICC key, pathway is in good, maintained condition.

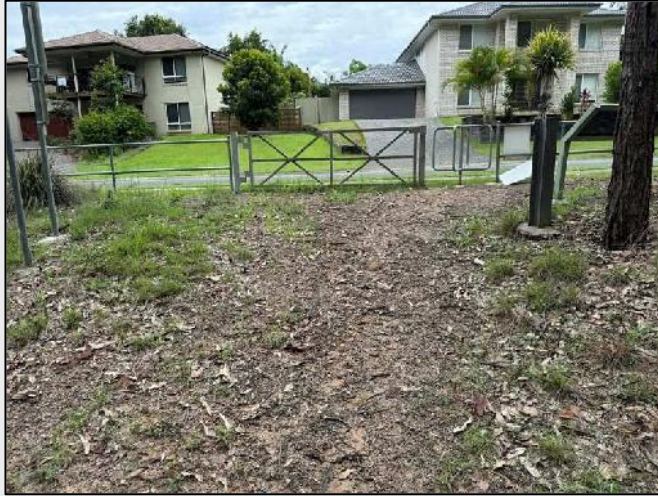
**Securement Points****Securement Point 5**

Pedestrian Access only, signage is present and in good condition

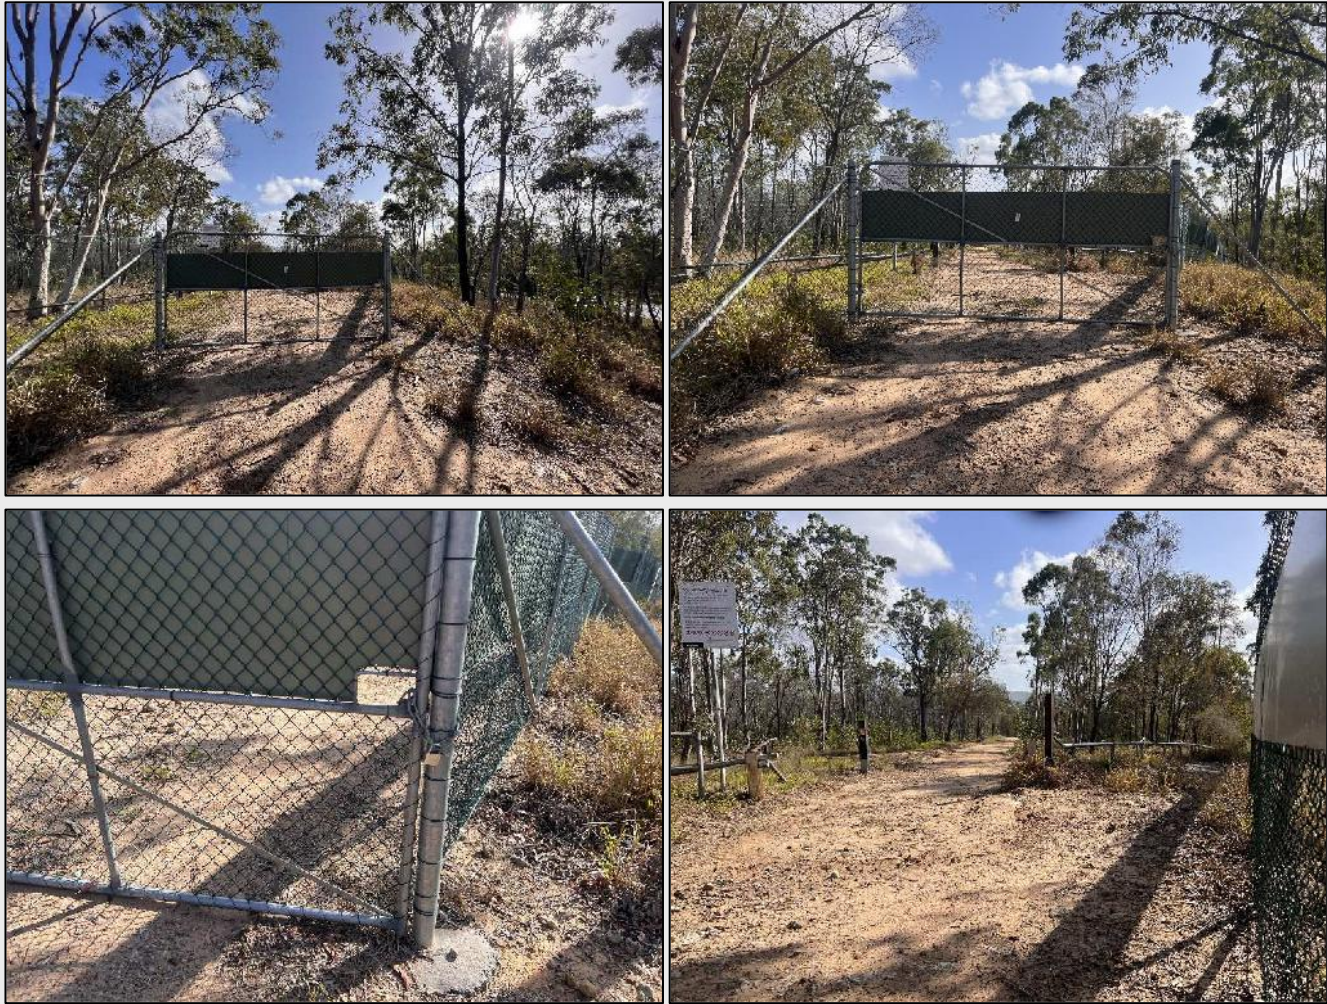
**Securement Point 6**

Locked fauna fence gate and vehicle access bollards with ICC Key (outside of EPBC 2013/7057 Conservation Area)

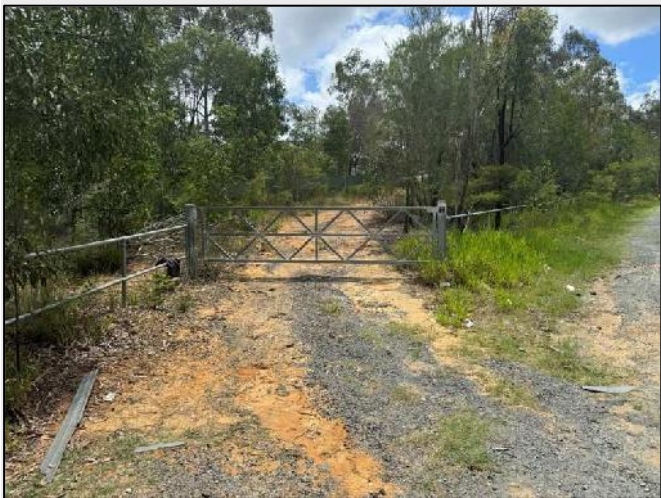
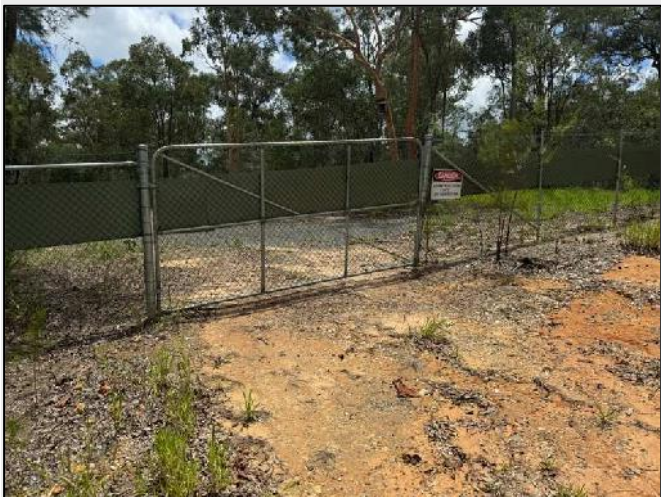
**Securement Points****Securement Point 7**

Locked vehicle access gate and fauna fence gate (further in) with ICC Key (outside of EPBC 2013/7057 Conservation Area)
